# **Whangamata Stormwater Catchment Management Study Catchment Management Study**

**Updated** Issues and Options Report

Draft **Version 2**

*Thames-Coromandel District Council*

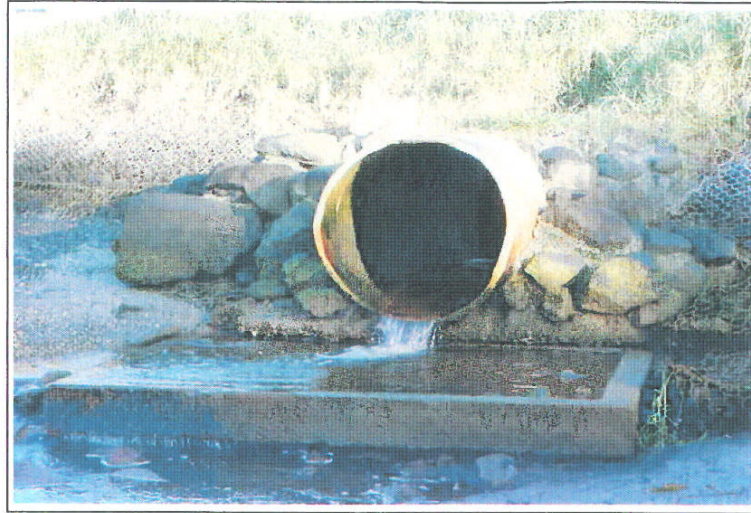
**ASSET NUMBER:** 50820  
**LOCATION:** Kotuku Street  
**CULVERT SIZE:** 1000mm corrugated iron culvert  
**CONDITION:** SW flows into concrete spill basin before reaching the beach. Concrete7d rock around outlet. Banks are stabilised by rock riprap in wire netting. SW has strong sulphur smell. No erosion around outlet or sedimentation in culvert evident.  
**RECOMMENDATION:** None

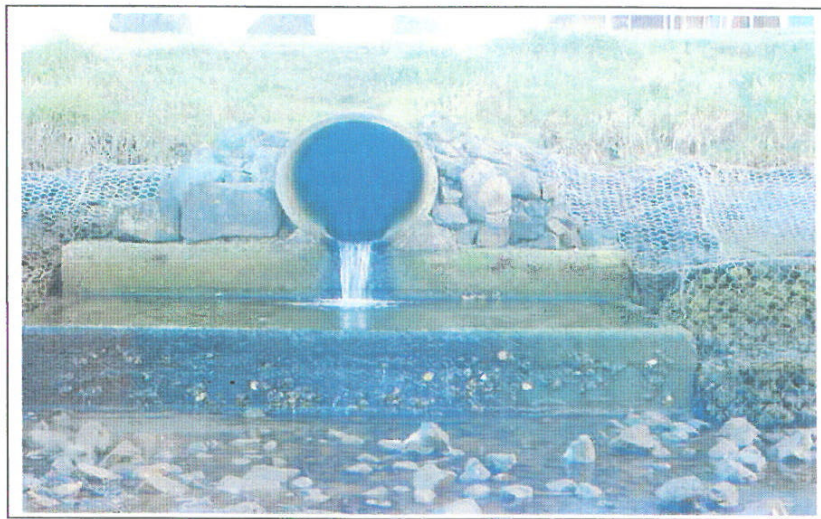
**ASSET NUMBER:** 50883  
**LOCATION:** Kotuku Street  
**CULVERT SIZE:** 900mm concrete culvert  
**CONDITION:** SW flows into concrete spill basin before reaching the beach. Concreted rock around outlet. Banks are stabilised by rock riprap in wire netting. No erosion around outlet or sedimentation in culvert evident.  
**RECOMMENDATION:** None.

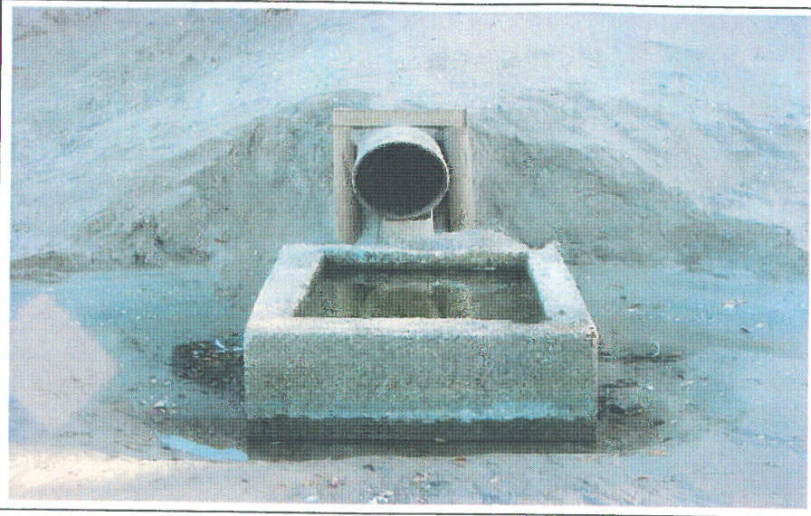
**ASSET NUMBER:** 50965  
**LOCATION:** Off Patuwai Drive  
**CULVERT SIZE:** 375mm concrete culvert  
**CONDITION:** SW flows into concrete spill basin before reaching the beach. A timber cradle supports the outlet. Some erosion around the cradle exists. No sedimentation within the culvert is evident. Culvert appears dry.

**RECOMMENDATION:** Place rock riprap around the outlet to support the bank.

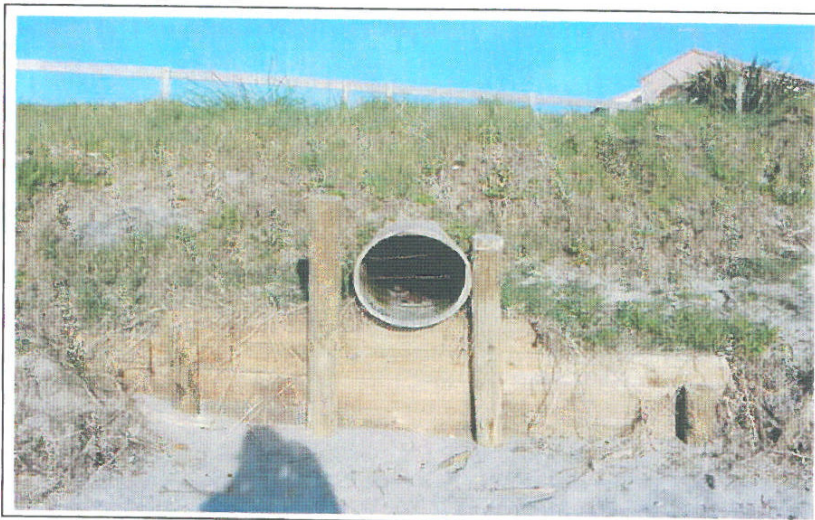
**ASSET NUMBER:** 50976  
**LOCATION:** Off Pohutakawa Crescent  
**CULVERT SIZE:** 375mm concrete culvert  
**CONDITION:** Culvert outlet is supported on top of a low timber retaining wall which acts as a cradle. 3x horizontal steel grates are at the outlet. No sedimentation within the culvert or erosion around the outlet is evident. The surrounding banks are vegetated/stabilised with dune grass.

**RECOMMENDATION:** None

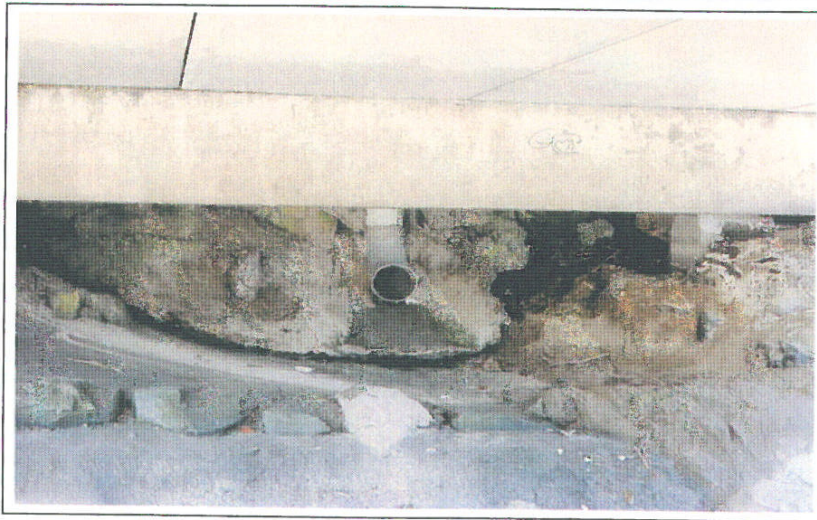
**ASSET NUMBER:** 50550  
**LOCATION:** Off Port Road Under Wharf  
**CULVERT SIZE:** 225mm PVC Pipe  
**CONDITION:** PVC pipe exists under the wharf with its outlet surrounded by concrete and rock. No erosion or sedimentation is evident.  
**RECOMMENDATION:** None

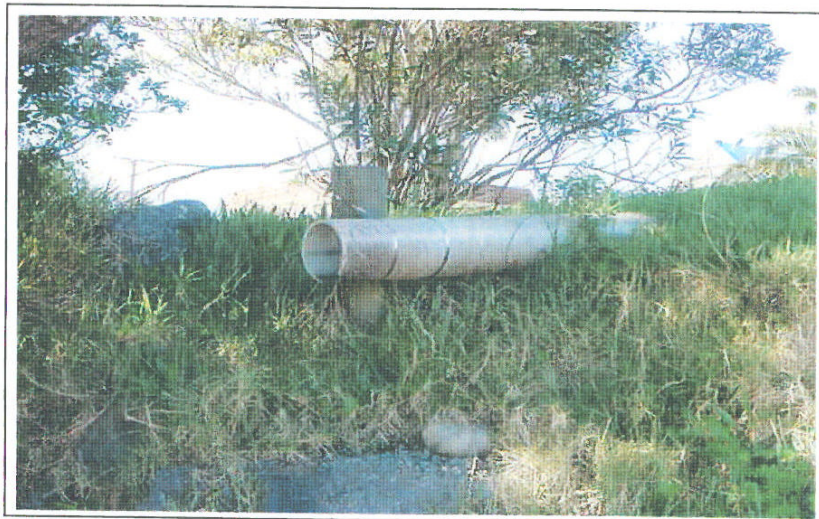
**ASSET NUMBER:** 103033  
**LOCATION:** End of Bond Street  
**CULVERT SIZE:** 225mm concrete culvert  
**CONDITION:** Culvert outlet is at road level. SW falls through vegetation and rock down a bank to the beach. The outlet is supported against a timber post connected by a metal strap. No sedimentation or erosion is  
**RECOMMENDATION:** None

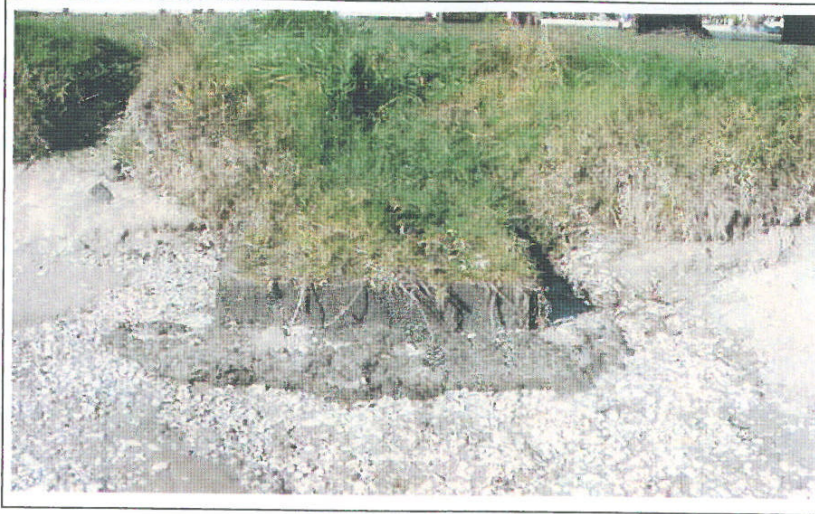
**ASSET NUMBER:** 50535  
**LOCATION:** Off Beach Road  
**CULVERT SIZE:** GIS shows this as a 300mm culvert  
**CONDITION:** Culvert outlet could not be located due to overgrowth. A catchpit exists in the carpark and is in line with the photo above. Concrete spillway is full on soil and grass. No surrounding erosion is evident.

**RECOMMENDATION:** Clear vegetation, unblock culvert and clean spillway.

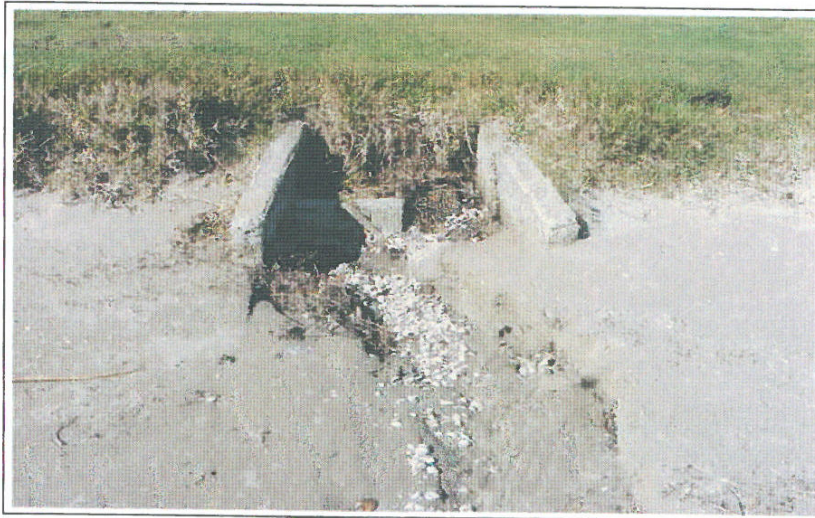
**ASSET NUMBER:** 102857  
**LOCATION:** Off beach Road  
**CULVERT SIZE:** 225mm concrete culvert  
**CONDITION:** Outlet is at beach level and is 50% blocked. A 0.5m high by 1m long concrete headwall exists on either side of outlet to channel SW flow. A piece of concrete within the channel is partially restricting SW flow. The surrounding bank is vegetated with no sign of erosion.

**RECOMMENDATION:** Remove debris from outlet. Remove concrete that is partially restricting flow.

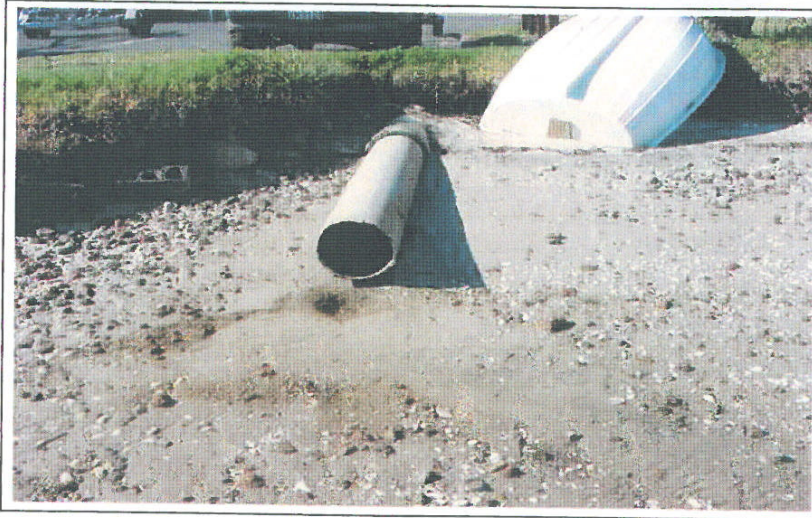
**ASSET NUMBER:** 102866  
**LOCATION:** End of Harbour View Road  
**CULVERT SIZE:** 300mm concrete culvert  
**CONDITION:** Outlet is at beach level with a 0.5m bank behind to the road level. Bank is vegetated with no sign of erosion. The end of the culvert is chipped at the outlet. No rock support exists around the outlet but is not required. No sedimentation evident.  
**RECOMMENDATION:** None

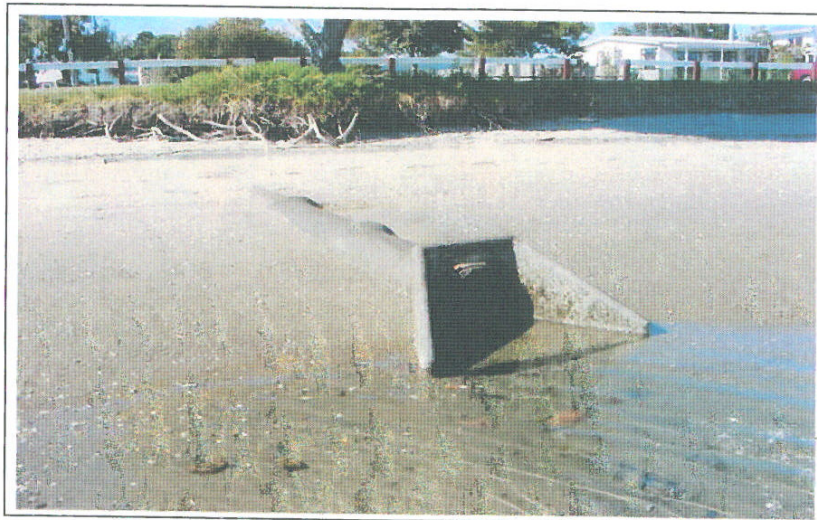
**ASSET NUMBER:** 50530  
**LOCATION:** End of Harbour View Road  
**CULVERT SIZE:** 300mm concrete culvert  
**CONDITION:** Outlet extends approximately 5m from the bank. Concrete headwall exists around outlet. No sedimentation or erosion is evident.  
**RECOMMENDATION:** None

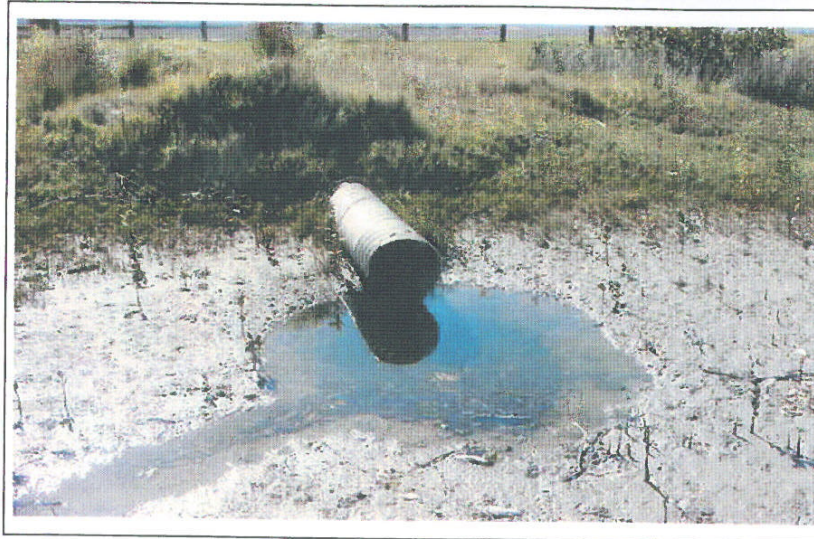
**ASSET NUMBER:** 102871  
**LOCATION:** End of Beach Road near proposed marina  
**CULVERT SIZE:** 300mm corrugated iron culvert  
**CONDITION:** Outlet exists at road level. Bank is vegetated and no erosion exists. No sedimentation exists within the culvert. No rock support is around the outlet for support.

**RECOMMENDATION:** Place minor rock riprap around outlet.

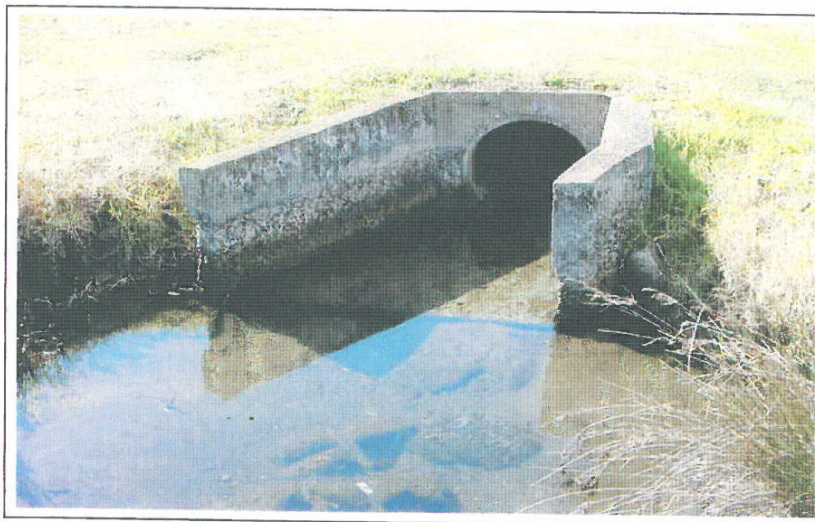
**ASSET NUMBER:** 50142  
**LOCATION:** Heatherington Rd at estuary bridge  
**CULVERT SIZE:** 675mm concrete culvert  
**CONDITION:** Concrete headwall exists around the outlet. SW flows into mangroves. No erosion or sedimentation evident.

**RECOMMENDATION:** None

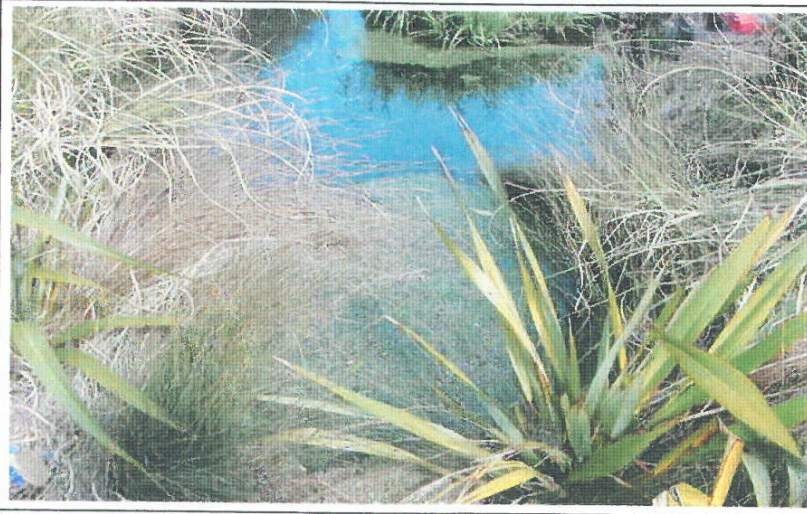
**ASSET NUMBER:** 99340  
**LOCATION:** Casement Road  
**CULVERT SIZE:** Open Drain  
**CONDITION:** Open drain within industrial area that flows toward the estuary mangroves. Culverts under crossings 50% blocked with sediment and rubbish. No bank erosion as banks are heavily vegetated.

**RECOMMENDATION:** Clear drain and remove rubbish.

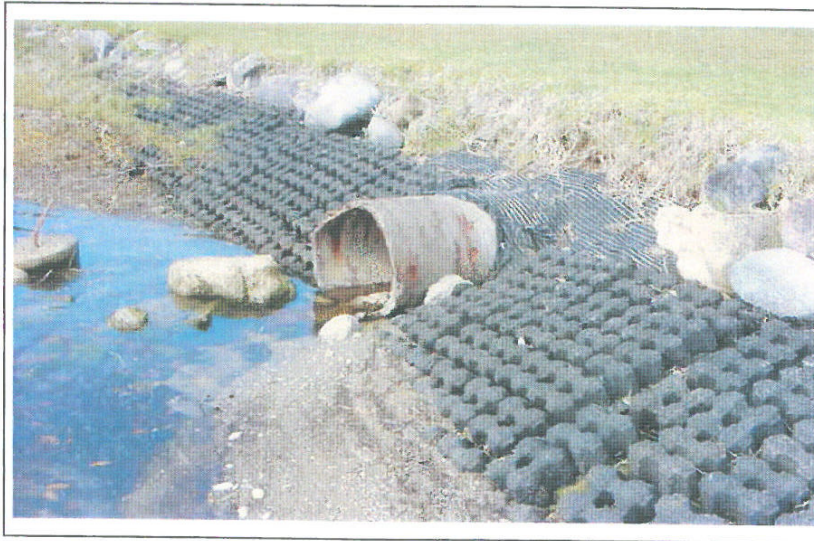
**ASSET NUMBER:** 50061  
**LOCATION:** End of Awarua Place  
**CULVERT SIZE:** 600mm concrete culvert  
**CONDITION:** Concrete blocks support the bank around the outlet. No erosion or sedimentation evident. Outlet end is crumbling.

**RECOMMENDATION:** None

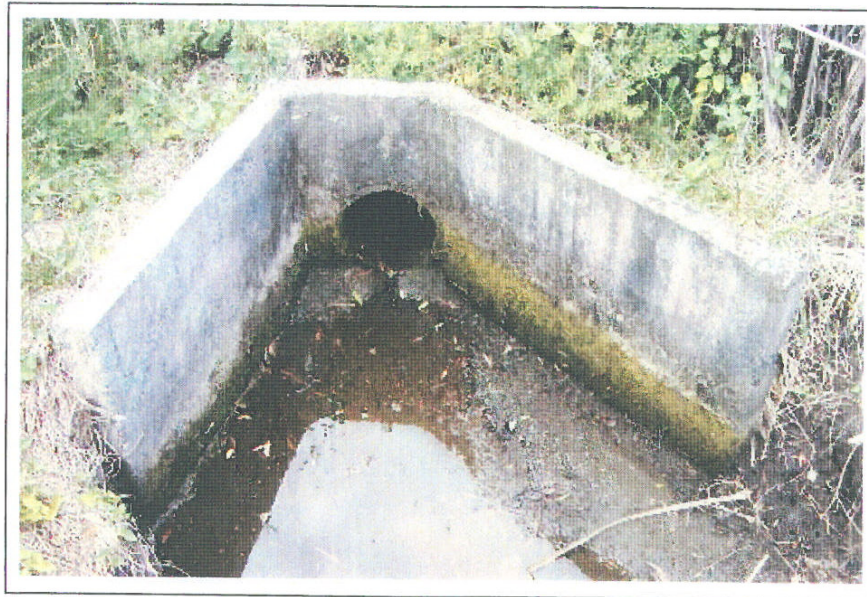
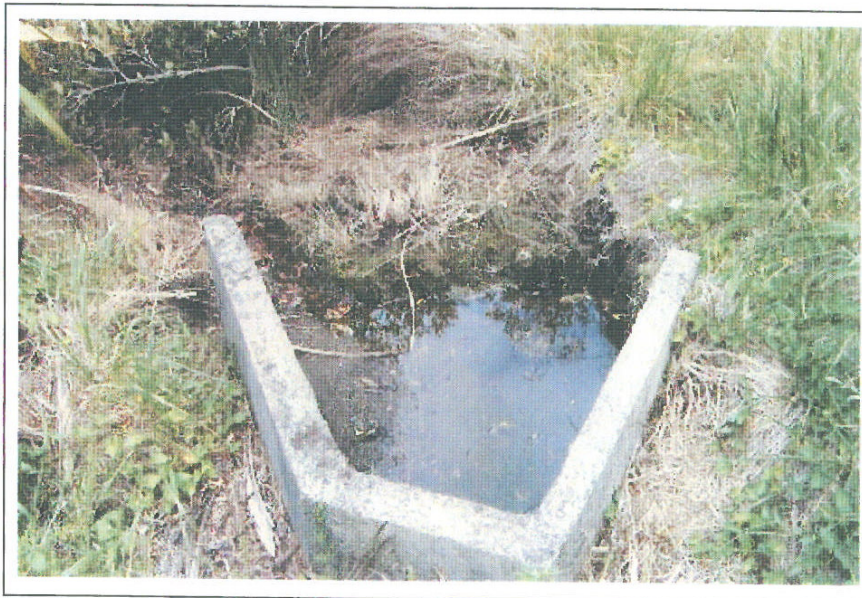
**ASSET NUMBER:** 25607  
**LOCATION:** Off Pipi Road  
**CULVERT SIZE:** 300mm concrete culvert  
**CONDITION:** Concrete headwall exists around culvert outlet, good condition. SW flows out to harbour. No erosion evident, slight sedimentation build up around apron.  
**RECOMMENDATION:** None.

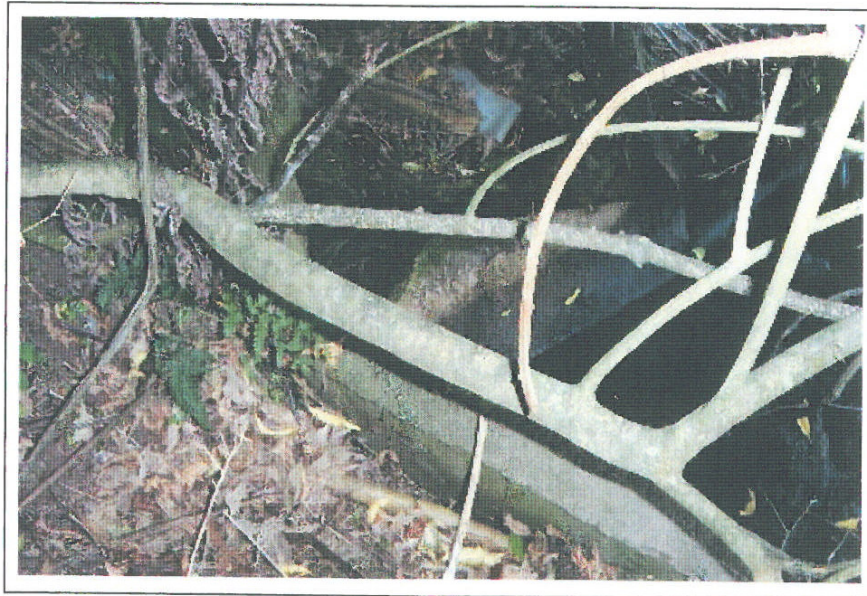
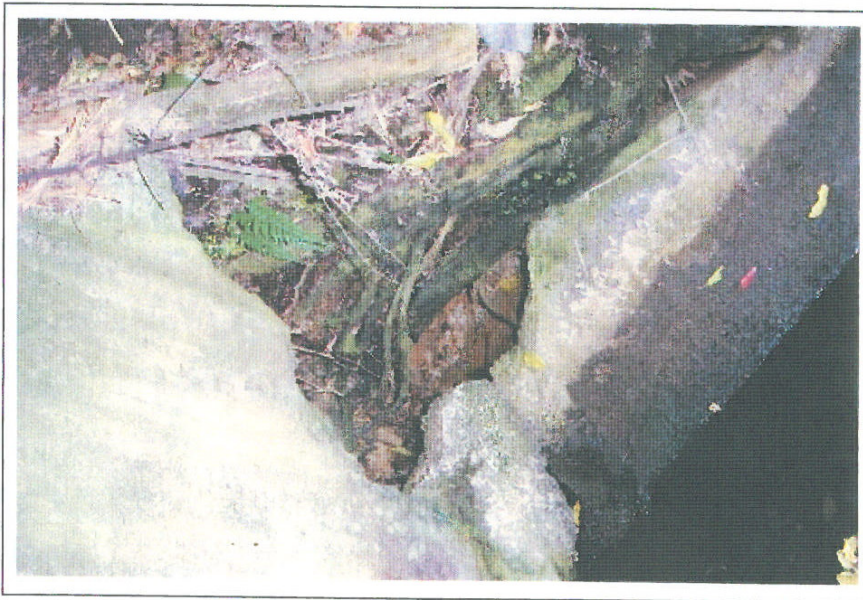
**ASSET NUMBER:** 25620  
**LOCATION:** Off Durrant Drive  
**CULVERT SIZE:** 300mm concrete culvert??  
**CONDITION:** Culvert outlet has separated from concrete headwall. Headwall badly damaged and requires replacement. SW flows out to harbour. No sedimentation evident, scouring present under apron.  
**RECOMMENDATION:** Replace headwall structure, rock riprap outflow.

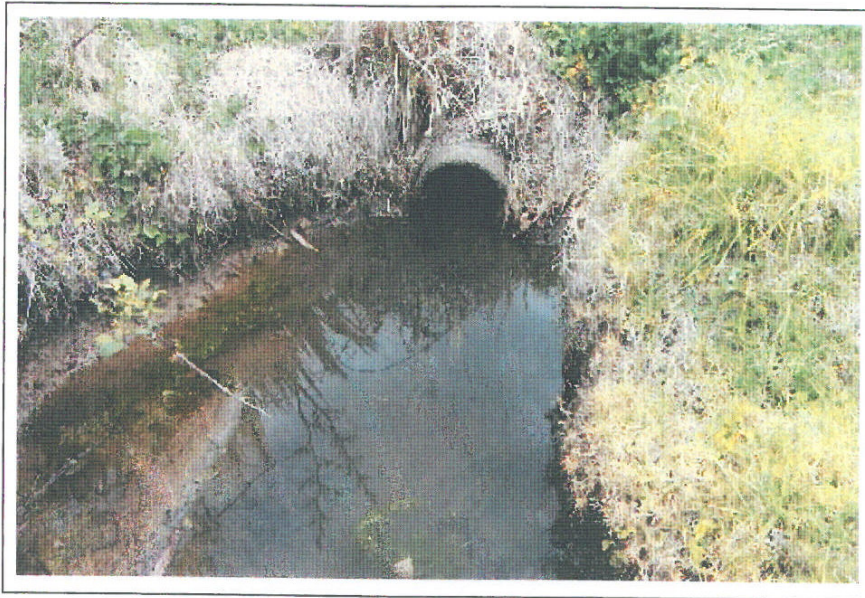
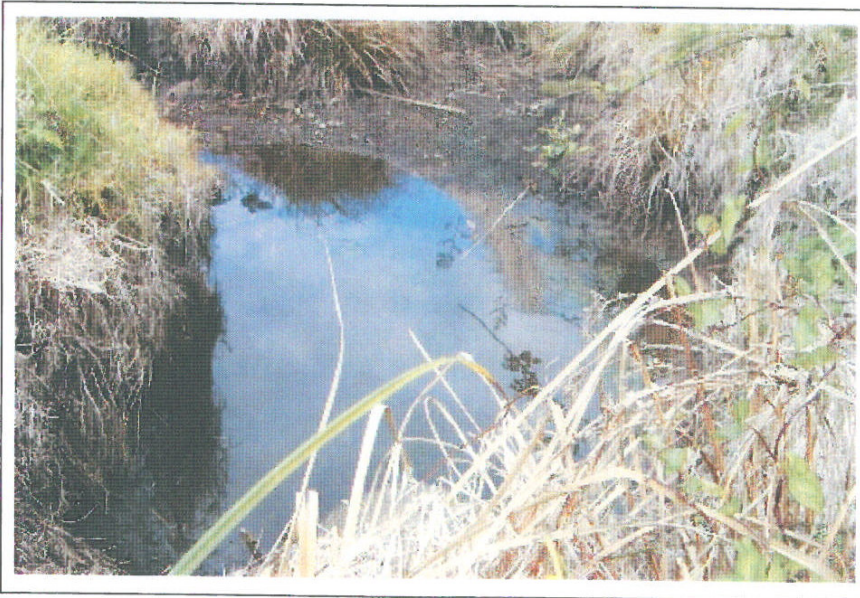
**ASSET NUMBER:** 26666  
**LOCATION:** Off Patiki Place  
**CULVERT SIZE:** 300mm concrete culvert  
**CONDITION:** Concrete culvert outlet in good condition. SW flows out towards harbour. Banks vegetated. No erosion and slight sedimentation build up evident.

**RECOMMENDATION:** None.

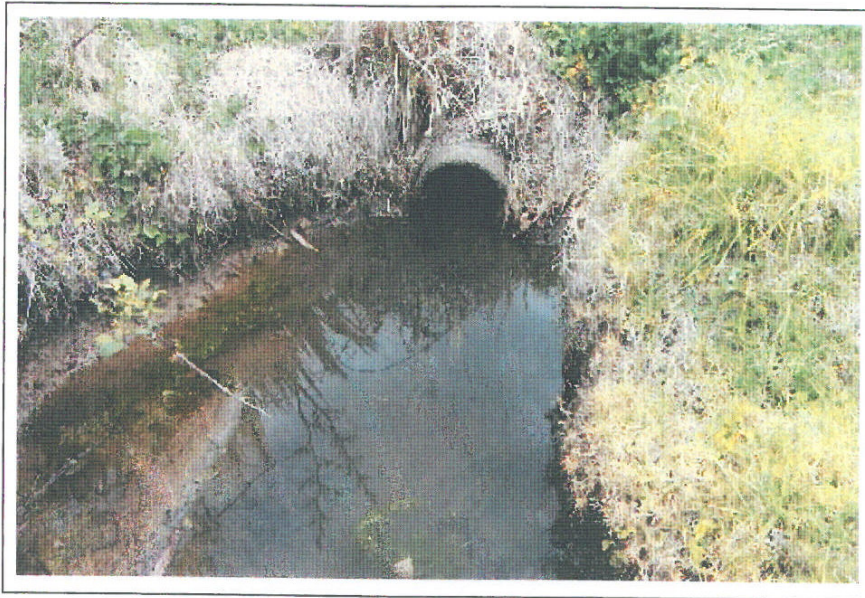
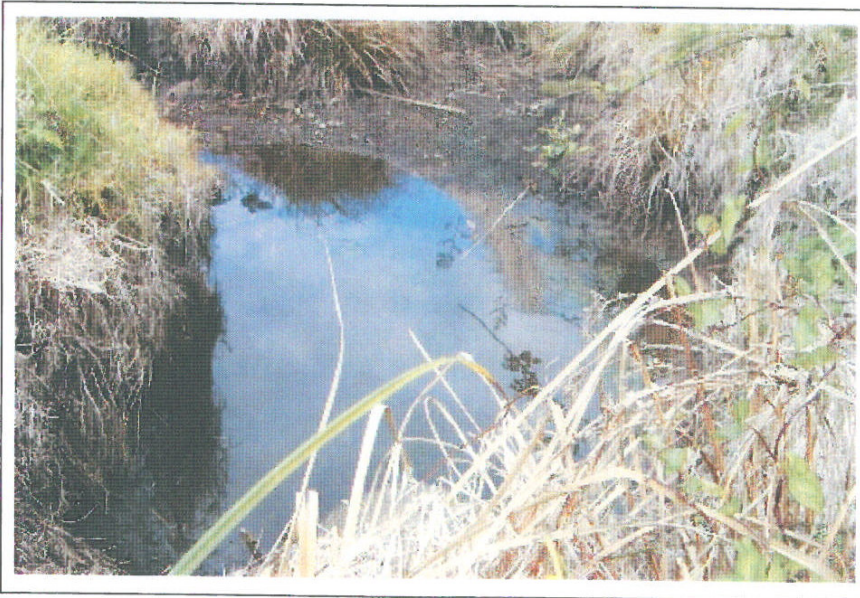
**ASSET NUMBER:** 26666  
**LOCATION:** Off Patiki Place  
**CULVERT SIZE:** 300mm concrete culvert  
**CONDITION:** Concrete culvert outlet in good condition. SW flows out towards harbour. Banks vegetated. No erosion and slight sedimentation build up evident.

**RECOMMENDATION:** None.

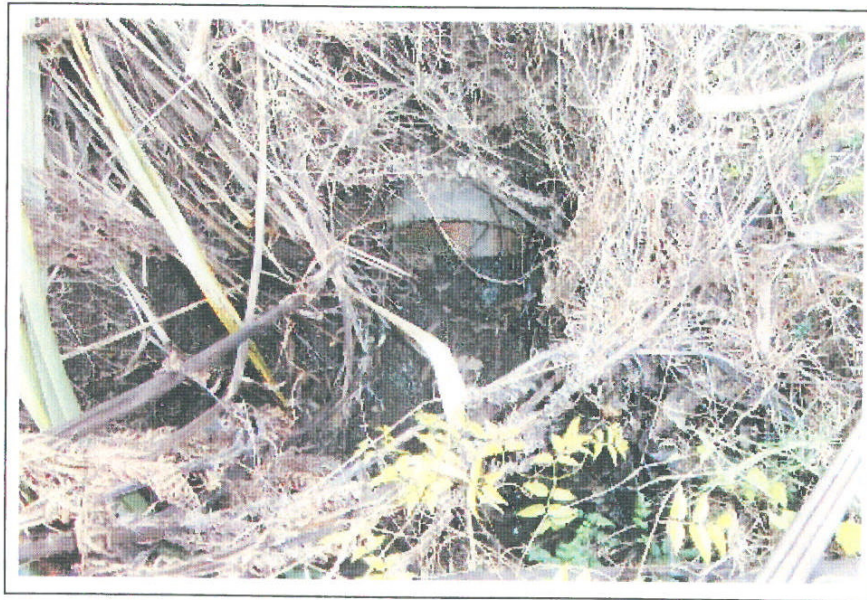
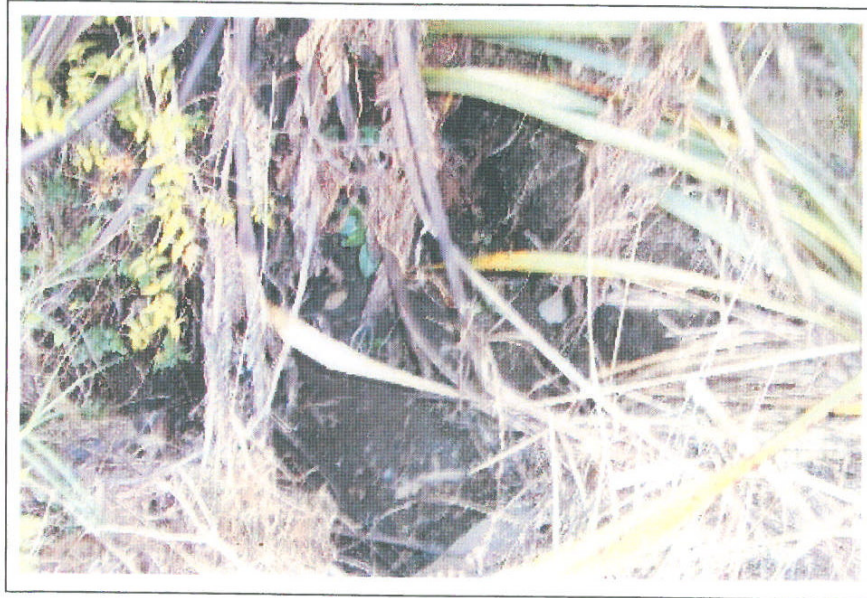
**ASSET NUMBER:** 26701  
**LOCATION:** Off Tukere Drive  
**CULVERT SIZE:** 375mm concrete culvert  
**CONDITION:** Concrete culvert outlet in good condition. SW flows out towards harbour. Banks heavily vegetated, outlet partially blocked with vegetation. No erosion or sedimentation evident.

**RECOMMENDATION:** Trim/ remove vegetation.

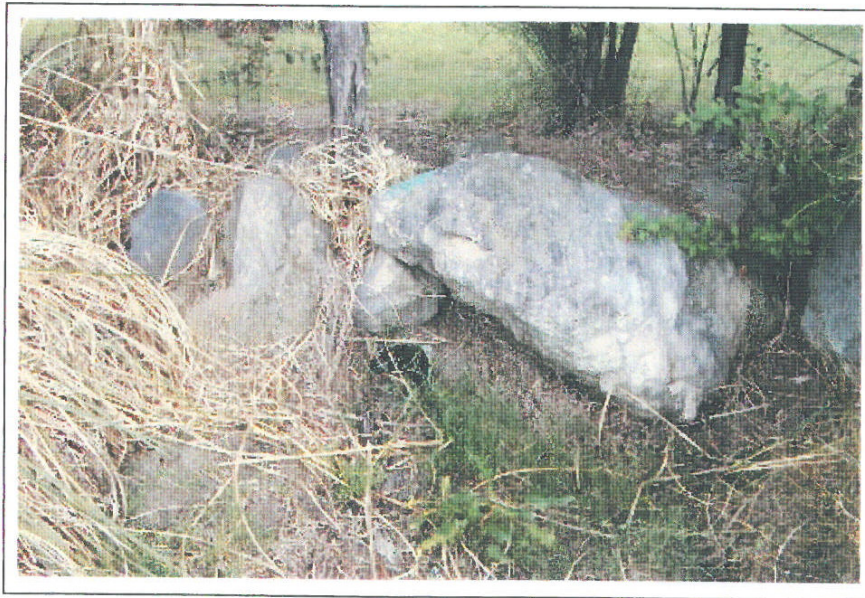
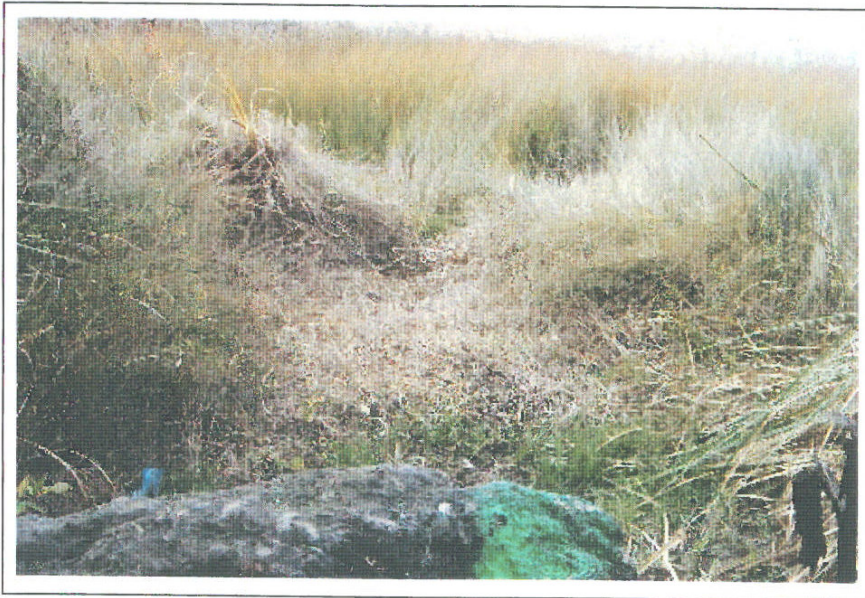
**ASSET NUMBER:** 26712  
**LOCATION:** Off Tukere Drive  
**CULVERT SIZE:** 375mm concrete culvert??  
**CONDITION:** Concrete culvert outlet in good condition. SW flows out towards harbour. Outlet 50% blocked, sedimentation build up. No erosion evident.

**RECOMMENDATION:** Clean open channel. Remove excess vegetation.

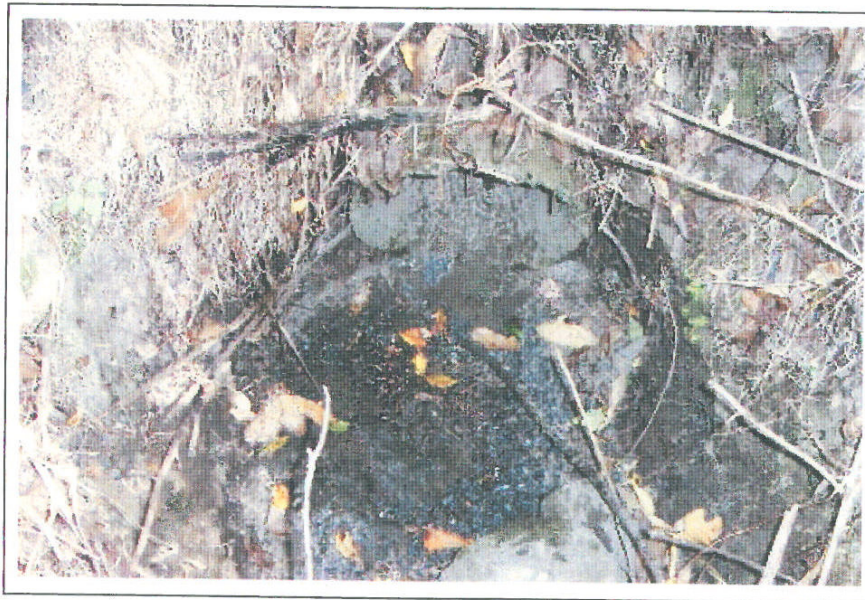
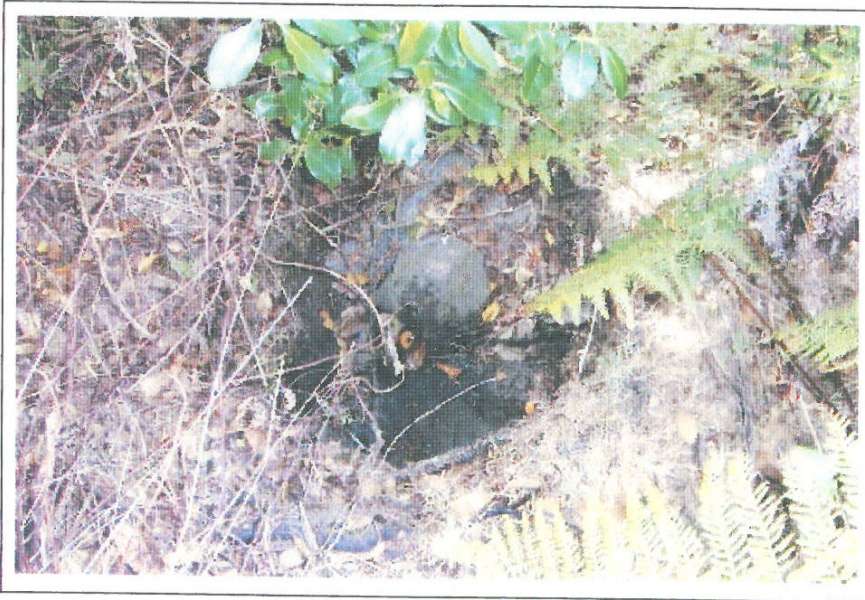
**ASSET NUMBER:** 26716  
**LOCATION:** Off Tukere Drive  
**CULVERT SIZE:** 300mm concrete culvert  
**CONDITION:** Concrete culvert outlet in ok condition. SW flows out towards harbour.  
Banks heavily vegetated. No erosion or sedimentation evident.

**RECOMMENDATION:** Trim excess vegetation. Low priority.

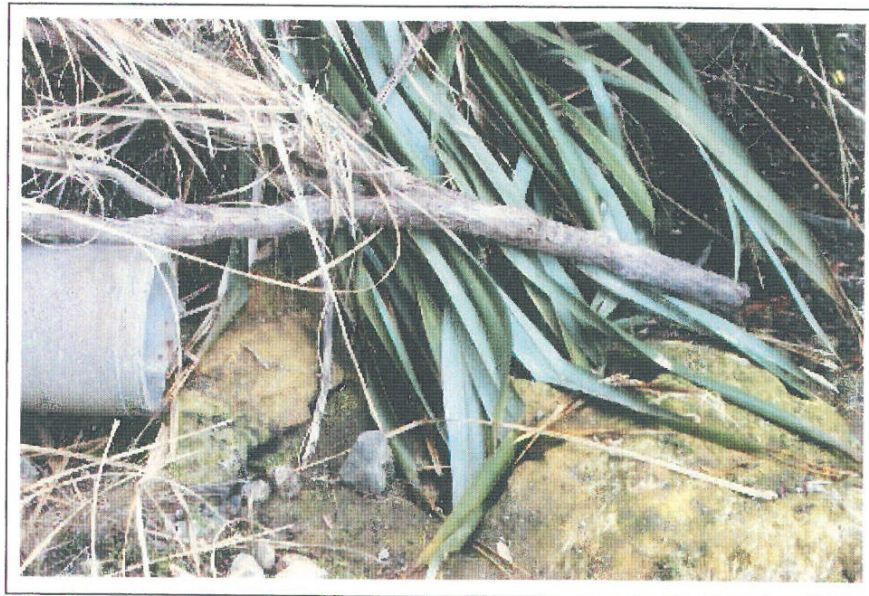
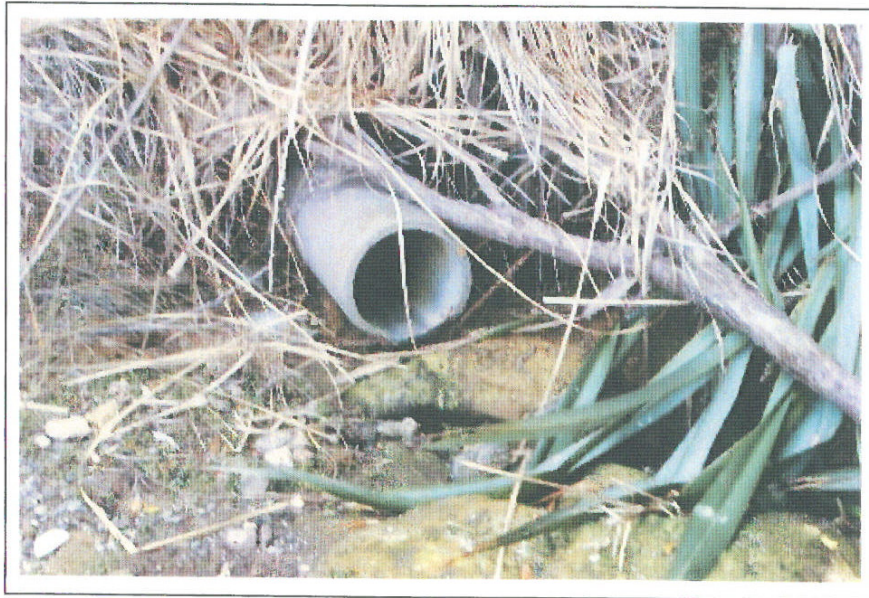
**ASSET NUMBER:** 26720  
**LOCATION:** Off Tukere Drive  
**CULVERT SIZE:** 300mm concrete culvert  
**CONDITION:** Concrete culvert outlet in good condition. SW flows directly into harbour. No erosion or sedimentation evident.

**RECOMMENDATION:** None.

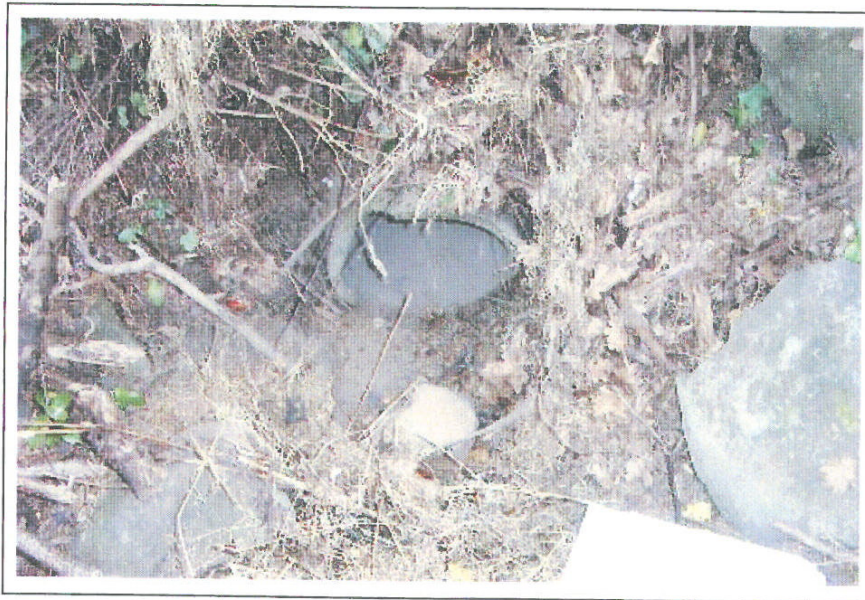
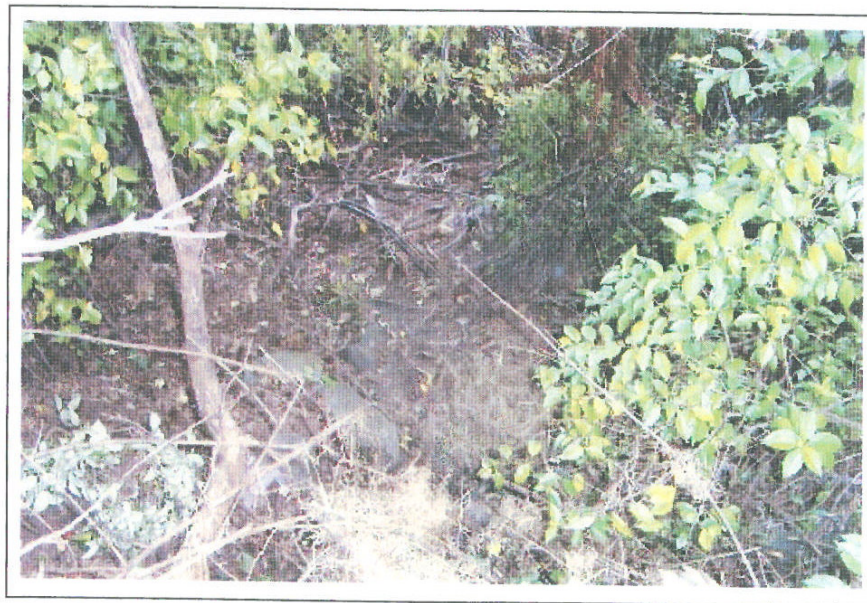
**ASSET NUMBER:** 26724  
**LOCATION:** Off Tukere Drive  
**CULVERT SIZE:** 300mm concrete culvert  
**CONDITION:** Concrete culvert outlet in ok condition. SW flows out towards harbour. Banks heavily vegetated. No erosion or sedimentation evident. Outlet channel partially blocked.

**RECOMMENDATION:** Clear debris. Low priority.

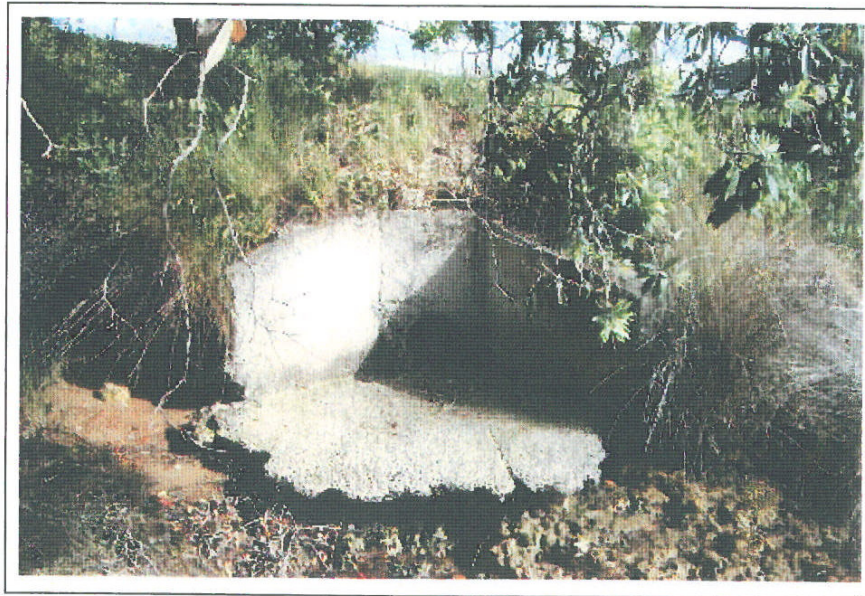
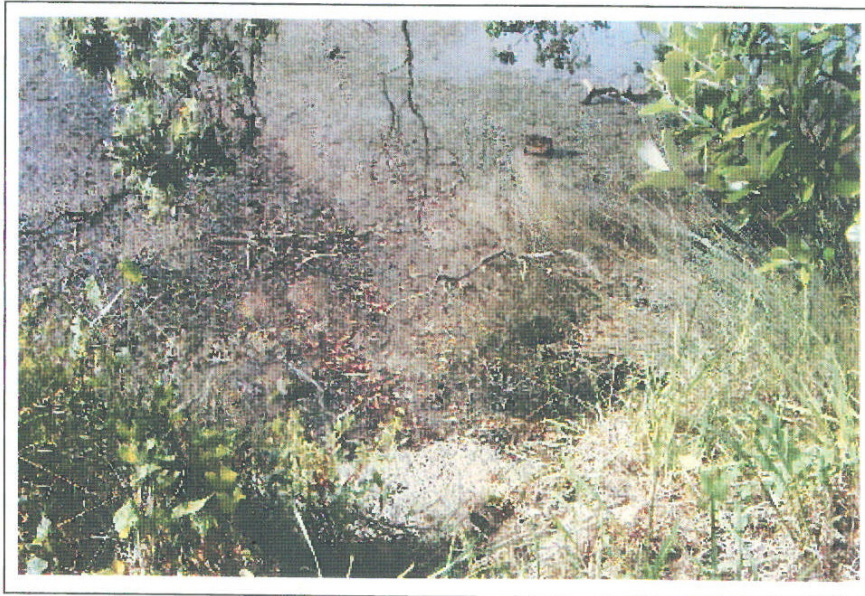
**ASSET NUMBER:** 50022  
**LOCATION:** Off Moana Anu Anu Avenue  
**CULVERT SIZE:** 300mm concrete culvert  
**CONDITION:** Concrete headwall exists around culvert outlet, concrete apron suffering erosion and minor scouring present under apron. SW flows out to harbour. No sedimentation evident.  
**RECOMMENDATION:** Replace headwall structure or place grouted rock underneath and around outfall area.

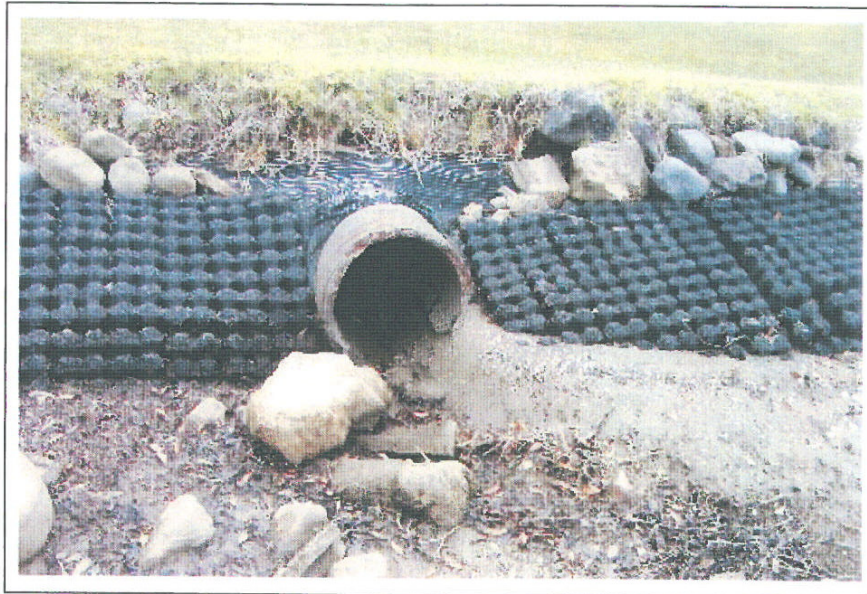
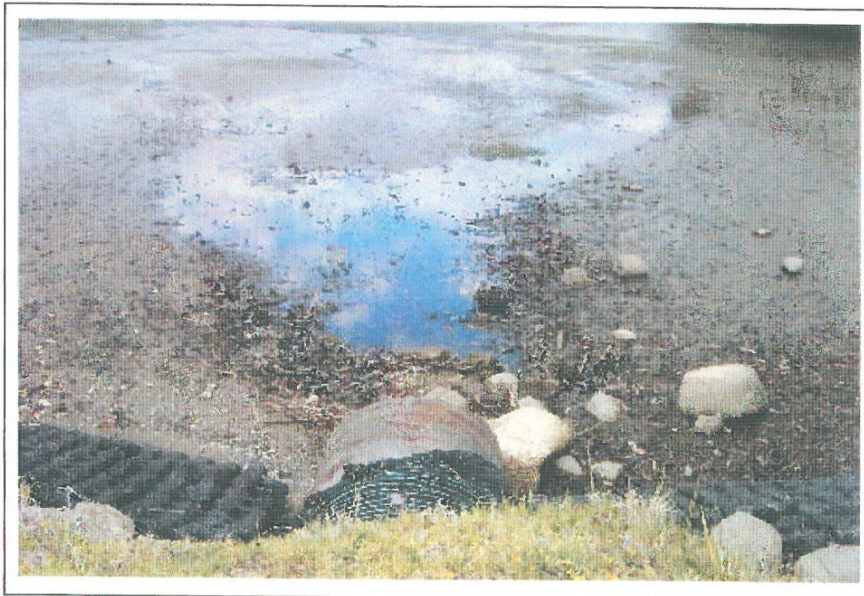
**ASSET NUMBER:** 50062  
**LOCATION:** Off Awarua Place  
**CULVERT SIZE:** 525mm concrete culvert  
**CONDITION:** Concrete culvert outlet in ok condition. SW flows directly into harbour. Embankment protected by a 'Gobi mat' type protection system. No erosion or sedimentation evident.

**RECOMMENDATION:** None.

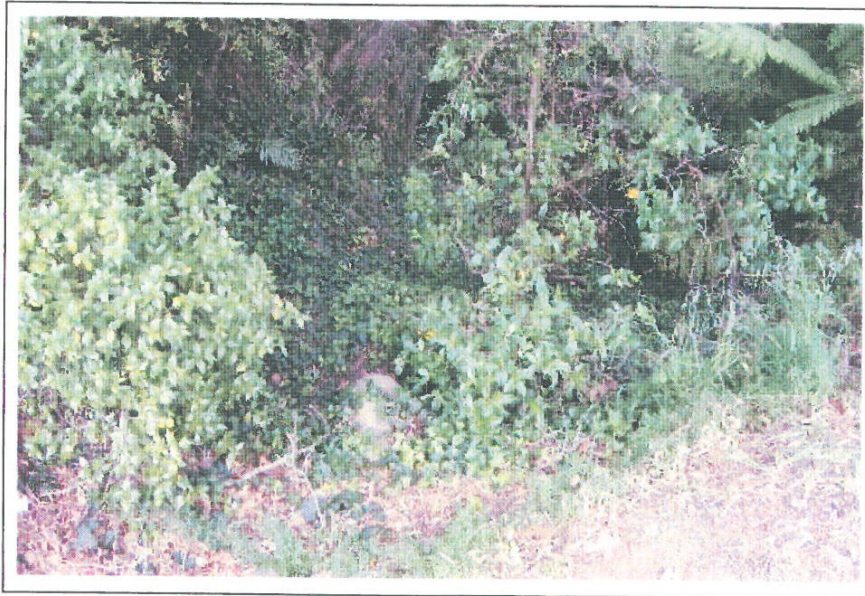
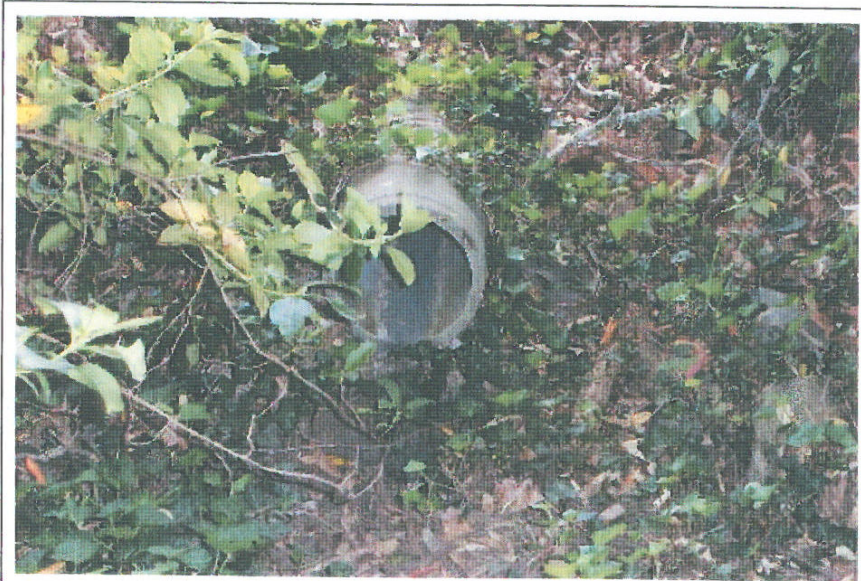
**ASSET NUMBER:** 50102  
**LOCATION:** Off Harry Watt Drive  
**CULVERT SIZE:** 225mm concrete culvert  
**CONDITION:** Concrete culvert outlet in good condition. SW flows down embankment out towards harbour. Banks heavily vegetated. No erosion or sedimentation evident.  
**RECOMMENDATION:** None.

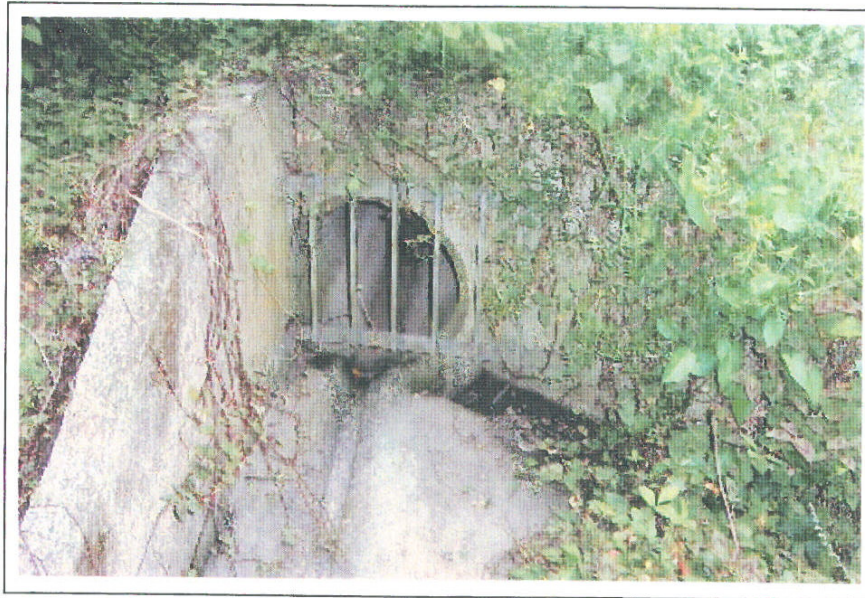
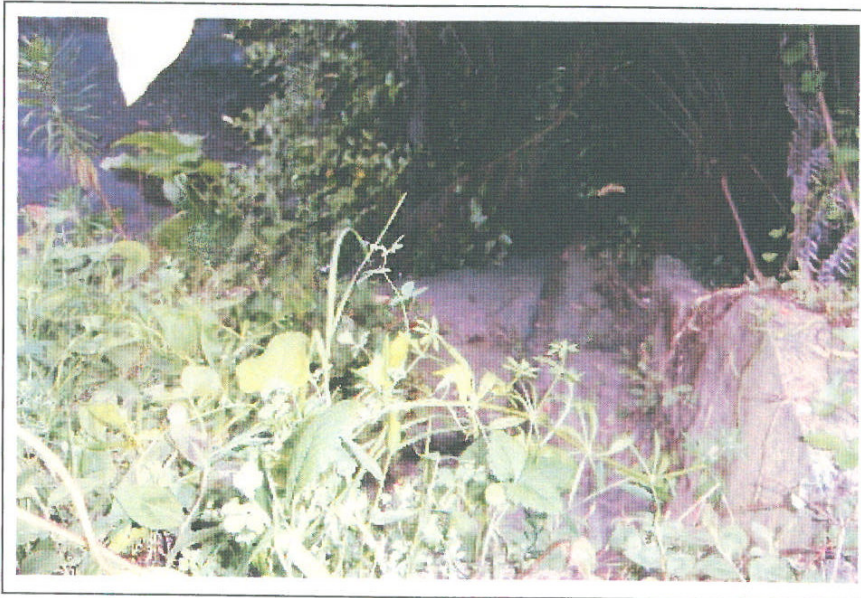
**ASSET NUMBER:** 50103  
**LOCATION:** Off Harry Watt Drive  
**CULVERT SIZE:** 525mm concrete culvert  
**CONDITION:** Concrete headwall exists around culvert outlet, concrete apron cracked/ broken at outfall. Scouring present under apron. SW flows out to harbour. No sedimentation evident.

**RECOMMENDATION:** Trim excess vegetation. Replace concrete apron and/ or provide grouted rock support underneath apron.

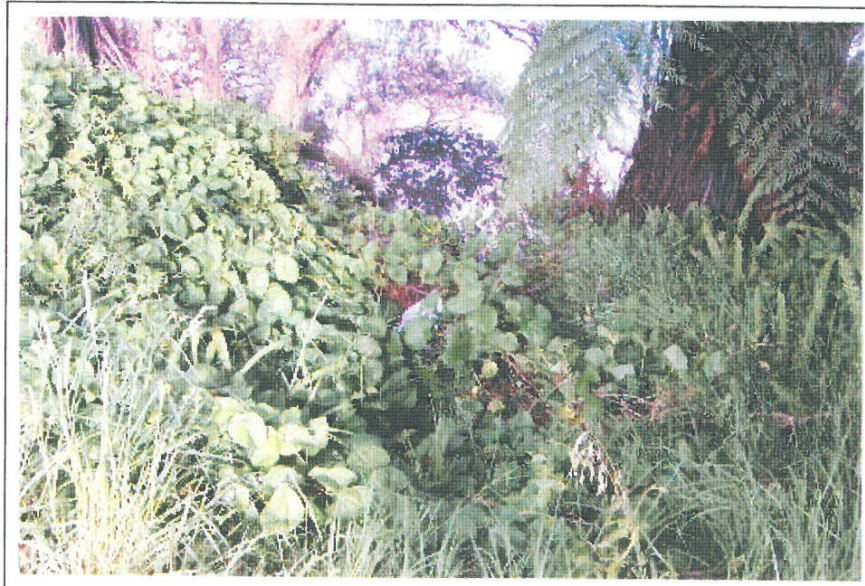
**ASSET NUMBER:** 50120  
**LOCATION:** Off Waireka Place  
**CULVERT SIZE:** ??  
**CONDITION:** Unable to locate outlet. Heavily vegetated embankment. Manhole present in reserve.  
**RECOMMENDATION:** Clear vegetation, locate culvert outlet and assess condition.

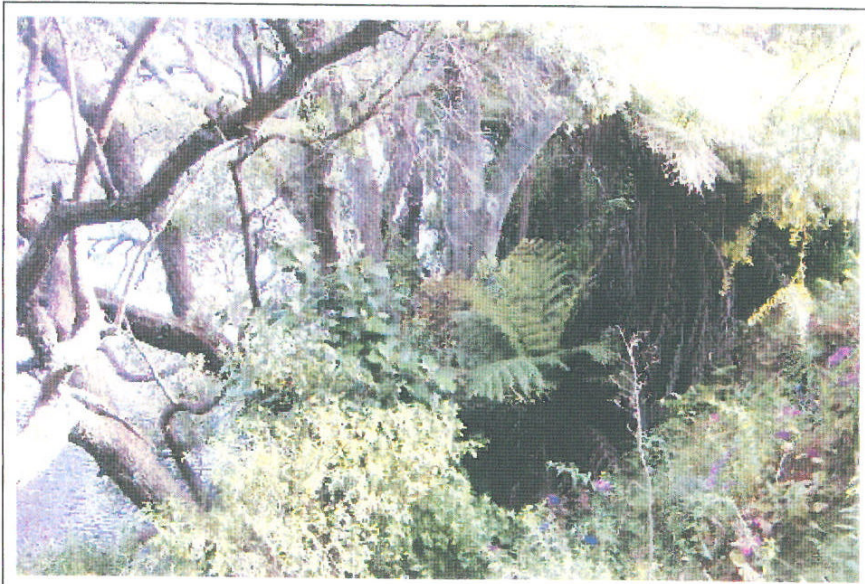
**ASSET NUMBER:** 50110  
**LOCATION:** Off Waireka Place  
**CULVERT SIZE:** ??  
**CONDITION:** Unable to locate outlet. Heavily vegetated embankment. Manhole present in reserve.  
**RECOMMENDATION:** Clear vegetation, locate culvert outlet and assess condition.
