# **Whangamata Stormwater Catchment Management Study Catchment Management Study**

**Updated** Issues and Options Report

Draft **Version 2**

*Thames-Coromandel District Council*

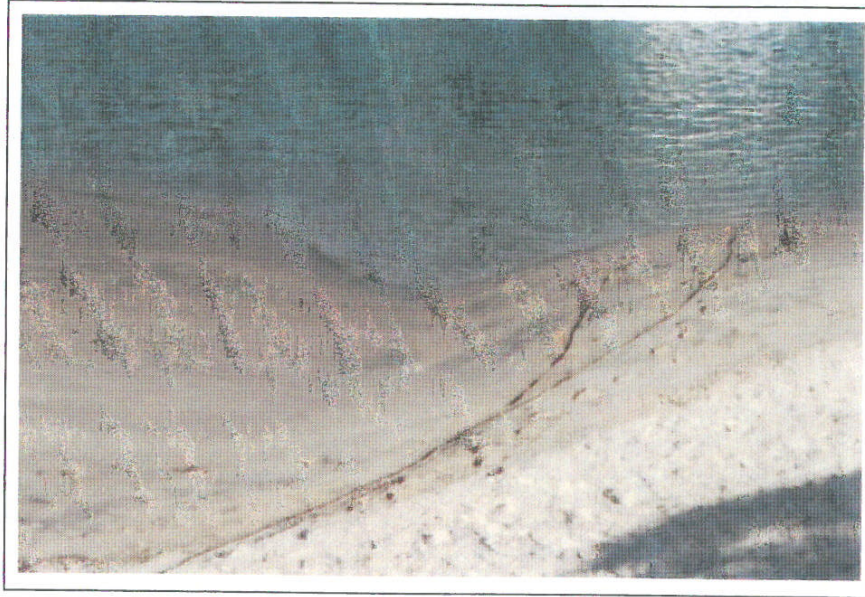
**ASSET NUMBER:** 50549  
**LOCATION:** Off Port Road (Wharf)  
**CULVERT SIZE:** 600mm+ (3/4 buried)  
**CONDITION:** Culvert outlet  $\frac{3}{4}$  buried under sand. Culvert joint at 2 pipe lengths from outlet separated. Photo taken at mid tide.  
**RECOMMENDATION:** May need to investigate raising level of culvert outlet above shore level. Further investigation required.
