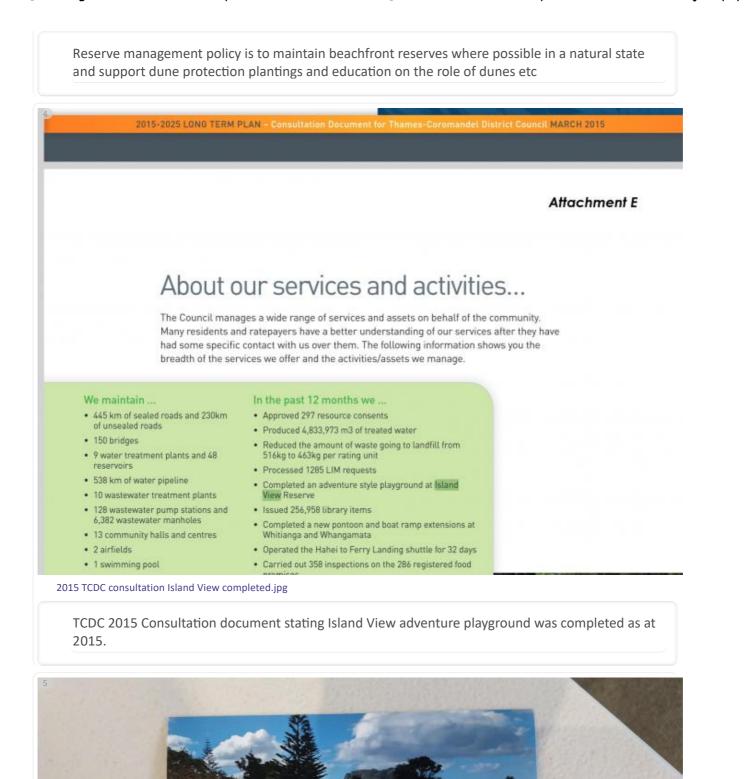
2017 after cyclone Cook.jpg

Taken from Hinemoa and before lake burst/erosion - note sand dunes along right - all washed away.

The Norfolk Tree in the background is used in a later reference from the toilet end.

Note Cyclone Cook was the first cyclone since the adventure park was built.

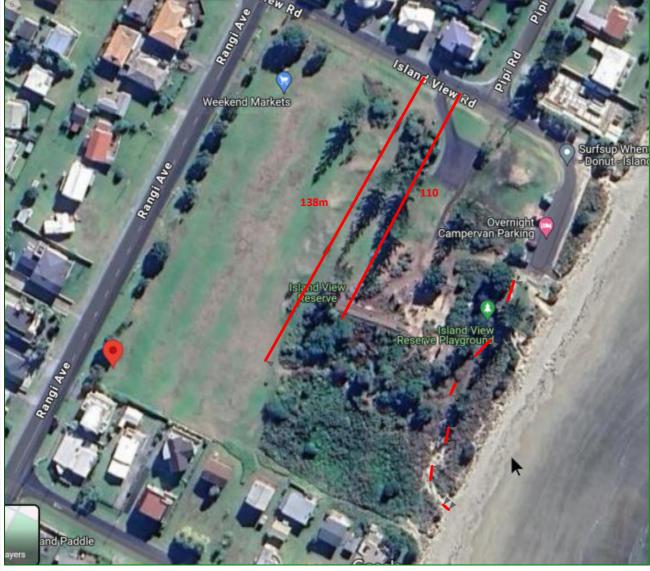
2017 arial showing adventure playground.jpg

Attempted plot of current detention edges is now 110m from Island View Rd.

Resident feedback is they claim about 1/3 of the pond length was filled for the flying fox. This could be true if the old detention area ran along the flying fox line - with a bend.

It is likely the flying fox bed required raising the surface which means the slope will be steeper or the detention base moved further towards the path.

Note the boardwalk is not yet installed. This construction could well have caused the detention area width to be reduced to save building piles.

Note sand dunes still in tact BUT their is a scarf on the dotted line - this could be erosion from previous storm events meaning this stormwater system has never worked at all.

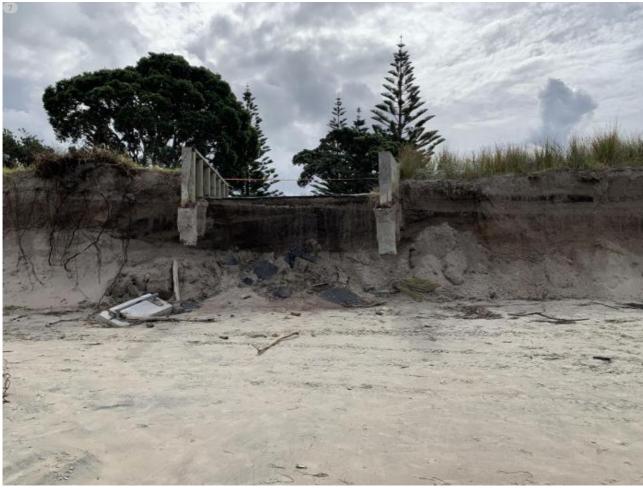
2023 boat ramp washed out after winter storms.jpeg

Natural erosion at boat ramp.

NB: the area of sand dunes on the right was the recent (2022 I think) dune restoration which was all but eroded away during the winter storms - not in Gabrielle but the ongoing spring and king tides in heavy seas.

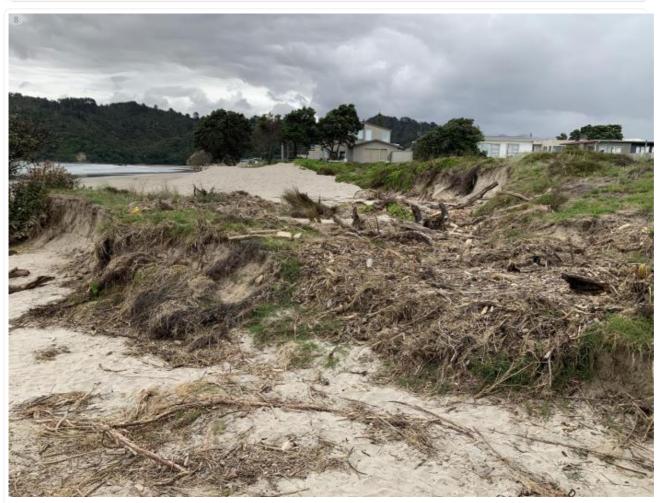
2023 erosion and debris beside toilet.jpeg

With the loss of the sand dunes in 2017 storm surges have continued the erosion.

The foreground valley in this image is one of the overland flow paths from Pipi Rd/Island View Rds when the cesspits become overwhelmed - when pond is full.

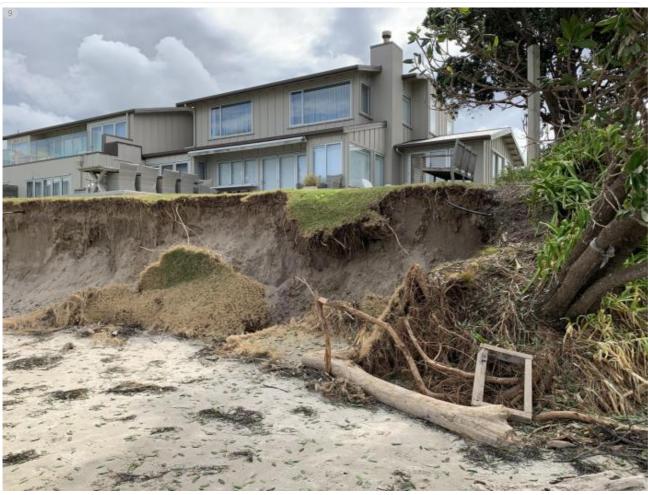
2023 erosion behind Hinemoa winter.jpeg

Last properties at end of Himemoa

This owner put large 1Ton bags filled with sand to protect further erosion and to protect the Pohutukawa Tree and was ordered to remove them.

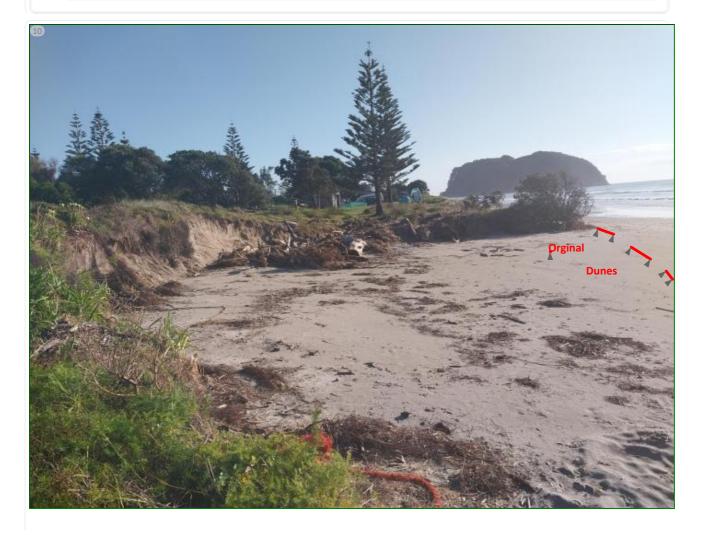
20230307_084914.jpg

Compare dunes now - the Norfolk Pine is now in danger of erosion with the sand dunes lost to the left.

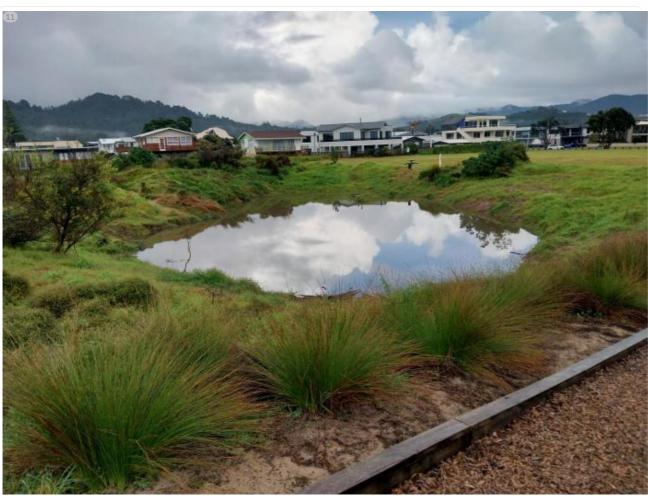
20230618_093121.jpg

Island View pond water level above the boardwalk and both Rangi and Pipi discharge pipes

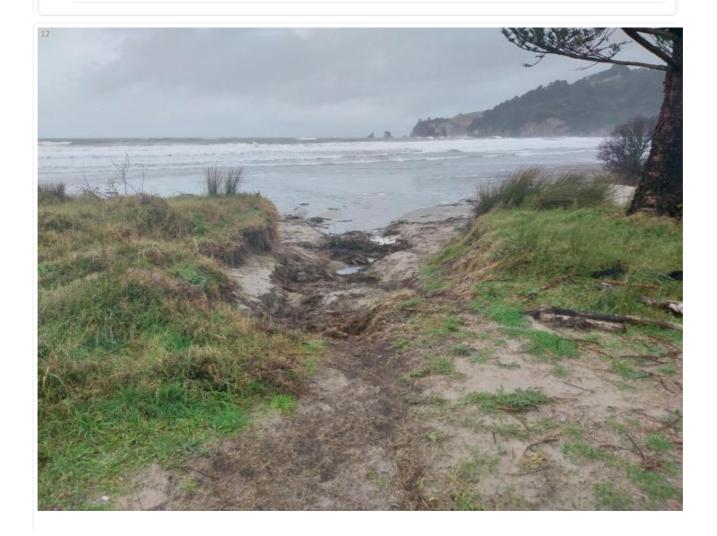
20230624_103549.jpg

Erosion beside toilets - overflow from Pipi/Island View Rds washes down and cut this valley - part goes here and part continues on. The earlier photos do depict this so is not new.

The Norfolk Pine on the right is the same tree sighted from Hinemoa behind the lake pre sand dune erosion/wash out.

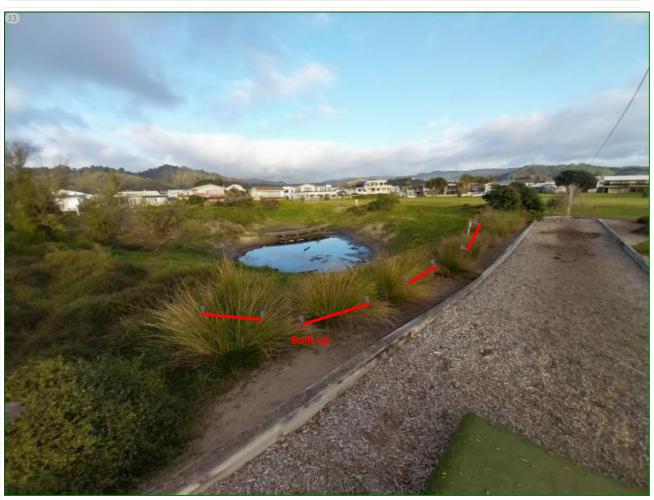
20230713_082522.jpg

Shows pond in relation to flying fox.

Residents claim this area was built up to create the fall of the flying fox by filling 1/3 of the pond along the flying fox.

The walkway is shown in the end of the pond - reference used in location.

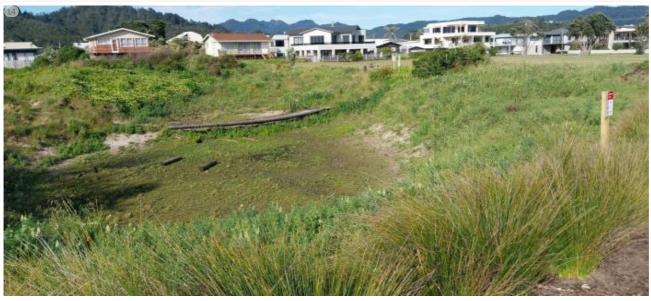
20231102_084521.jpg

Water all but gone - 3 days after 200mm rain event

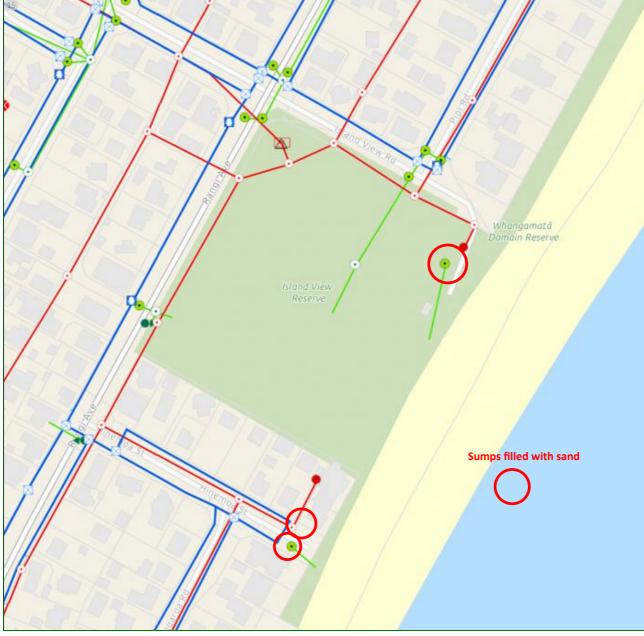
320231029 TCDC SmartMaps Island View stormwater assets.jpg

From 3 Waters Smart Maps looks like the playground entry is Pipi Rd and the other is an unmarked extension from Rangi Rd.

The circled sumps were filled with sand after last weekends big blow. Sumps cannot b installed within the sand dune areas. They fill with sand and then cannot function so causes low lying nearby properties to flood. This is why Hinemoa and Pipi properties flood. The sand dunes build up when lighter sand is blown up the coastal boundary and drops on ventury effect. This raises the batters around the coastline and protects against sea surges. Roads like Hinemoa should NOT be extended into the sand dunes as this stops the natural defence to coastal erosion. Stormwater assets cannot function during events because the natural event brings sand with it. These need moving back out of range of the sand.

Be useful to check that the Pipi one is clear as the carpark often gets flooded from Pipi and Island View Rd.
