**MEMO****To:** Jonathan Smith**From:** Tim Lockie; Manu Ward**CC:****Subject:** WILLIAMSON ROAD STORMWATER ASSESSMENT**Date:** 9 May 2018**File number:** J000056.01

This memo report outlines the hydraulic relationship between Williamson Golf Course and Williamson Park Pond in Whangamata, based on the 2007 model of the stormwater network.

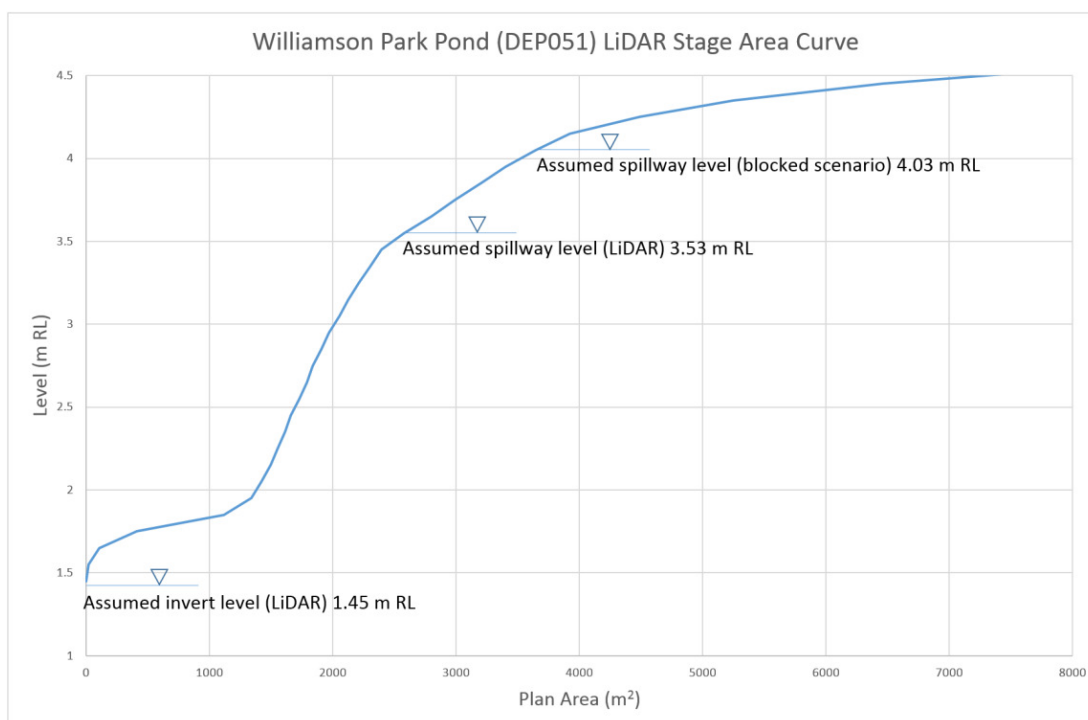
Figure 1 Williamson Park Pond Stage-Area Curve based on LiDAR surface

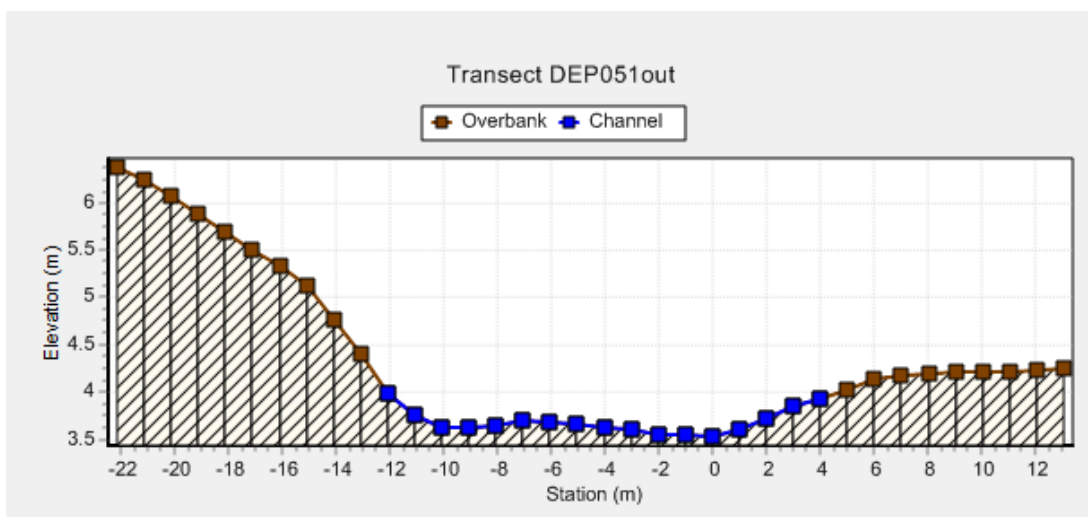
Figure 2 Williamson Park Pond Spillway Cross-Section based on LiDAR surface

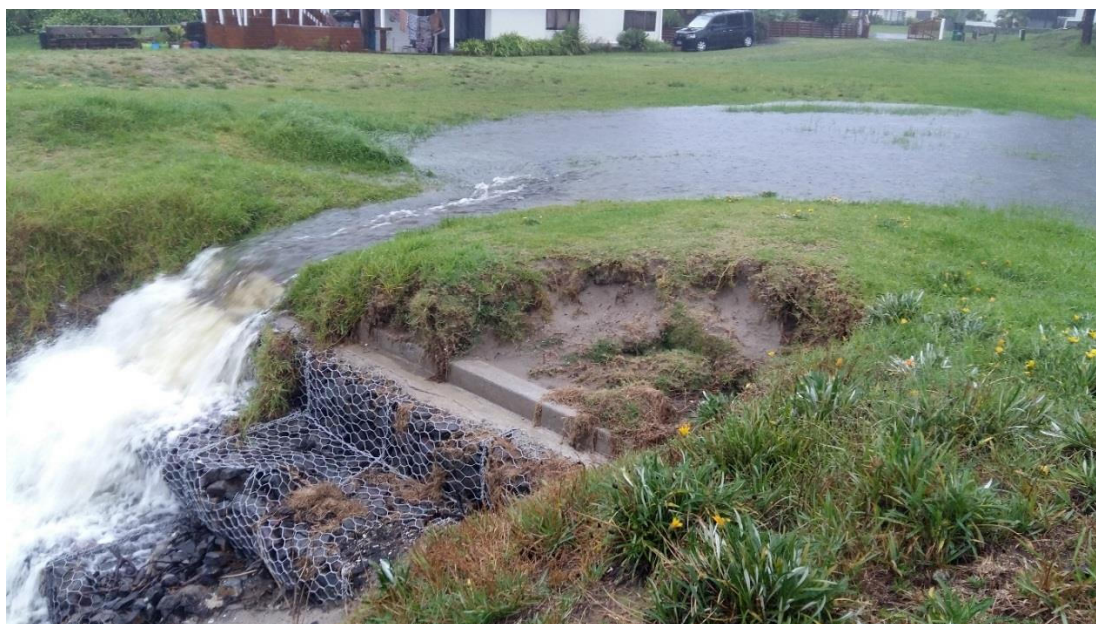
We understand that in April 2017, Williamson Golf Course and some adjacent properties experienced ponding for an extended period. During the same period, the Williamson Park Pond remained full, at a water level that was partly elevated by prior build-up of grass and sand on the overflow spillway, reportedly raising the spillway level by about 500 – 600 mm over the original level.

Note that under this scenario, the spillway level is at 4.03 m RL. According to design drawings for the spillway, overflow levels at the time of weir construction appear to be at a maximum of 3.0 m RL (Riley Consultants Drawing 05284-1, Nov 2005, appended to this report). Based on this, and comparing photos of spillway clean-out on 5 April 2017 (figure 3), a spillway level of 4.03 m RL seems conservatively high above the spillway design level. Further survey is needed to verify the actual spillway as-built level and the level at the time of flooding. However, the levels as stated here are sufficient for this sensitivity analysis.

*Figure 3 Williamson Park Pond Spillway with sediment build-up, overflowing 5 April 2017.*

The network will perform better if the pond is well maintained, including regular removal of sludge to ensure good infiltration rates, and shaping/levelling the overflow path for extreme events.

- Regular maintenance of the pond is recommended, including removal of sludge and periodically clearing sediment and vegetation from the spillway.
- If Council wish to carry out options analysis for additional work to address wider flood issues in the Williamson Road area, it is recommended that the 1D model is updated to a coupled 1D/2D model. Better efficiencies and economies of scale can be achieved if this is carried out for the entire Whangamata Catchment as part of a wider strategy to develop a Catchment Management Plan.

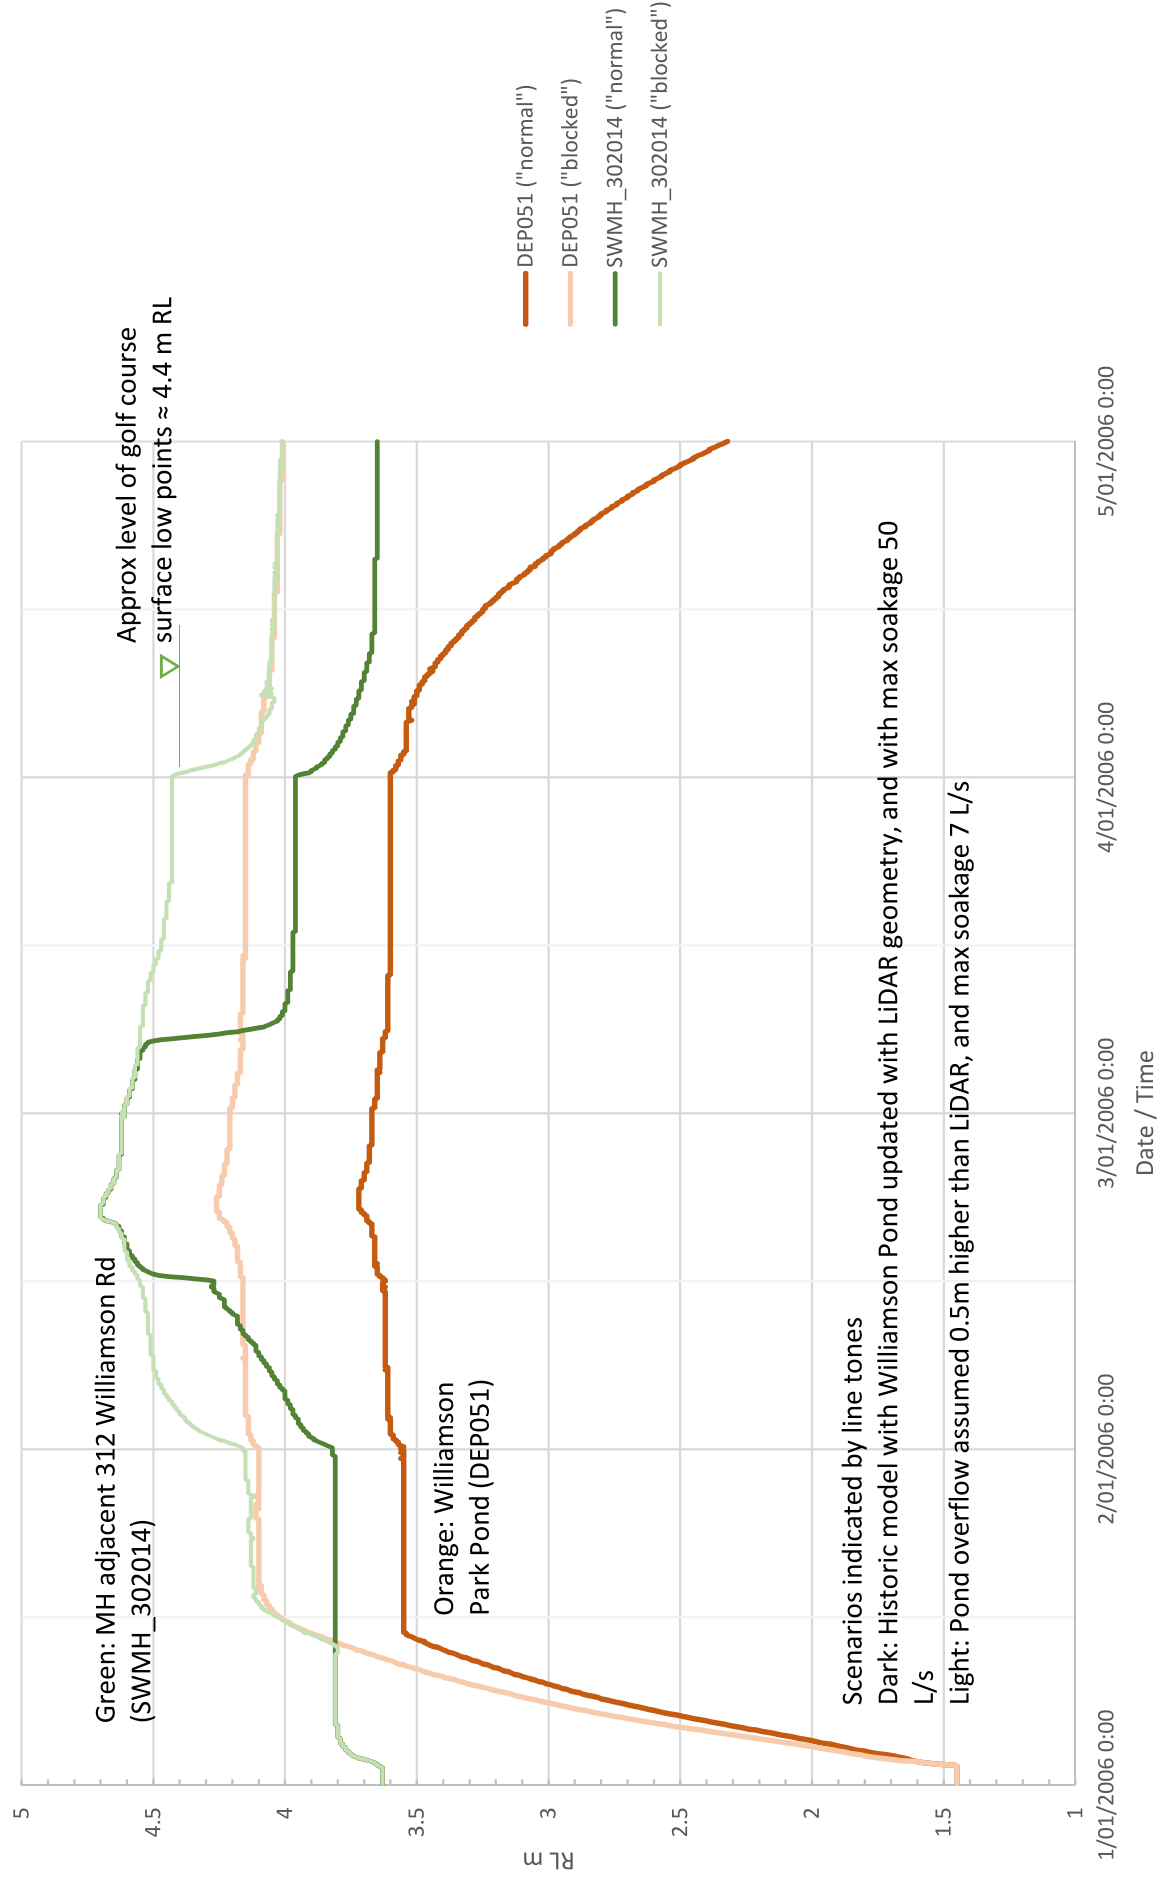
FIGURE 5: SWMM 5YR MODELLED LEVELS

The results indicate that the actual peak water levels in the upstream network in the area of Williamson Golf Course are not affected by the spillway blockage and reduced soakage at Williamson Park Pond.

However, spillway blockage and reduced soakage at the pond does appear to affect the length of time that water levels are raised within in the upstream network. At the manhole near Williamson Golf Course, water levels are higher than 4.4 m RL for 17.1 hours under “normal” conditions, but 45.8 hours under “blocked” conditions (compare the dark and light green lines in Figure 4 attached). According to LiDAR information, low points in the golf course surface are at about 4.4 m RL, so flooding is expected when TWLs are above that level.

This longer period of elevated water levels near the golf course correlates to the experience of the ponding in April 2017. Interestingly, however, the model shows that when rainfall ceases (after timestep 4/01/2006 00:00), water levels in the network quickly drop to levels equivalent to the Williamson Park Pond, which in the “blocked” scenario are held at about the assumed spillway level just above 4.0 m RL.
