**Folder [20240320 Williamson Park Pond Stormwater Detention Basin Alternate Design (2)]**

**Second alternate design for Williamson Pond**

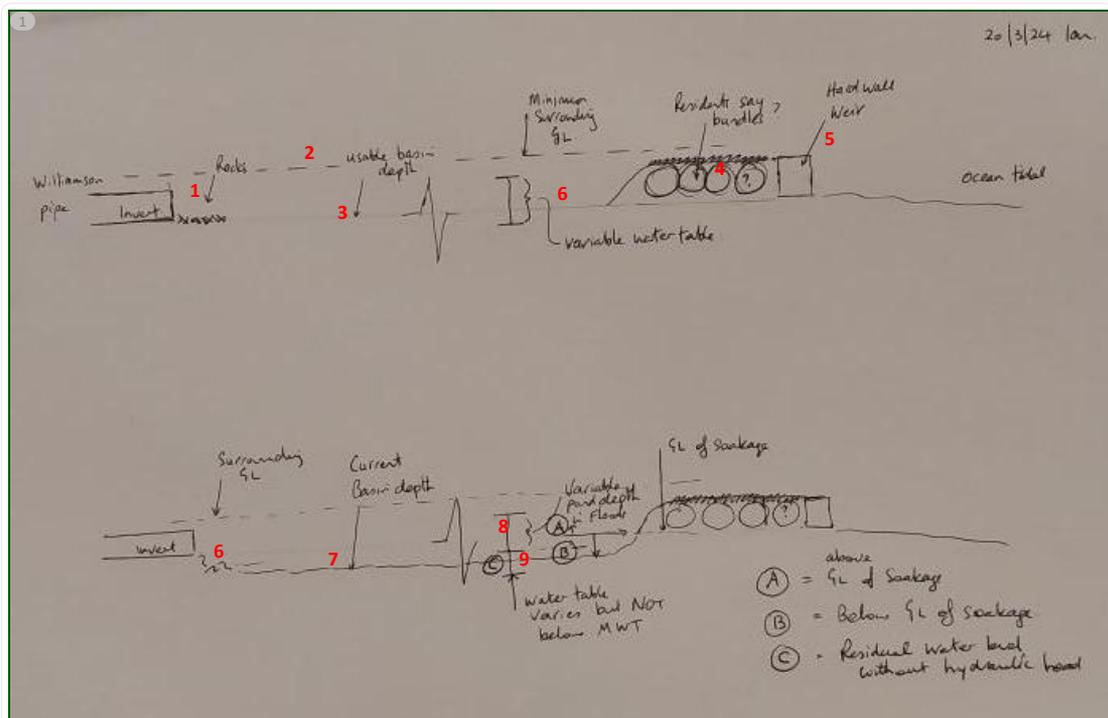
20240320\_071010\_SC\_.jpg

#### Freehand sketch cross section of Williamson basin

**Top image** is my extrapolation of what I believe it looked like at design/build.

1. Is invert of 1.05m dia discharge pipe ex Williamson/Ocean. The rocks we see are likely to stop erosion when outflow is increased.
2. Is surrounding GL of park land
3. Is the basin depth - ie 2-3 times area is water storage potential (minus weir depth to GL)
4. Is a soakage system - best I can get from residents is its a series of wrapped devices - likely Geotech around something. It has a plastic grate surface to prevent erosion and the Geotech. At design it would not be sensible to have these below the basin depth as they would then be in the water table. ie the expected depth is just below the invert for fall from one end to the other
5. Is the weir height which will only operate when discharge rate exceeds the absorption back into the surrounding water table plus what travels through 4 the soakage devices.

Since the basins construction we believe was around the later 1970's when the Ocean outfall pipes were cut back residents say a new weir was constructed 2m back from the original one. The remnants exist so I accept this. They date this around 5 or so years ago. I cannot confirm this.

**Bottom image** is my extrapolation of what I believe it now looks like. We were not given copies of the Metis workings so if heights to RL or whatever need refining then do so.

6. Rocks have sunk down but show no silting
7. Basin depth now lower - Bruce from EPL stated they remove 150mm-200mm of the basin at each maintenance event.
8. Variable pond depth in flood - before basin depth was lowered
9. Line RL of current water table NB: this RL line is below the old basin depth and below the soakage devices so remains as ponding corresponding to surrounding water table level

The issue is the maintenance has changed the operation of the original design by lowering the basin depth into the water table.

A: When water level is above A the soakage devices can work - if they have been maintained

B: Below this line the soakage through device does not work so to remove this water relies on a lower surrounding water table - which is variable depending on preceeding rain events volume/time

C: The continuation of current maintenance regime will cause more still water depth and be

undesirable.

(i) clean out the basin

(ii) clean out the wall of the soakage device and likely remove 2/3 of them to speed up through soakage in heavy rains

(iii) backfill the basin to its original depth at invert level

(iv) create a cleaning mechanism like a concrete pit to clean out any residual sands that escape being caught in the road cesspits.

(v) create a new maintenance regime that does not alter its original design.
