Alternate Stormwater Proposal for Island View

Ian Holyoake. 8 November 2023

The purpose of this project is to deal with the stormwater discharges from the Pipi Rd and Rangi Rd pipes.

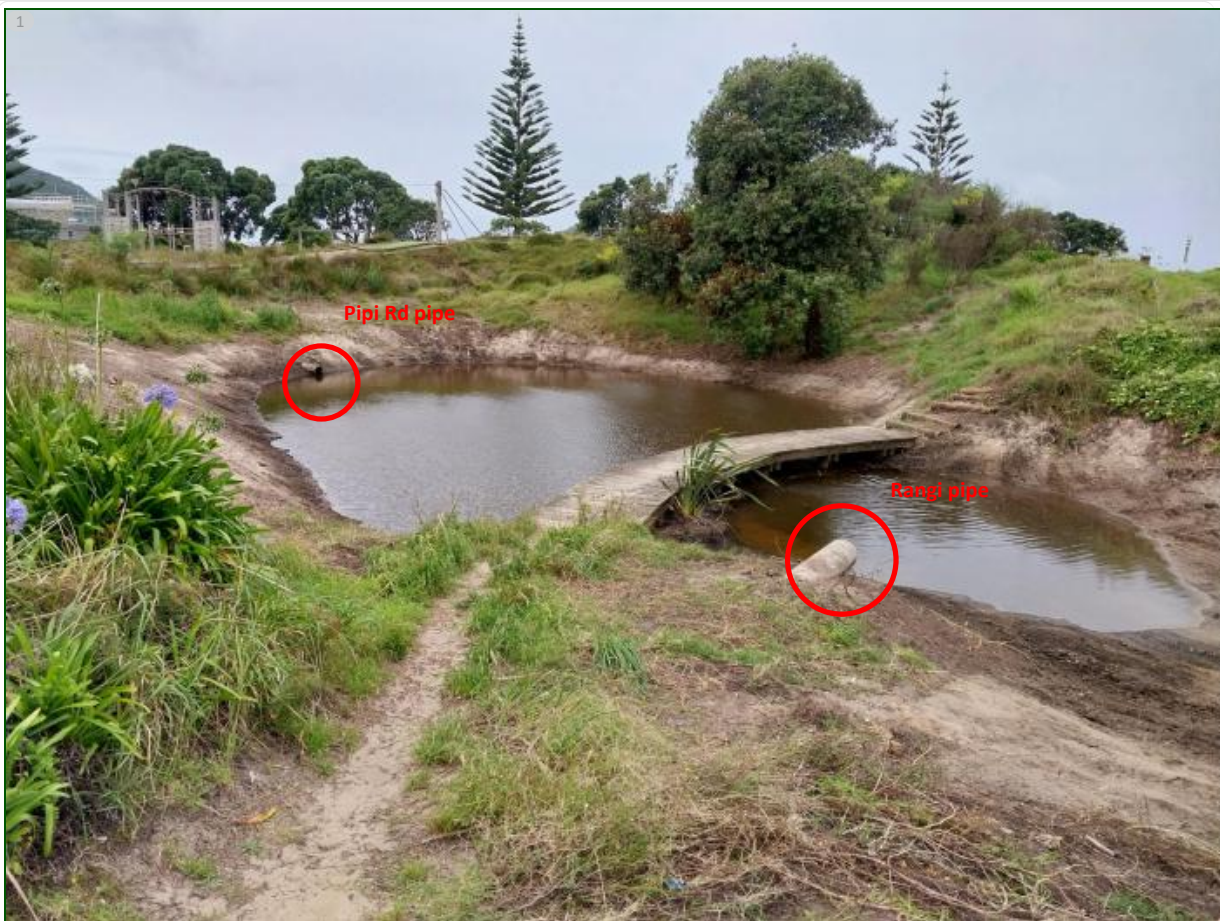
20230211_174026.jpg

11 February 2023 Just been cleaned

This was between Hale (10 January 2023) and Gabrielle (20 February 2023)

Before the clean out the bracken was so thick it was difficult to push through the walkway.

Pipi pipe about water level

Rangi pipe above water level

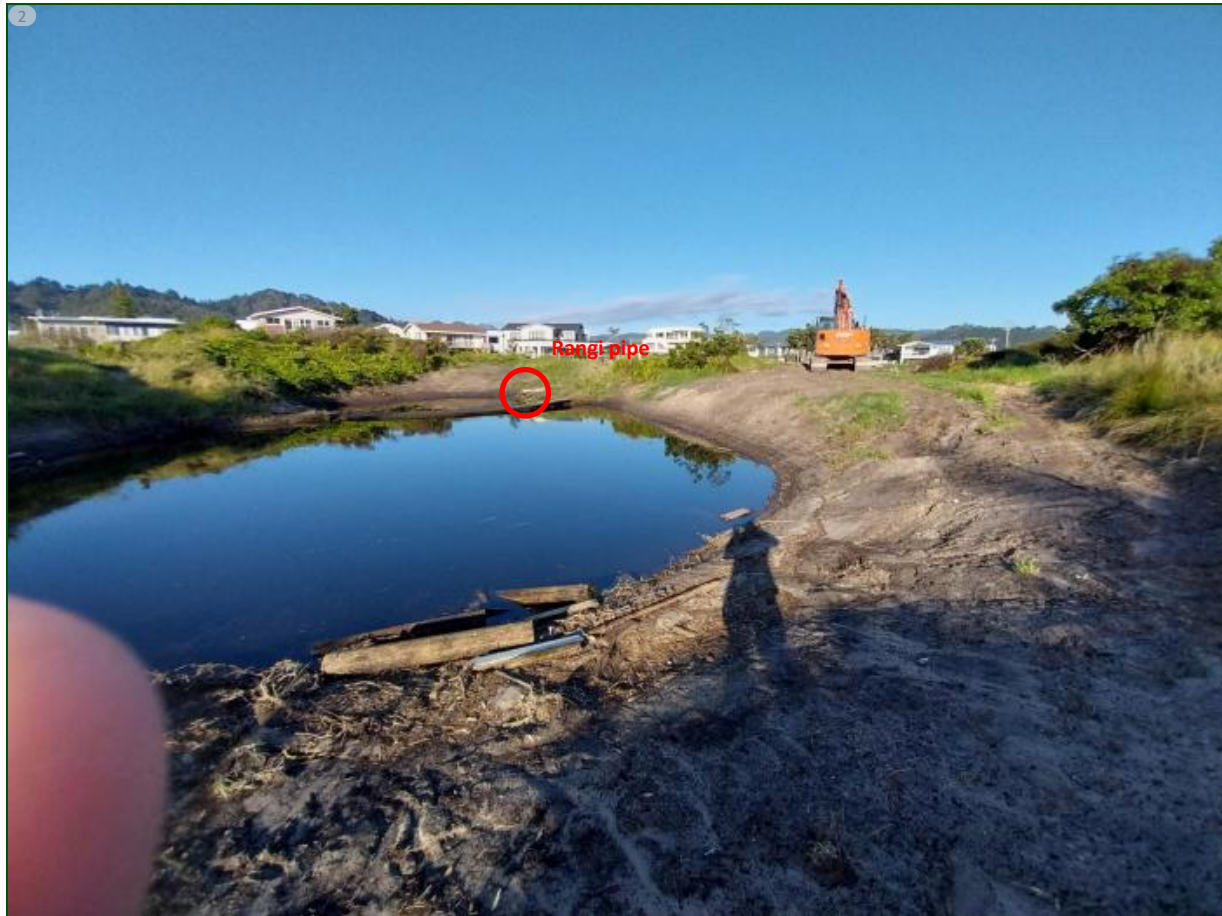
[20230307_084333.jpg](#)

7 March 2023

Pond view digger still on bank

Rangi pipe about 300mm above water level

Around pond embankment can see water table and water rings as pond level drops

The water level will be the water table level

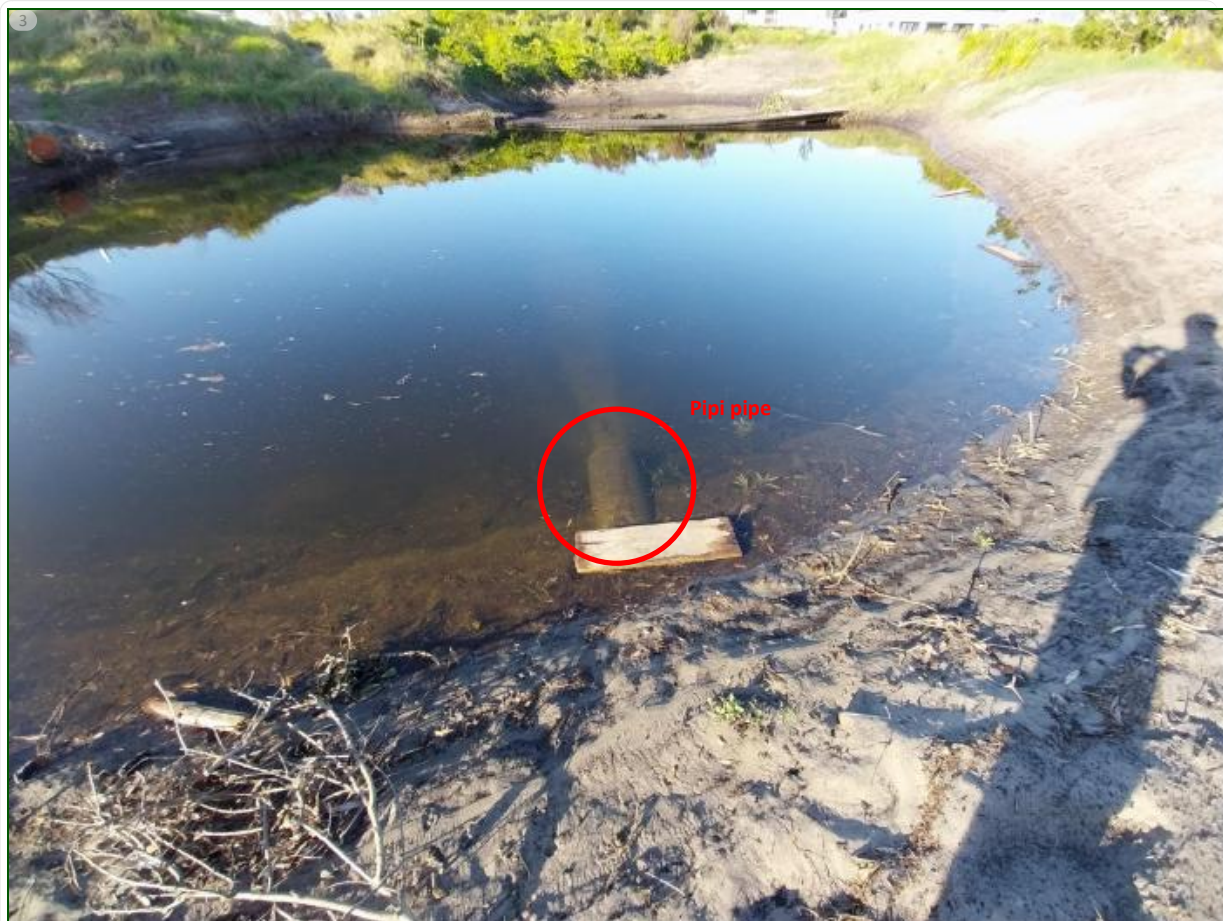
20230307_084348.jpg

7 March 2023

Showing Pipi pipe submerged so must be around 300mm below Rangi pipe

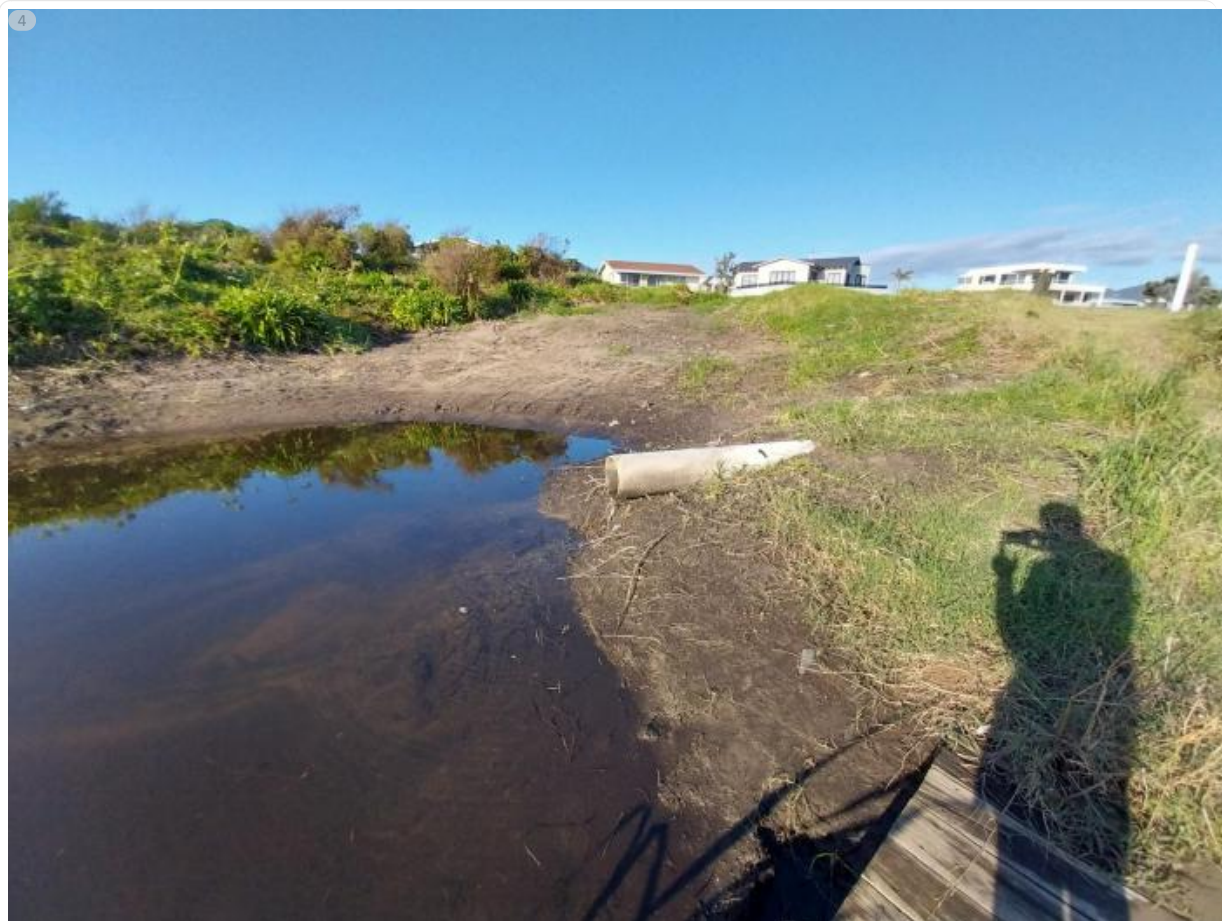
[20230307_084433.jpg](#)

7 March 2023

Rangi pipe above water table by about 300mm

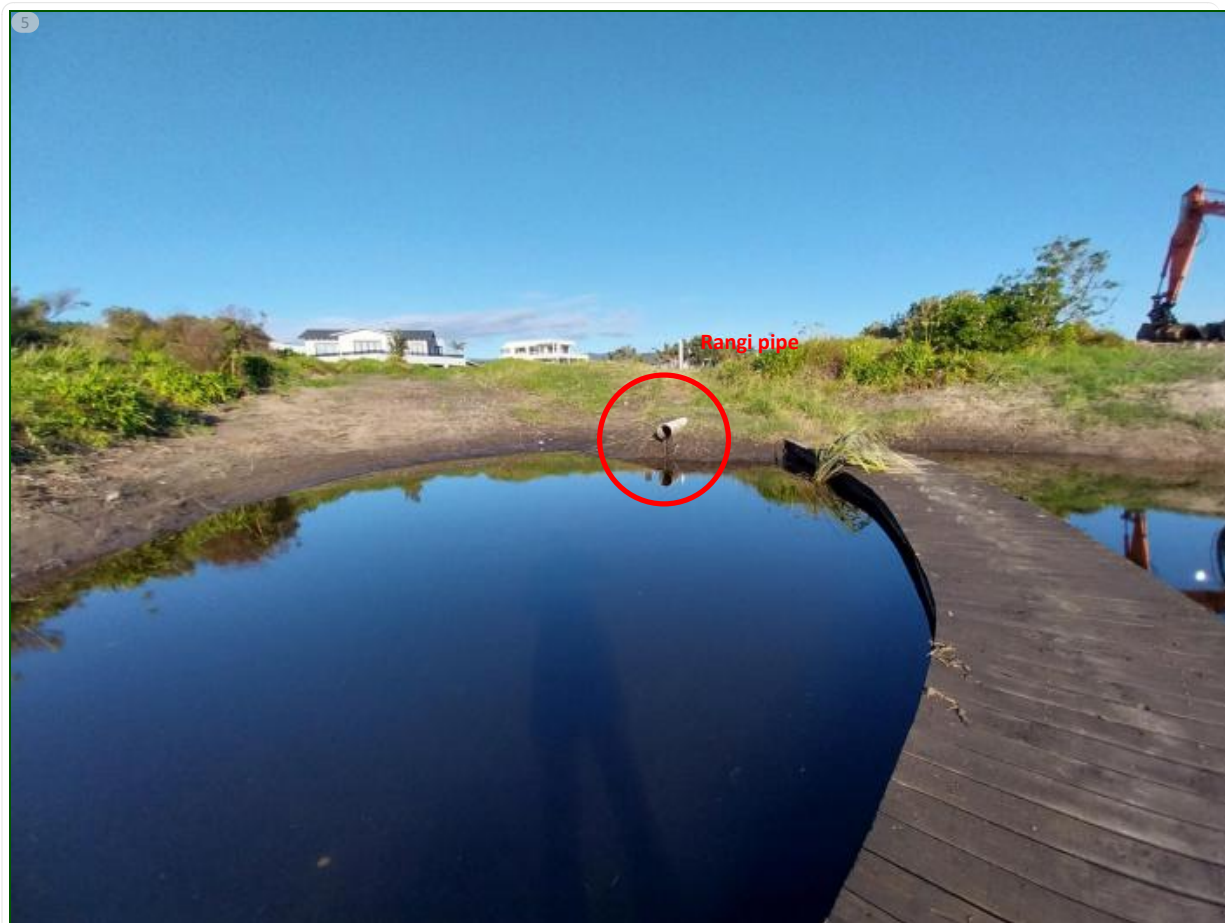
20230307_084459.jpg

7 March 2023

Showing depth of lake 2 weeks after Gabrielle

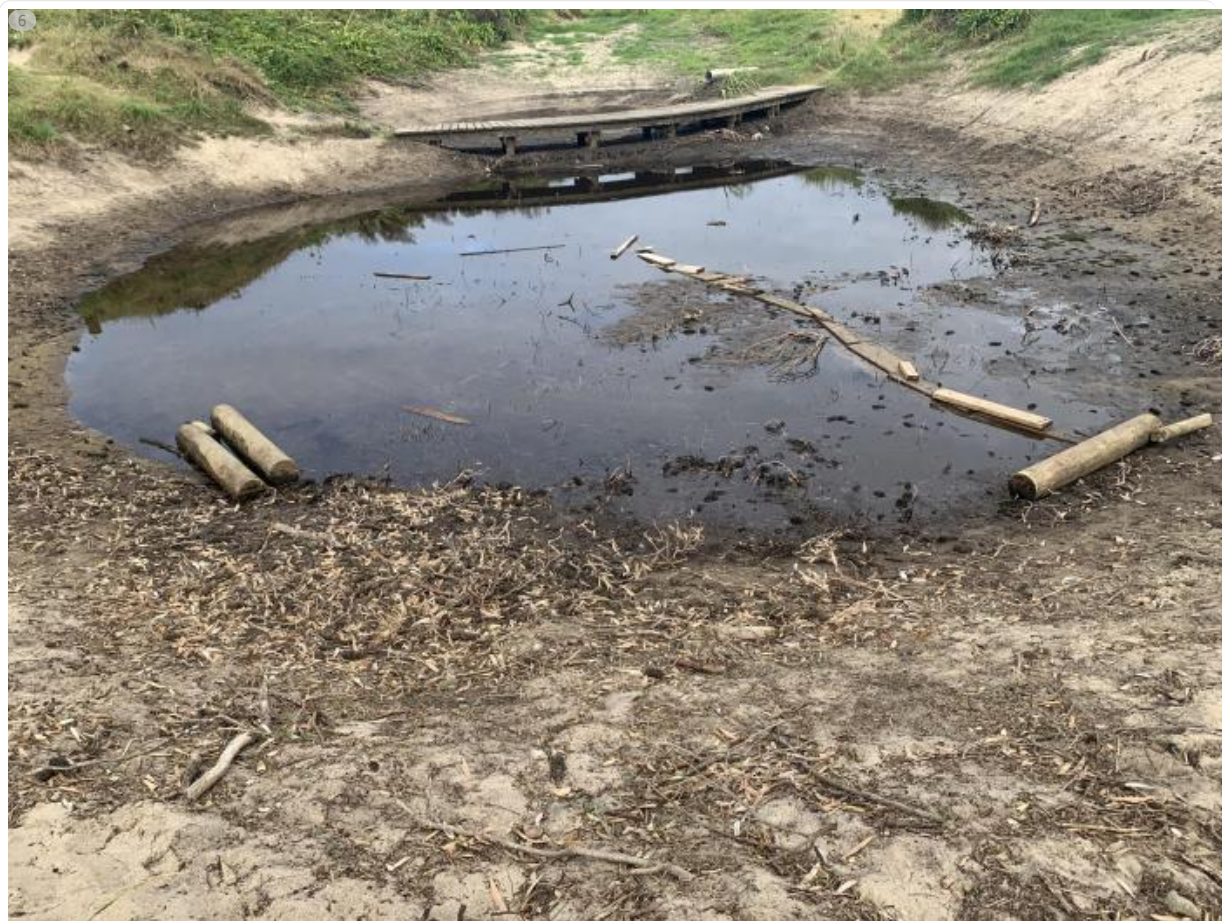
20230420 Date uncertain.jpeg

April 2023

Likely around April as grass is returning around the edges.

Kids have carried timber to create a walkway.

Often see dogs wading into it getting sludge all over them.

No-one can police safety - even parents won't have realised kids have done this.

Accept the lake must go for safety reasons alone.

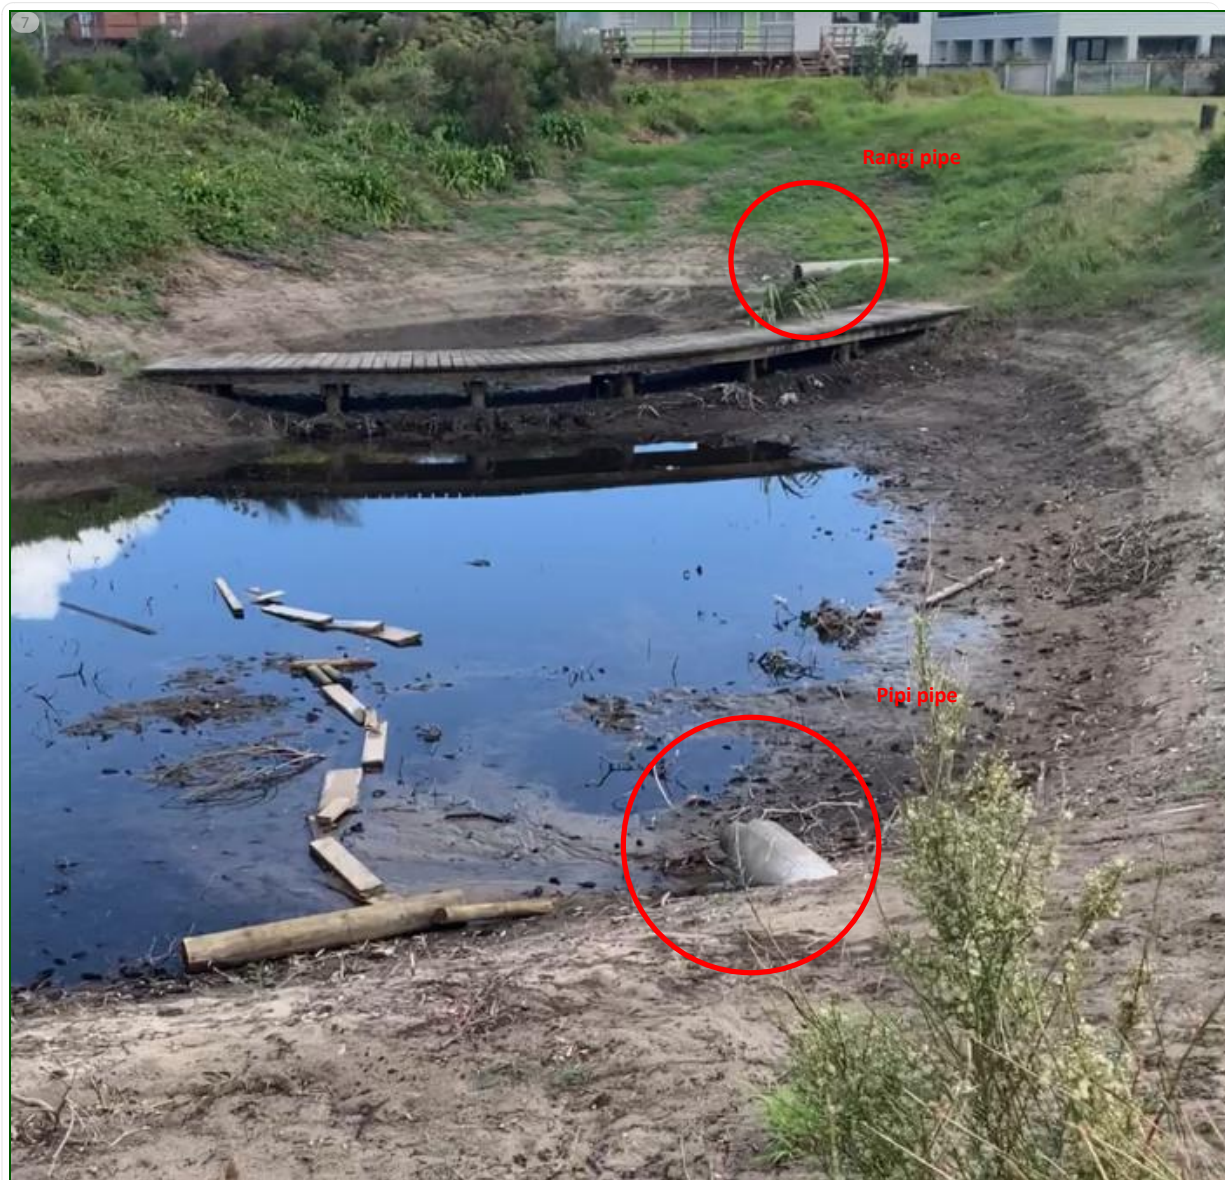
20230420 Date uncertain.jpg

No water discharging from either pipe.

The pond is close to the Ocean so likely can filter through

More likely this is the water table

Not from pipe discharge

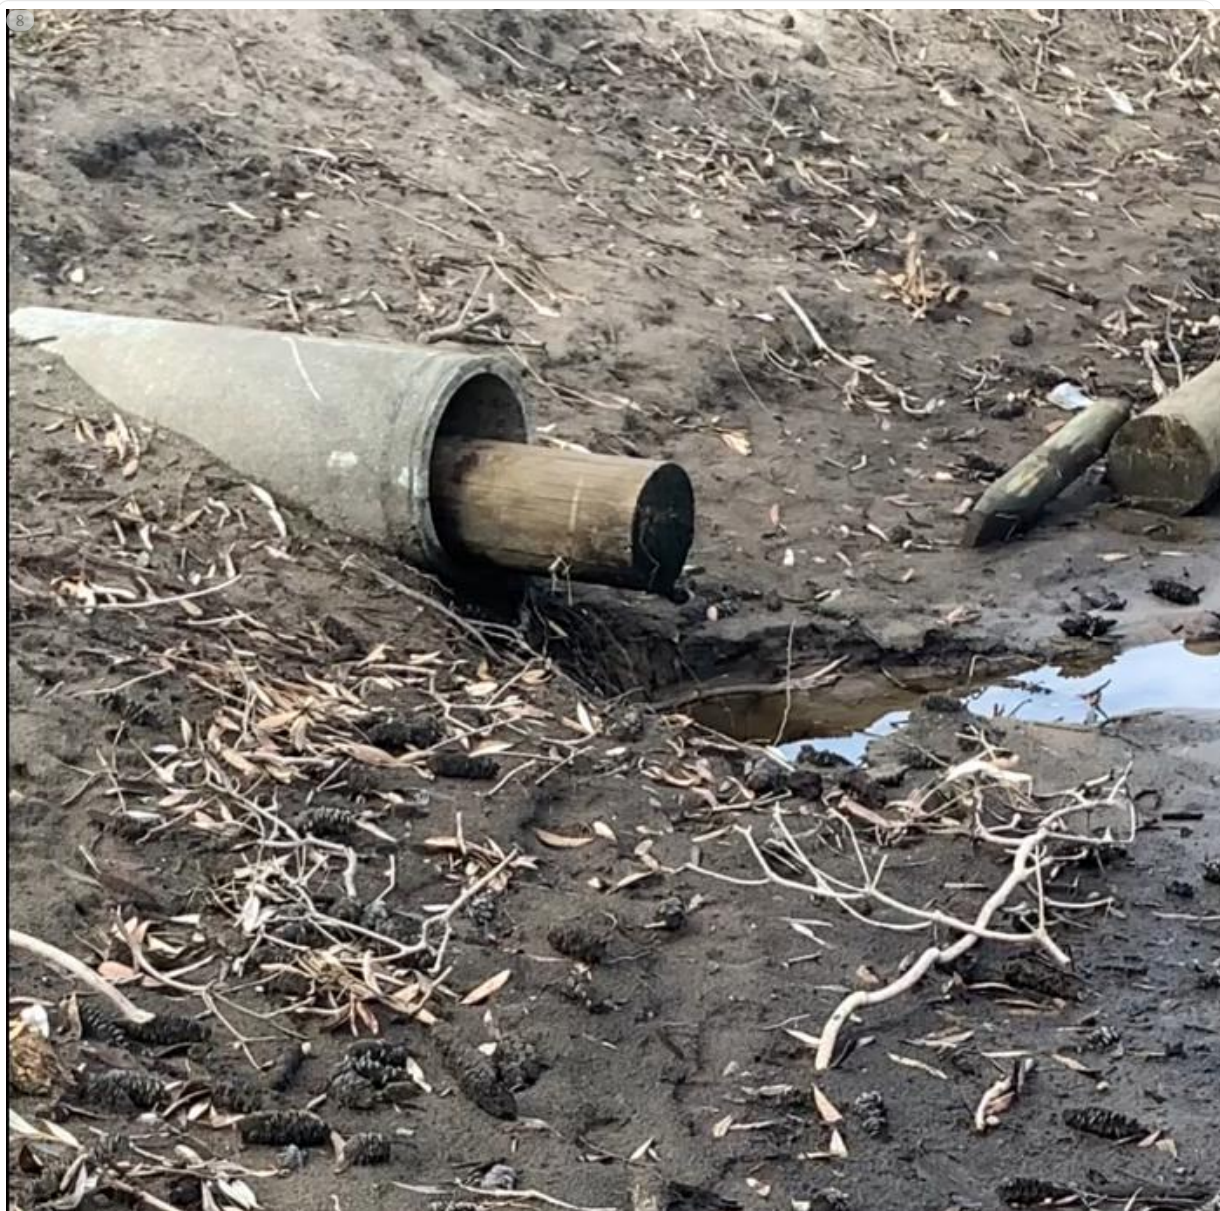
20230420 Date uncertain.jpg

Pipi Pipe below playground

No discharge

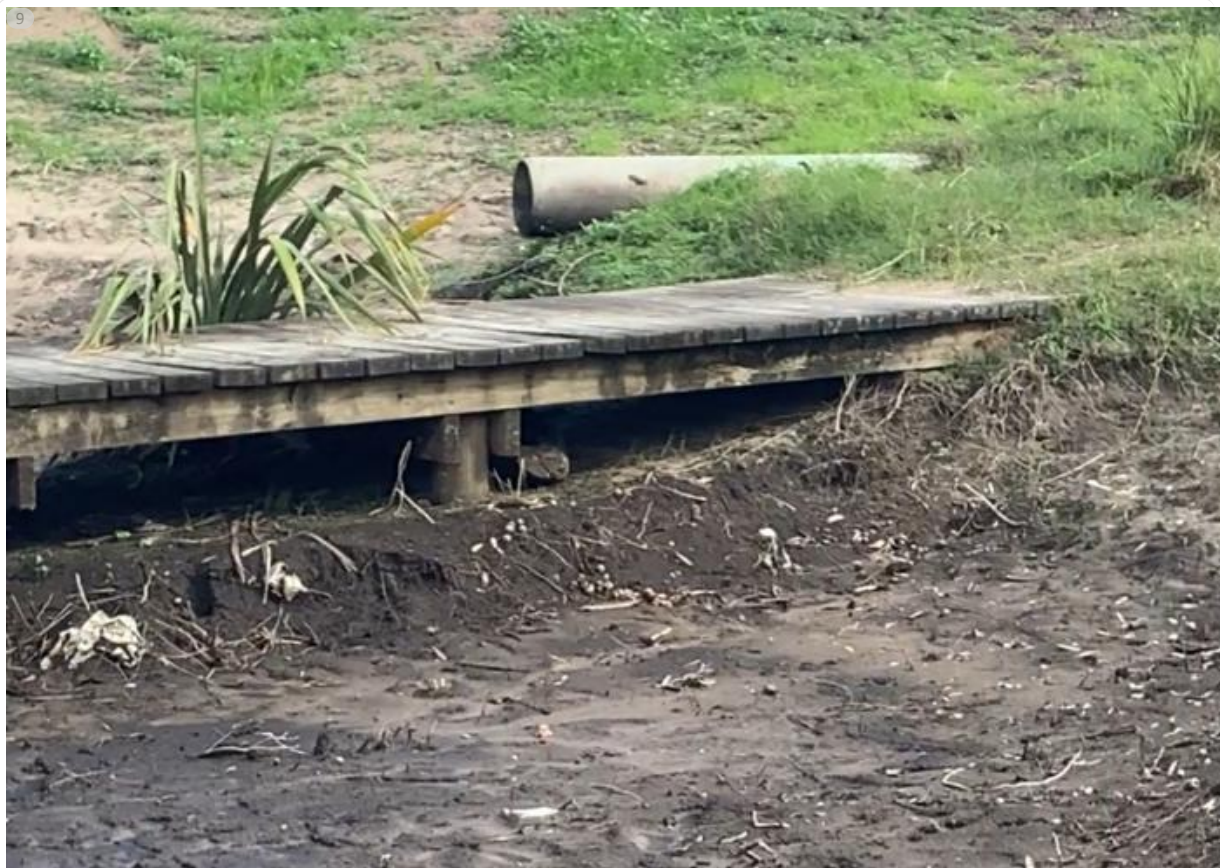
20230420 Date uncertain.jpg

Rangi pipe

Unknown invert LVL

Appears to b approximately 1m below ground level which is likely 1m below Rangi crown.

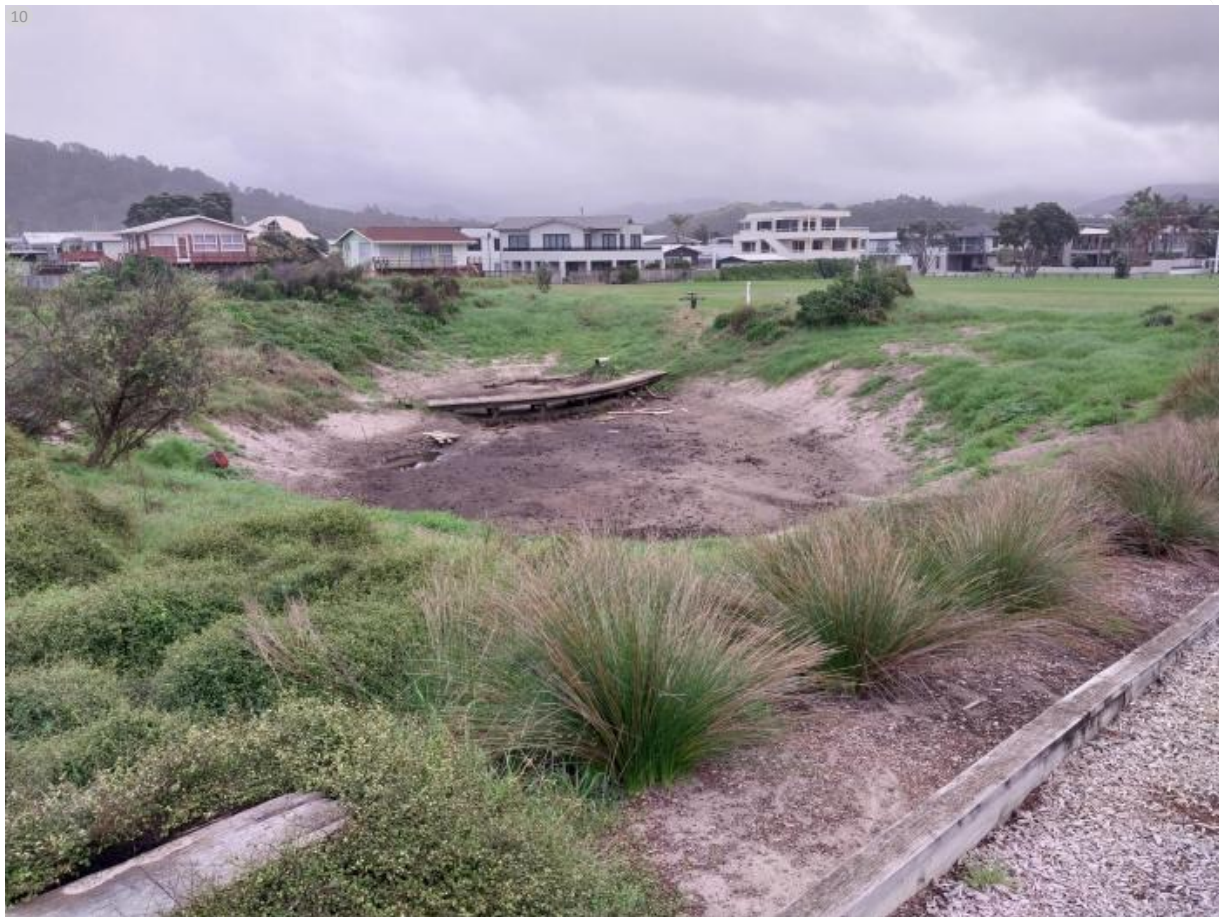
[20230508_163801.jpg](#)

8 May 2023

Shows Island View pond empty

Means water table has dropped

No discharges from either pipe

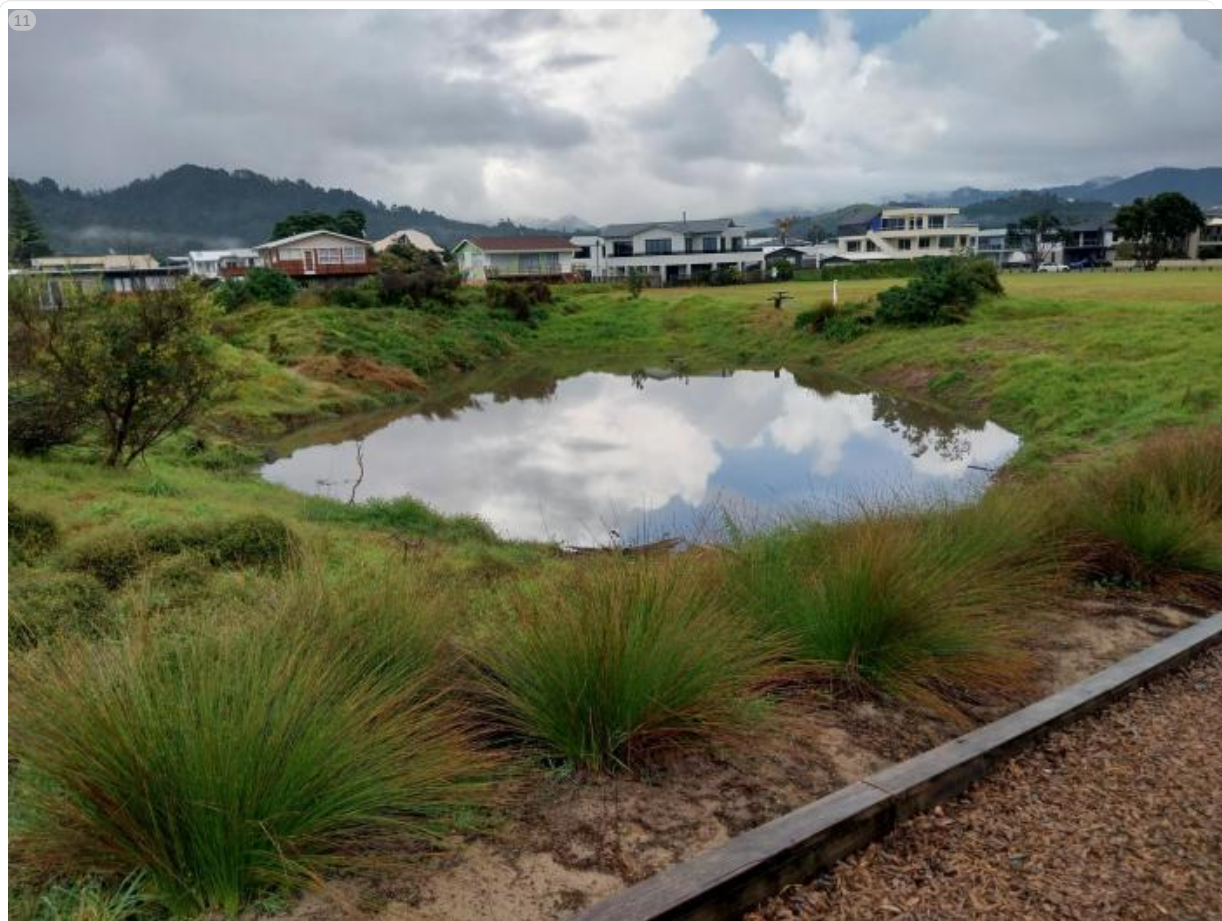
[20230618_093121.jpg](#)

18 June 2023

Island View pond water level above the boardwalk and both Rangī and Pipi discharge pipes

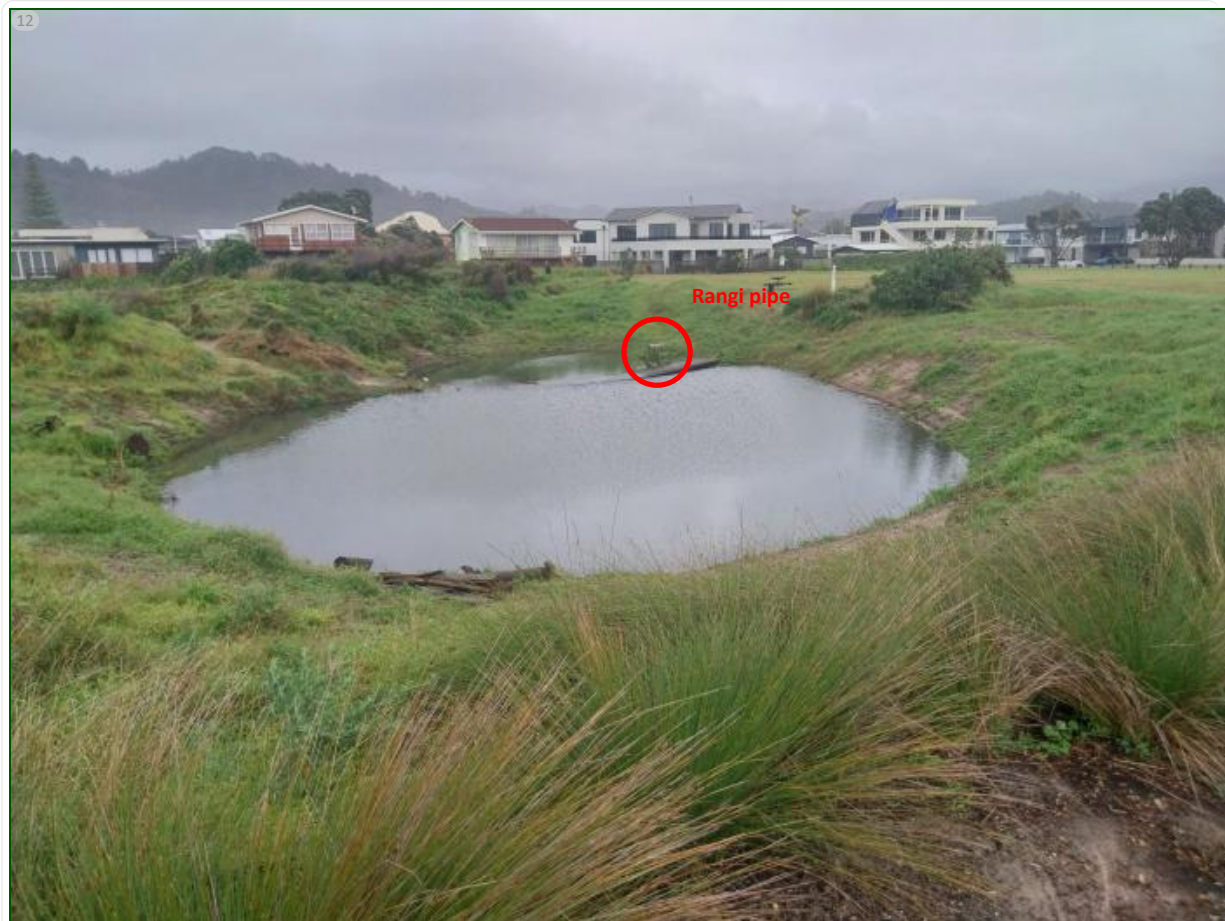
20230624_103419.jpg

24 June 2023

6 days later Rangi pipe now above the water table

Boardwalk now partly visible

Depth of lake 24 June 2023 - had a major event during the night. Level about 400mm below Rangi pipe invert

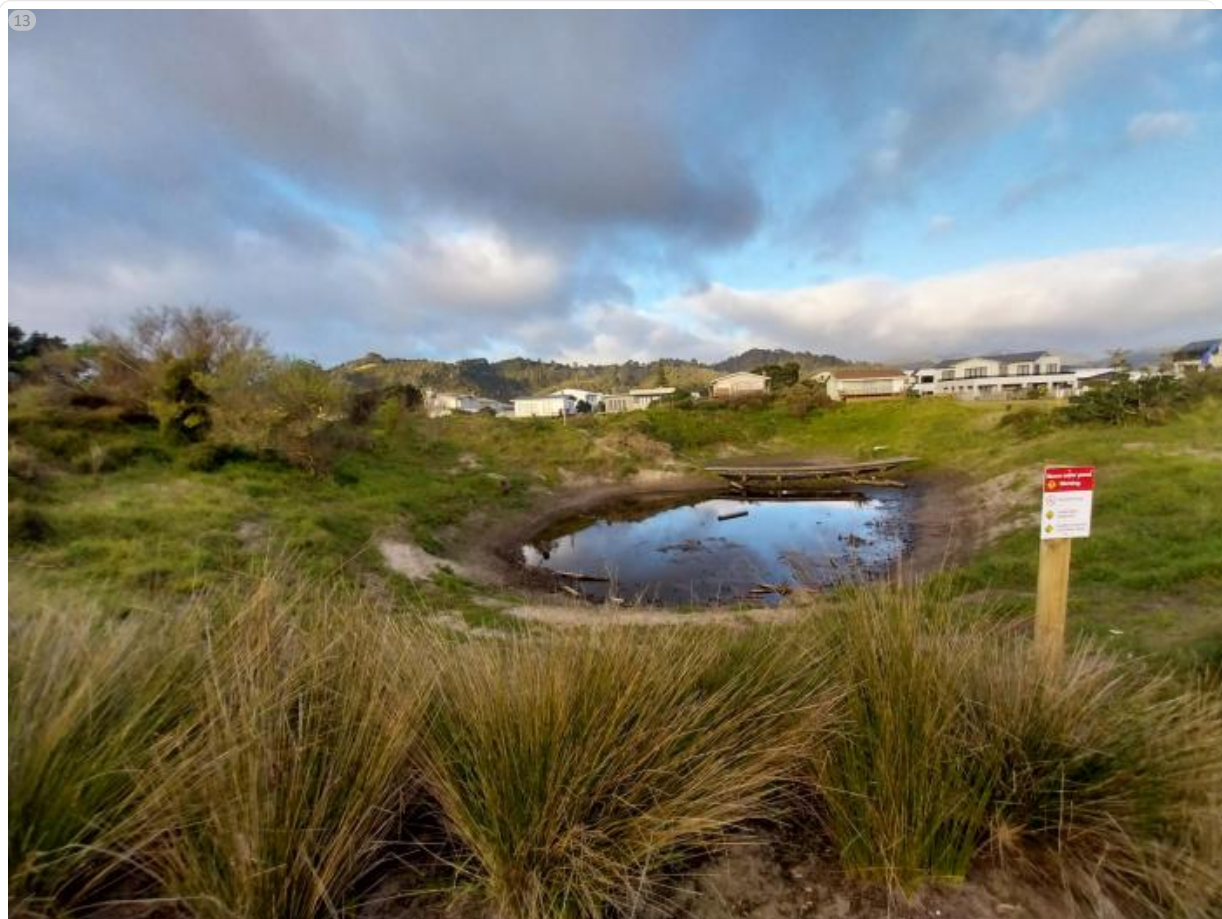
20230713_082551.jpg

13 July 2023

Pond has water in bottom

Likely this is the water table level

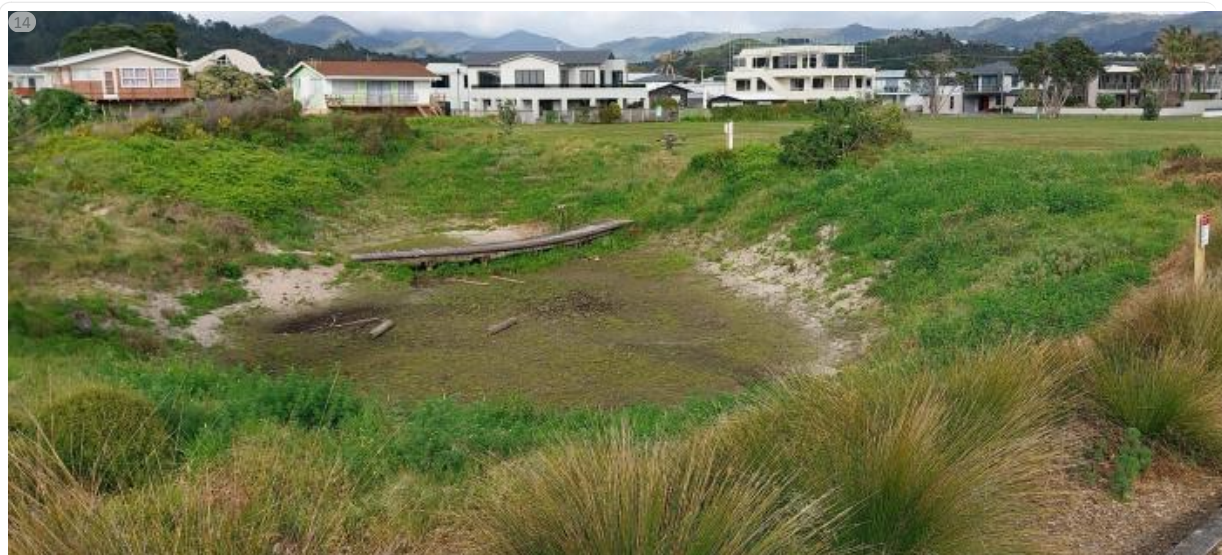
20231010_085711.jpg

10 October 2023

Pond empty

Nothing exiting the pipes

Vegetation starting which means been dry for a while

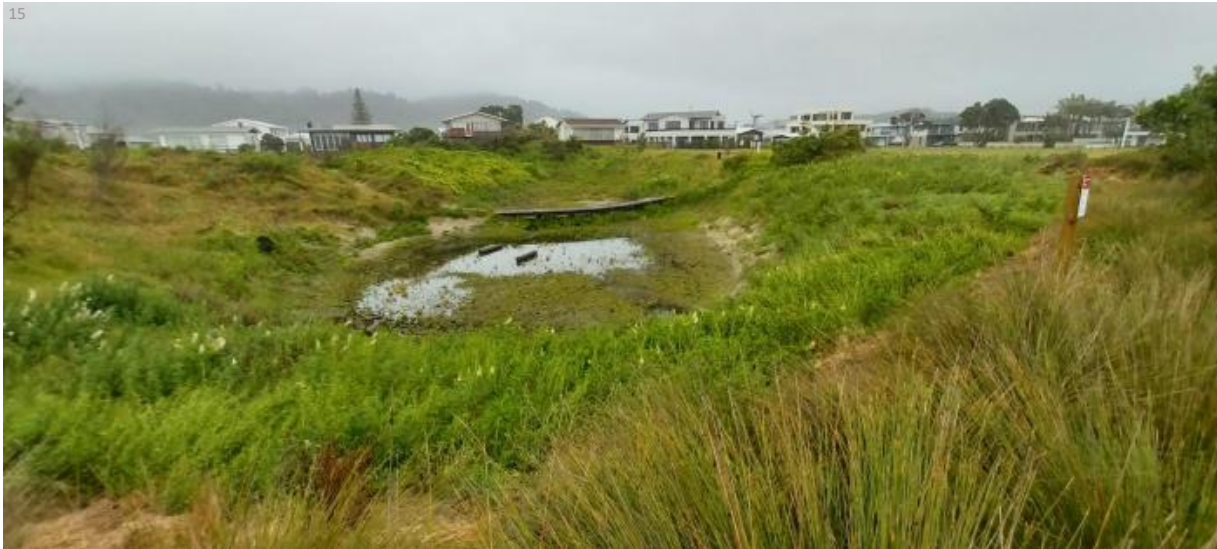
[20231031_081627.jpg](#)

31 October 2023

No discharging water from either Rangī or Pipi

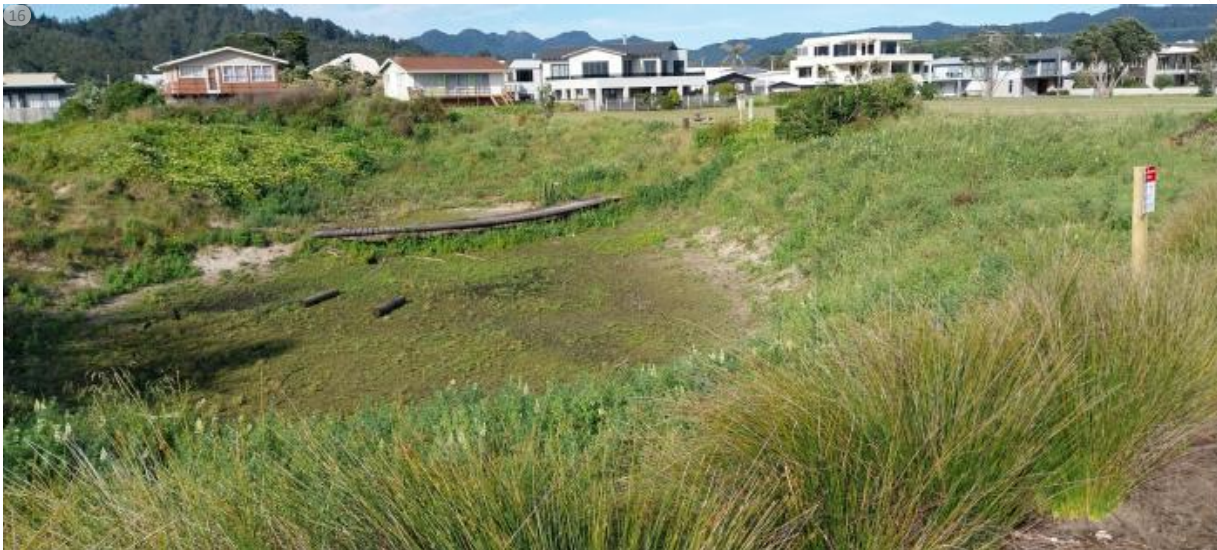
[20231102_084521.jpg](#)

2 November 2023

Water all but gone - 3 days after 200mm rain event

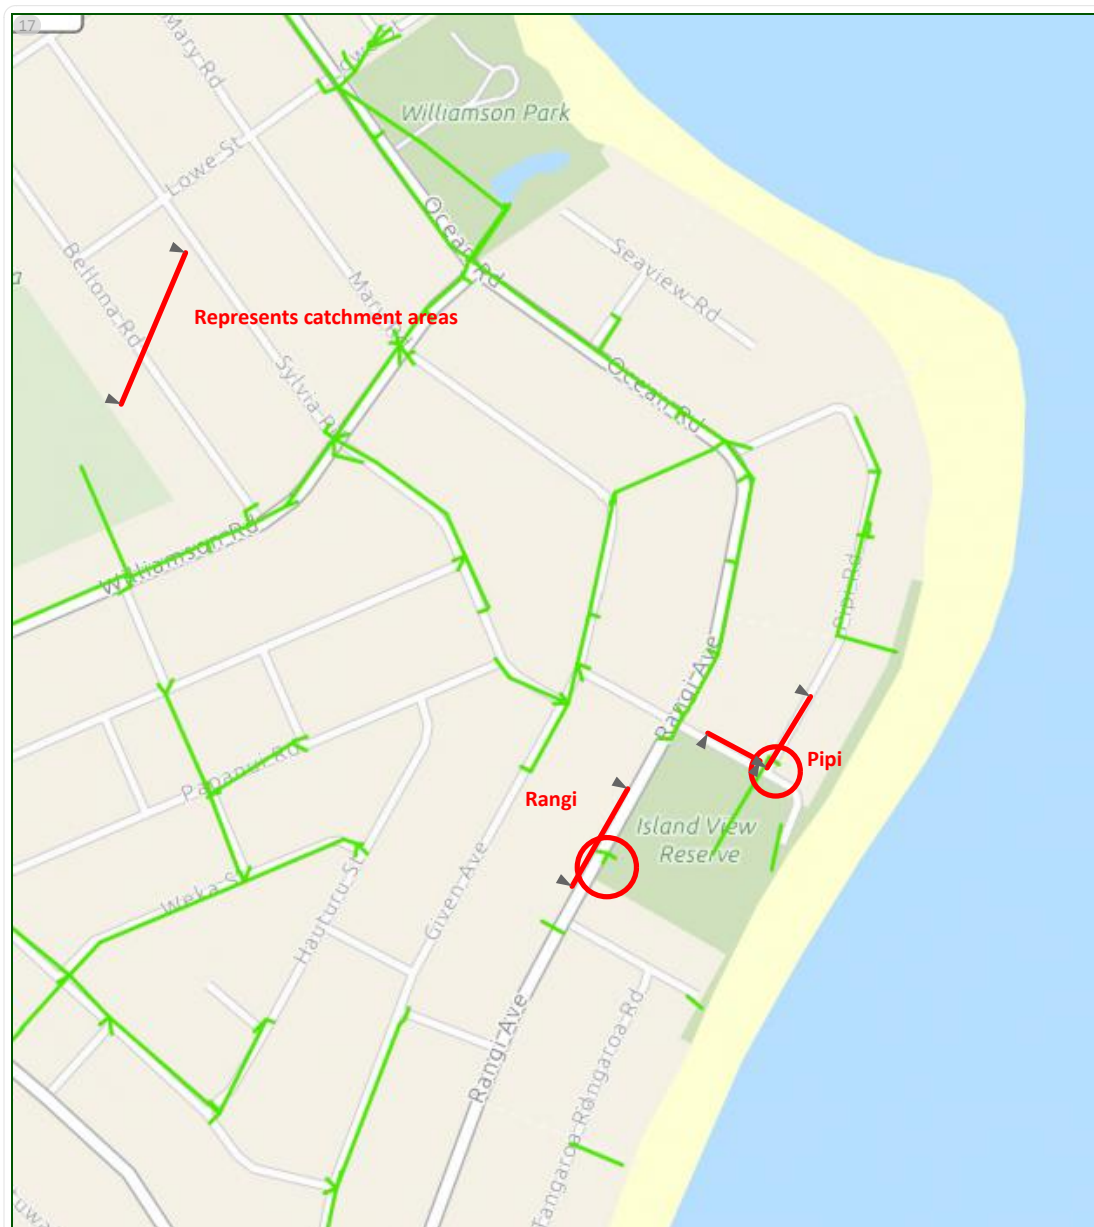
20231103_165203 pipe layout _SC_.jpg

Noted the sump in the car park is regularly blocked - recently targeted and opened the sumps and cleaned out the sand - but likely the stormwater is being supplied when the pond water level is submerged the Pipi discharge pipe so it does not flow so overwhelms the sumps and becomes surface water into the car park.

When the water table rises and the surface ground becomes saturated there will be runoff from the properties and verges into the kerb and channel. The area of this runoff is normally discounted by 50%.

The soakage devices for both Pipi and Rangi should be designed to manage minor rainfall only. This won't be much as the discharge pipes don't bleed after the kerb and channel stops running. That means the detention basin becomes a temporary storage of excess rain and needs a large enough area of grass to absorb most of the water and an overland flow path to the Ocean for the extreme events.

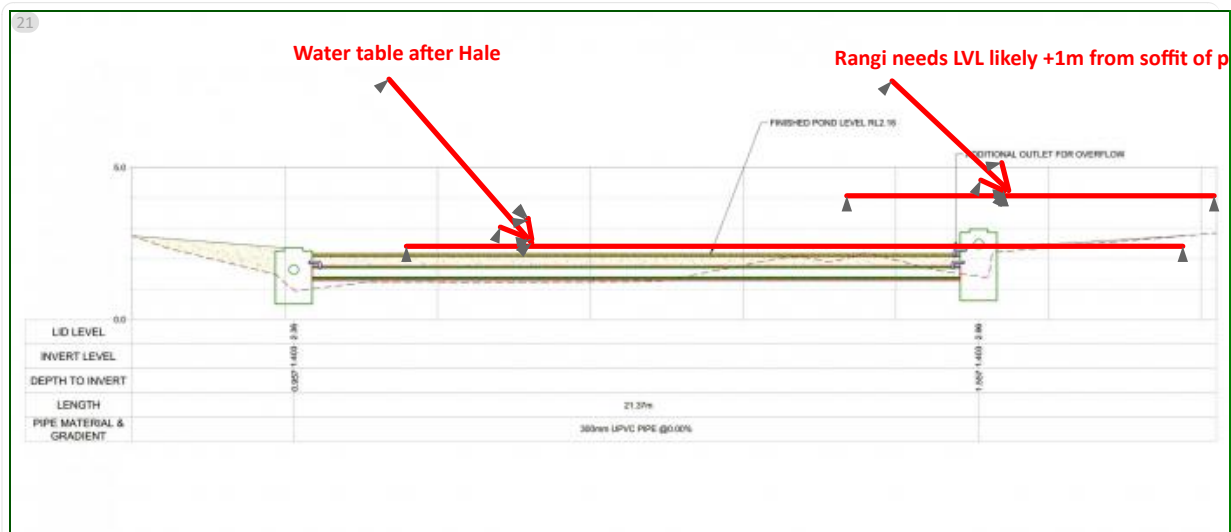
320231027 TCDC Pinnacle cross section showing drainage.jpg

Pinnacle proposal overlaid with water table levels.

Photos show watertable in February after Hale to be about invert. Having Cirtex below this (the red line) is not useful for storm-water management as they will be flooded and working in reverse. They will provide NO soaking away so the reasoning for having them is faulty.

Soakaway is only possible once the water table has fallen and by then surface flooding has gone away.

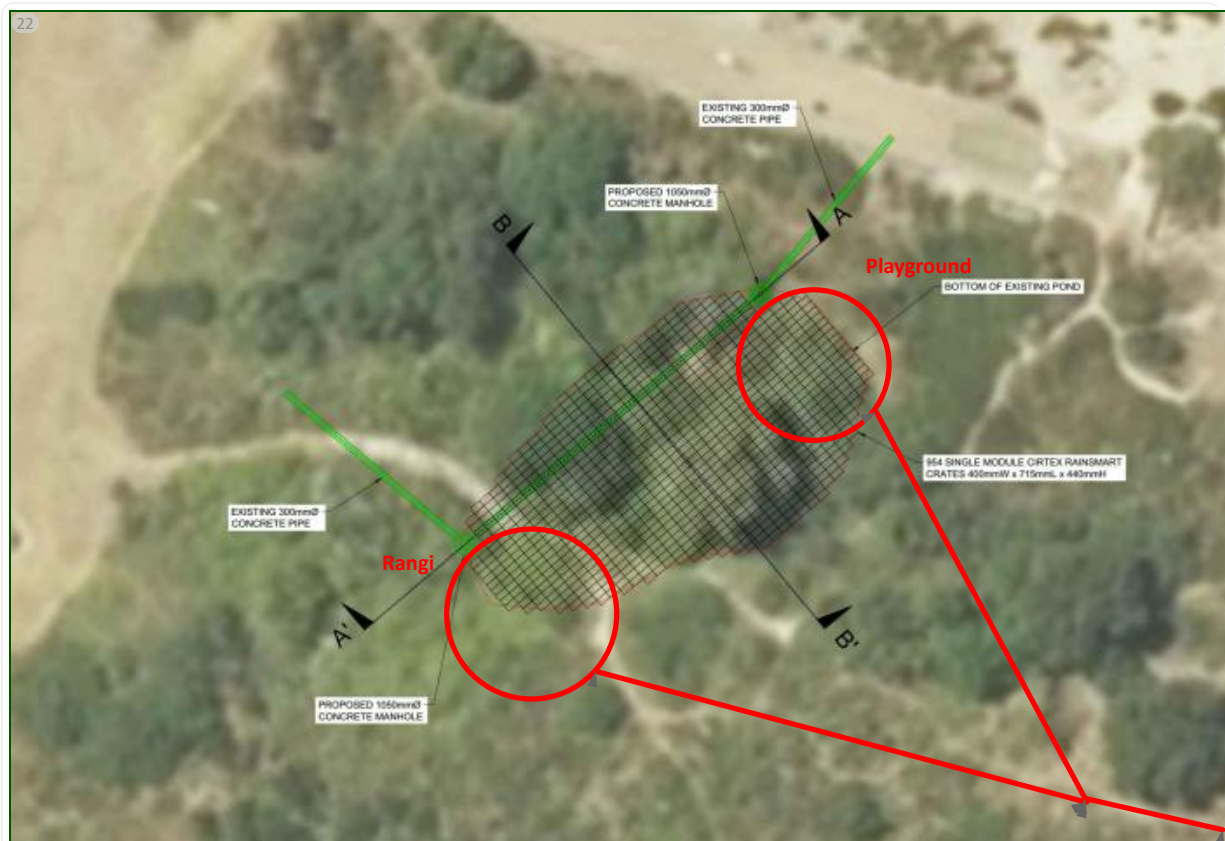
320231027 TCDC Pinnacle plan view Cirtex.jpg

Pinnacle design proposal to fill the pond with Cirtex

Cirtex is not useful in wild open spaces that have tree roots and uncontrolled sand movement.

There can be no objection to 10%AEP being discharged directly into the Ocean or river especially in a small township like Whangamata and especially a road as little used by trucks as Rangi

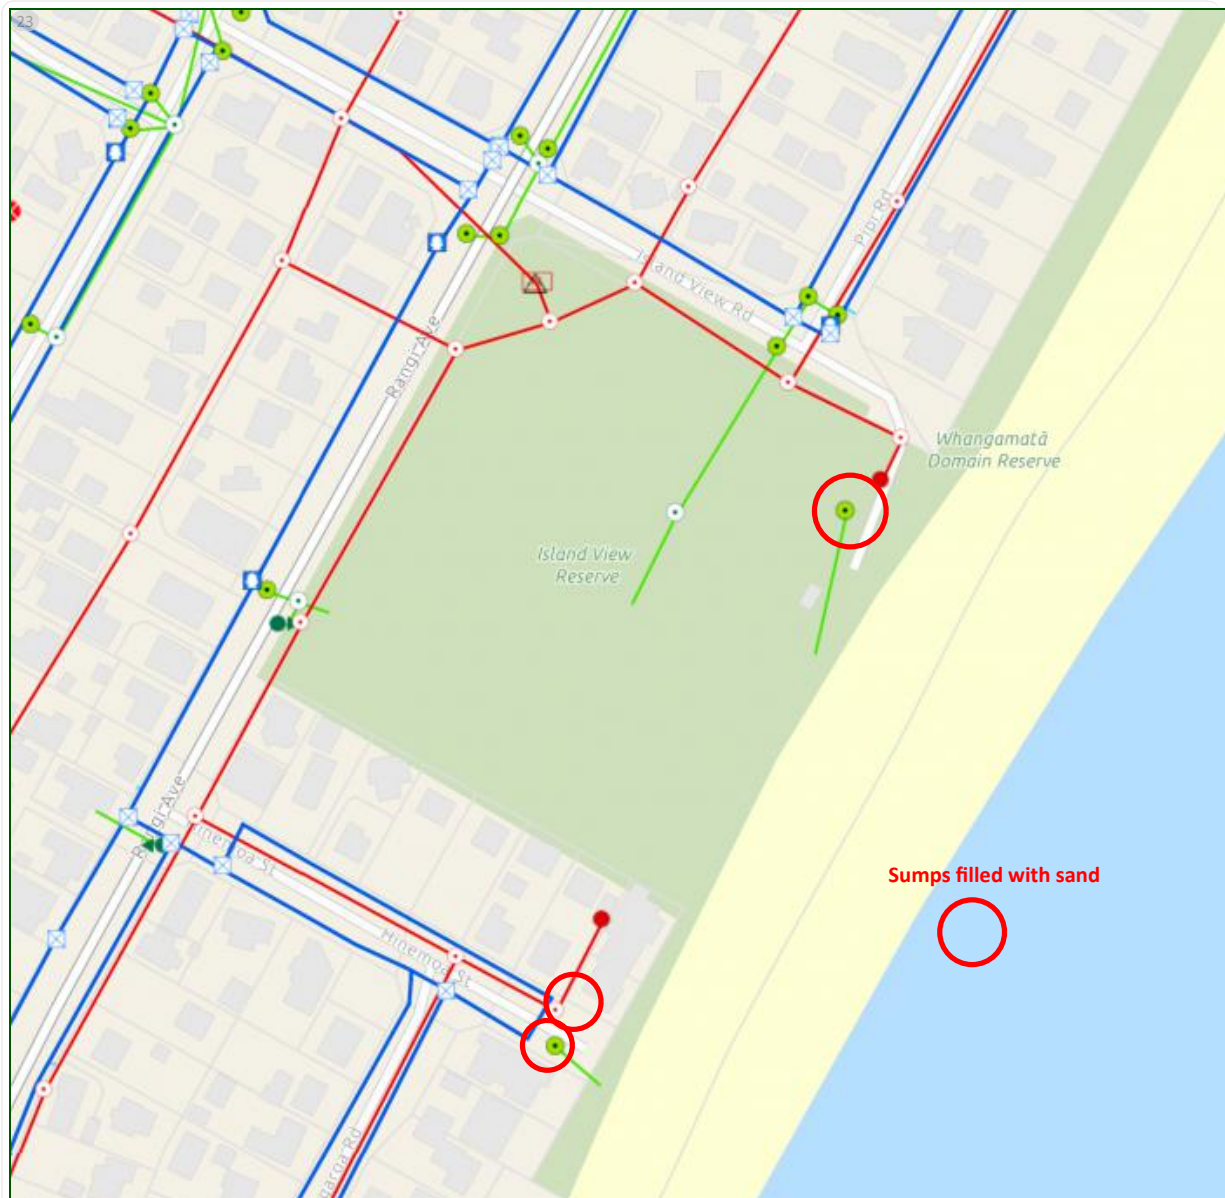
320231029 TCDC SmartMaps Island View stormwater assets.jpg

From 3 Waters Smart Maps looks like the playground entry is Pipi Rd and the other is an unmarked extension from Rangī Rd.

The circled sumps were filled with sand after last weekends big blow. Sumps cannot b installed within the sand dune areas. They fill with sand and then cannot function so causes low lying nearby properties to flood. This is why Hinemoa and Pipi properties flood. The sand dunes build up when lighter sand is blown up the coastal boundary and drops on ventury effect. This raises the batters around the coastline and protects against sea surges. Roads like Hinemoa should NOT be extended into the sand dunes as this stops the natural defence to coastal erosion. Stormwater assets cannot function during events because the natural event brings sand with it. These need moving back out of range of the sand.
