# **Assessment of Physical Changes after Mangrove Removal: Whangamata Harbour 2008**

For:  
Environment Waikato  
PO Box 4010  
HAMILTON EAST

23 June 2009

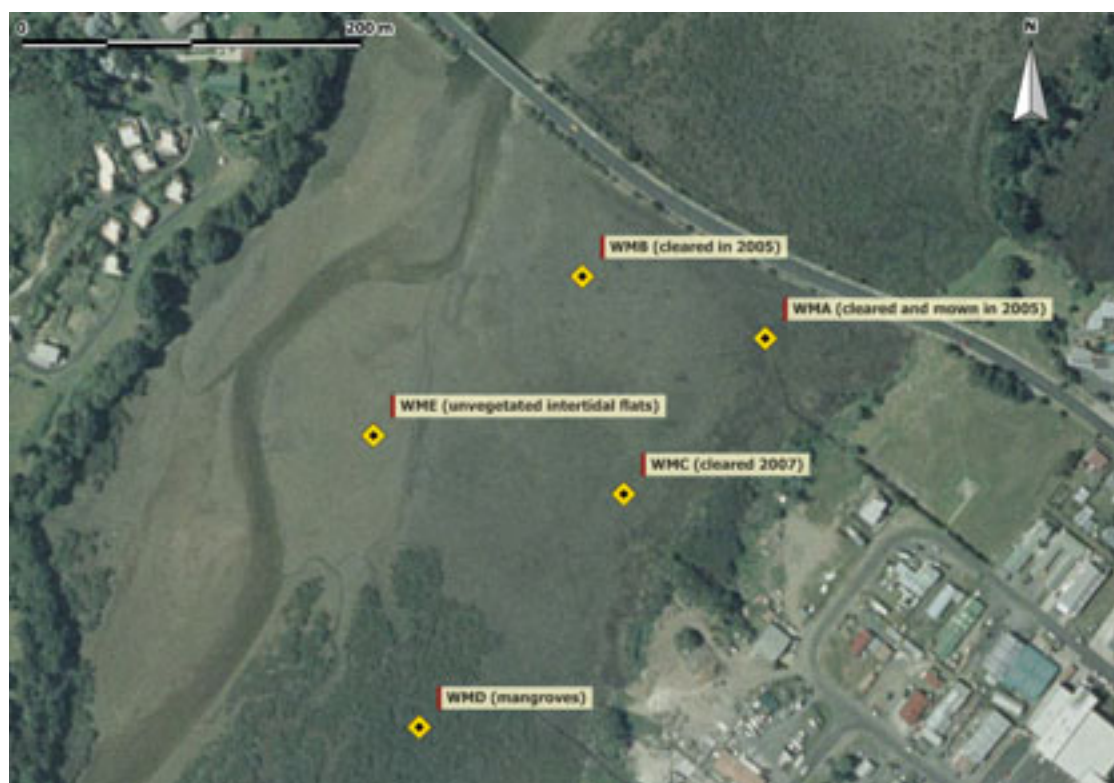
**Figure 1: Sampling point locations in Moanaanuanu estuary, Whangamata Harbour**

Within each of the areas a 50 x 50 m quadrat was marked out then subdivided into 10 sampling sub-sites/stations. A sampling location within each sub-site was then randomly selected and the following samples and information were collected:

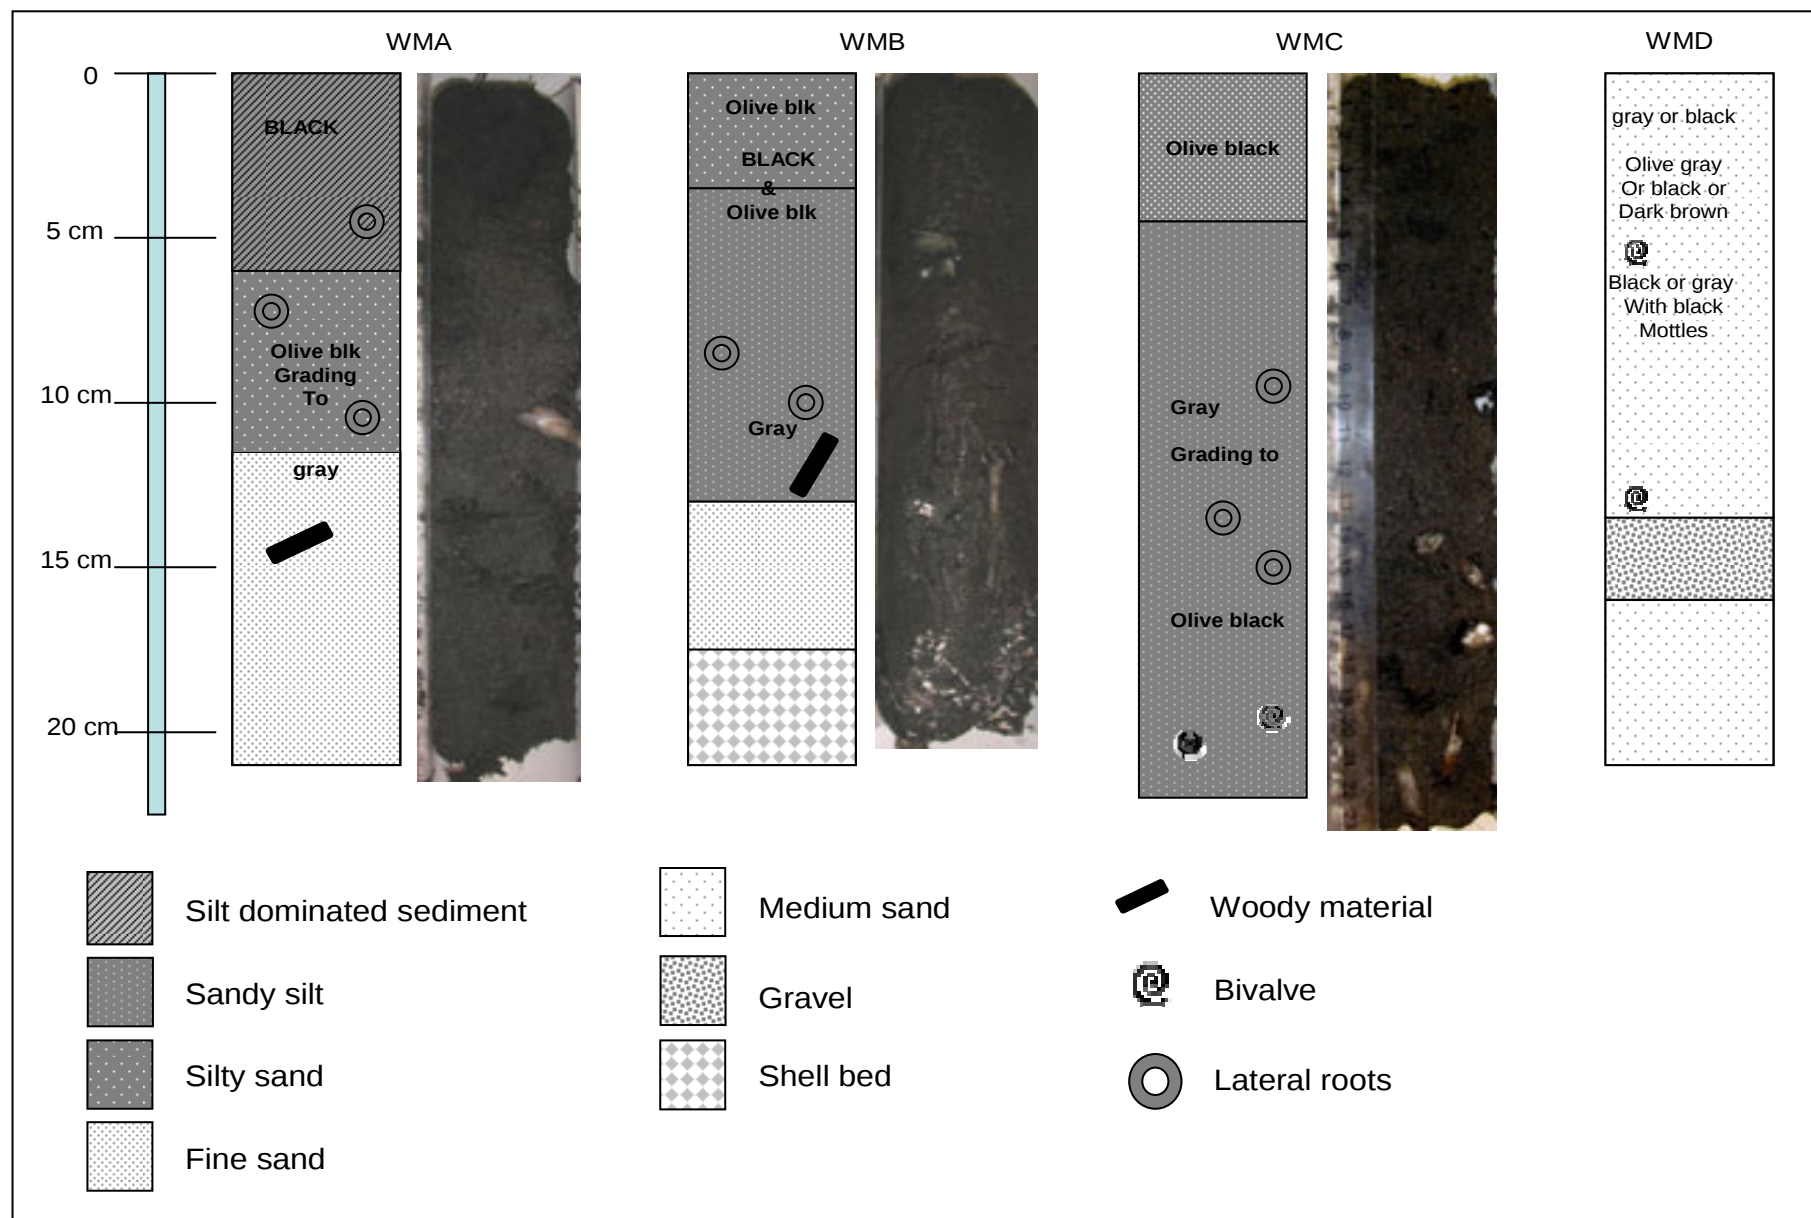
Descriptive core logs, representative of the characteristics recorded for an average of 7 cores per site, are presented in Figure 2.

**Figure 2: Representative core stratigraphy of each cleared site (WMA, WMB and WMC) and the unvegetated intertidal habitat (WME)**

Surface sediments in the cleared and mown site consisted of black slightly-sandy silt with over 50% mud, which graded from olive black at around 6 cm below the surface to gray toward the base of the core (~ 20 cm). Sediment texture ranged from sandy silt in the upper 5 – 8 cm, to silty sand at around 13 cm, grading to a slightly coarser slightly-silty sand and fine sand below 13 cm. Root material was observed to depths of around 20 cm, with dense roots found in the upper 7 cm.

Surface sediments in the cleared (but not mown) site were also mostly olive black/black with mean grain size of 230  $\mu\text{m}$  ( $\pm 14$ ) (Figure 4). Texture in the upper 3-5 cm was mostly silty sand, then black sediments between 5 cm and 15 cm were dominated by sandy- silt or silty sand. Below 15 cm gray sediments consisted mostly of medium and fine sand. A shell bed, consisting of variable percentages of shellhash, full single shells and large fragments of cockle shell in a sandy matrix, was present in half of the cores below 15 cm,

The upper 5 cm of the cores in the site cleared of mangroves in 2007 were dominated by olive-black sandy silt and silty sand, with surface sediments of 116  $\mu\text{m}$  ( $\pm 12$ ). Root material was dense in the upper 5 cm and present within the remainder of the cores. The sediments remained mostly olive black but graded to a gray or grayish olive below around 10 cm in some cores.

Surface sediments on the unvegetated intertidal flats were dominated by fine and medium sands, with a mean grain size of 393  $\mu\text{m}$  (medium sand). Surface colours ranged from yellowish brown to olive black. Coarse sand and gravel were found at depths of around 10 to 18 cm in some locations. Occasional wedge shells and cockles were also found between 9 cm and 15 cm. Sediments below the surface were mostly gray to black sands and gravels.

Core stratigraphy revealed silty sands to depths below 12 cm at all cleared sites, suggesting that it would be some time, if at all, before these sites evolve to a purely sandy environment under the present-day hydrodynamic regime. Surface sediments in cleared sites WMB and WMC were dominated by fine and medium sands (with some mud), indicating that some of the mud particles have been winnowed out over time, but that any further significant coarsening of sediments may either not occur, or will occur very slowly. This hypothesis is supported by the fact that sedimentology of the sites is similar, even though they were cleared two years apart (2007 and 2005). Further core sampling will provide valuable information on erosion of fine sediments over time at these sites.

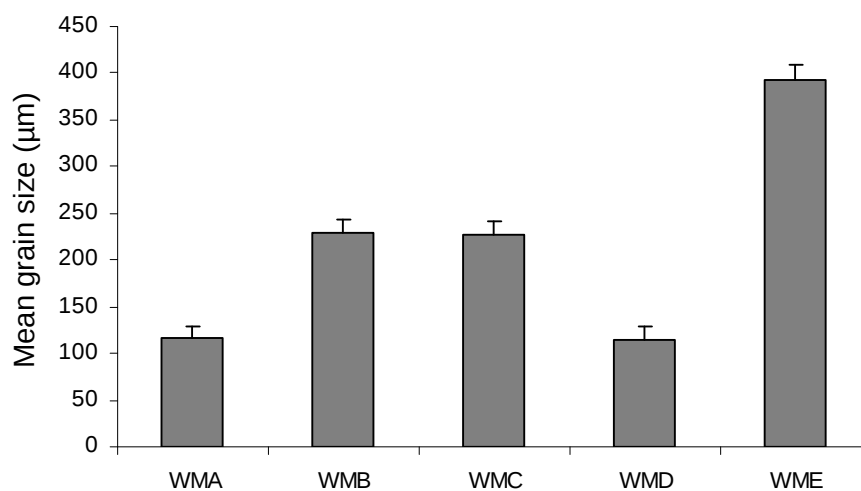
**Figure 3: Mean grain size (bars indicate standard error) at sites WMA (cleared and mown 2005); WMB (cleared 2005); WMC (cleared 2007), WMD (intact mangrove) and WME (unvegetated intertidal flat).**

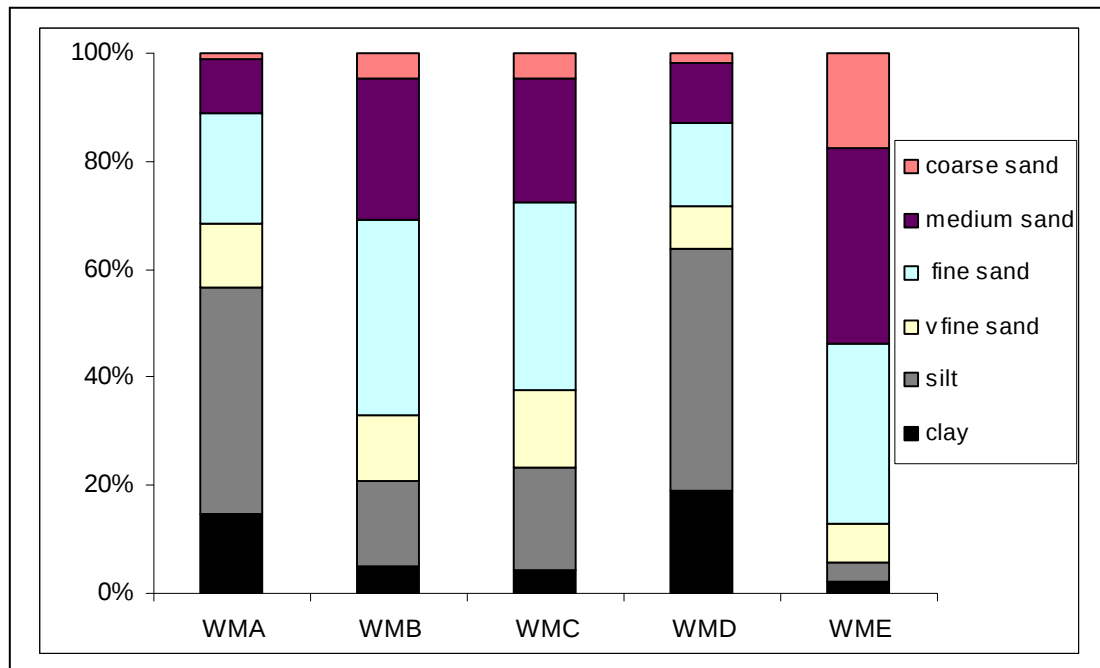
The mangrove site (WMD) and the highly impacted cleared site (WMA) were dominated by muddy surface sediments. Mangrove sediment consisted of an average of 64% mud\*\*, while WMA sediments contained around 56% mud (Figure 4). These two sites display similar volumes of very fine, fine and medium sand classes. Cleared sites WMB and WMC were also similar in sediment texture, with around 25% mud, around 10% very fine sand, 35 - 40% fine sand and 25% medium sand. Surface sediments in the unvegetated intertidal flat, WME, were dominated by fine and medium sand, and less than 10% mud.

**Figure 4: Surface sediment composition (% clay, silt, fine, medium and coarse sand) at sites WMA (cleared and mown 2005); WMB (cleared 2005); WMC (cleared 2007), WMD (intact mangrove) and WME (unvegetated intertidal flat).**

Sample analyses confirmed that surface sediments in the 2005 cleared mown site (WMA) are similar to those in the existing mangrove habitat, with over 50% mud present at both sites. The high mud content is not unexpected, given the location of the sites; close to the landward boundary of the estuary, where the combination of low tidal velocities and lower tidal inundation (relative to the other sites) creates a depositional environment rather than an erosive environment. Silty (mud-dominated) sediments occur to depths greater than 5 cm in the cleared site WMA, suggesting that the mud is either continuing to accumulate and/or is not being redistributed after mangrove removal.

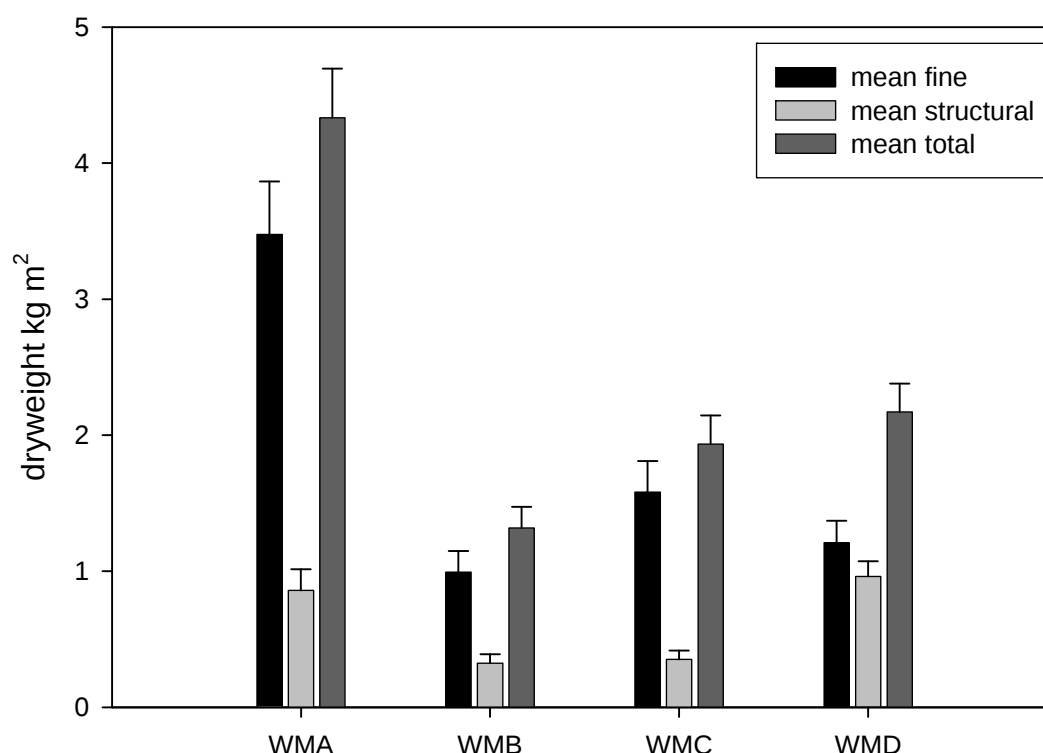
The highest proportion of mangrove root material (below-ground biomass) was present at Site WMA with an average of 3.47 kg m<sup>2</sup>. This was significantly greater than at the other three sites ( $p < 0.001$ ), including the mangrove habitat, which contained below-ground biomass averaging 2.17 kg m<sup>2</sup> (Figure 4). The difference was mostly due to a significantly larger volume of fine roots present. Post-hoc tukey test results are displayed in Table 2.

**Figure 5:** Dry weight ( $\text{kg m}^{-2}$ ) of below-ground biomass, structural roots and fine roots at sites WMA (cleared and mown 2005); WMB (cleared 2005); WMC (cleared 2007) and WMD (intact mangrove habitat).

Below-ground root biomass was measured to determine how much material remains post-clearance and by so doing, gain an idea of how quickly the root material is breaking down over time. The rate of biomass decomposition influences how surface sediment characteristics change over time, as the mass of fine roots remaining in the sediment still functions to trap fine sediment particles until such time that the roots decompose and break down completely. It is important to note in this case that interpreting biomass differences between sites is complicated by the fact that the amount of root material within any mangrove stand is (to some extent) related to the age and size of the trees (and that age and size often differ across a gradient from channel to land). Sizes and ages of (former) trees at sites WMA, WMB and WMC are unknown because they were cleared before any such measurements could be taken. Interestingly however, the below-ground biomass average of 3.47 kg m<sup>2</sup> in the highly impacted cleared site (WMA) is higher than that which has been measured in healthy (intact) mangrove habitat in an estuary in Tauranga Harbour (Stokes and Healy submitted). The other cleared sites also still have relatively high levels of root biomass with over 1 kg (dry weight) of root material per square metre.

There are two possible explanations for the significantly greater mass of root material found at the highly impacted cleared site (WMA) compared with all other sampling sites; firstly that the highly anoxic and hydrodynamically quiet environment is inhibiting decomposition and breakdown processes, and secondly that these processes have been further inhibited by sediment compaction resulting from vehicle use in the area. Compaction reduces the erosion potential of surface sediments and slows down decomposition processes by creating a highly anoxic zone (as demonstrated by the black colour of the sediments).

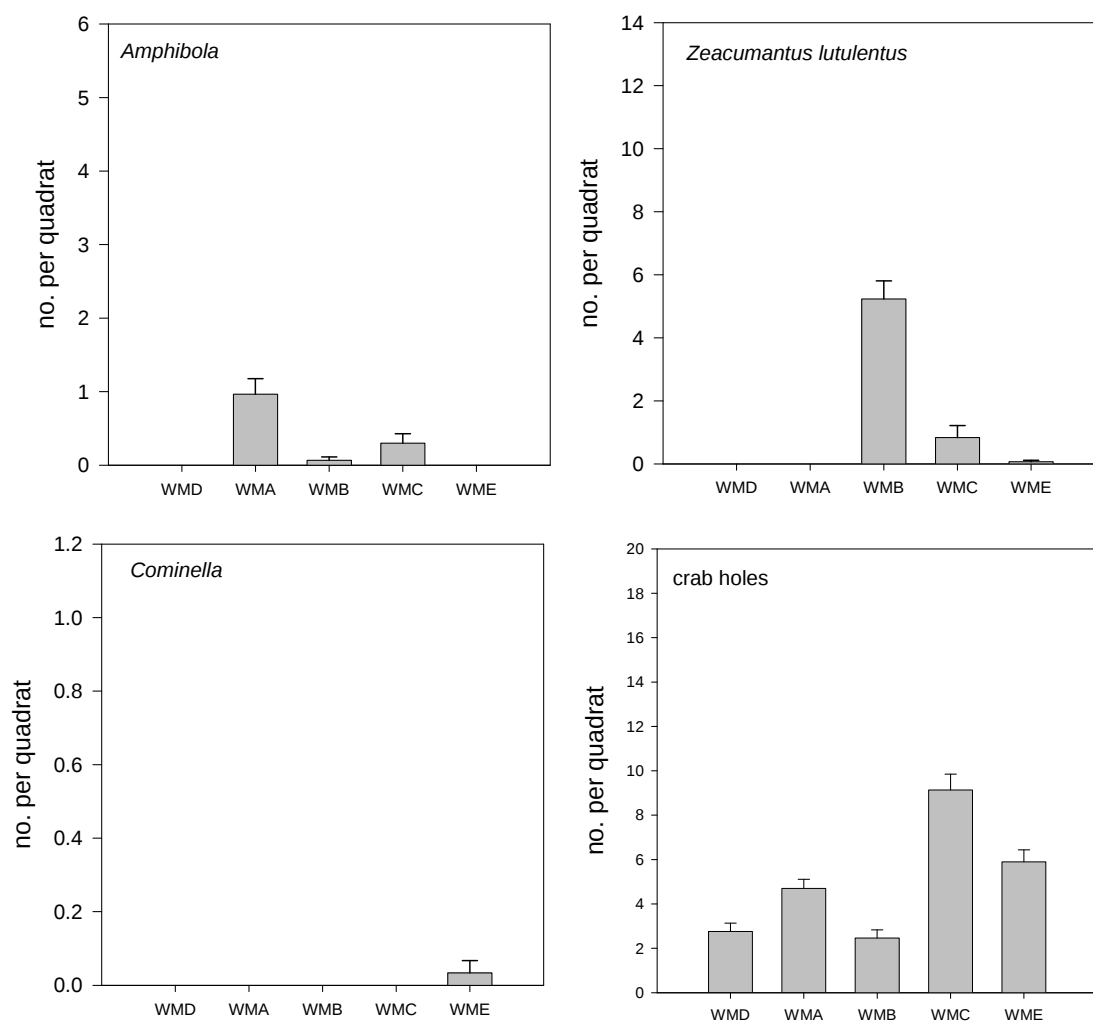
Overall very few epifauna were present. The mud-snail *Amphibola* was present in low and patchy numbers in all the cleared areas but absent from both mangrove and

intertidal flat sites. *Zeacumantus lutulentus* (horn-snail) numbers were also low, with an average of 5 or fewer per quadrat in cleared areas WMB, WMC and the intertidal flats WME (Figure 6).

**Figure 6: Abundance of surface macrofauna at sites WMD (intact mangrove habitat); WMA (cleared and mown 2005); WMB (cleared 2005); WMC (cleared 2007) and WME (bare intertidal flats).**

Surface macrofauna were generally only present in low numbers at all sites (Figure 6). Crab holes were observed in all sampled areas, and variation in the density of these did not appear to be related to either surface sediment type or distance from the tidal channel. The mudsnail, *Amphibola crenata*, was only found in the cleared areas, though typically < 2 individuals per quadrat (mudsnails are deposit feeders and are likely exploiting the food provided by the rotting mangrove roots). The carnivorous gastropod *Zeacumantus lutulentus* (hornshell) was present both in the cleared areas WMB and WMC and also on the bare intertidal flat. The whelk (*Cominella*), another carnivorous species, was also present on the bare intertidal flat. Its primary food source is the cockle (*Austrovenus stutchburyi*), and so whelks are typically found in abundance where cockles are present (Jones and Marsden, 2005). As these gastropods were mostly absent from the sampled areas, it is also likely that cockles are not abundant at this site.
