ANNUAL REPORT

**Comprehensive Stormwater Discharge Consents
2018 - 2020**

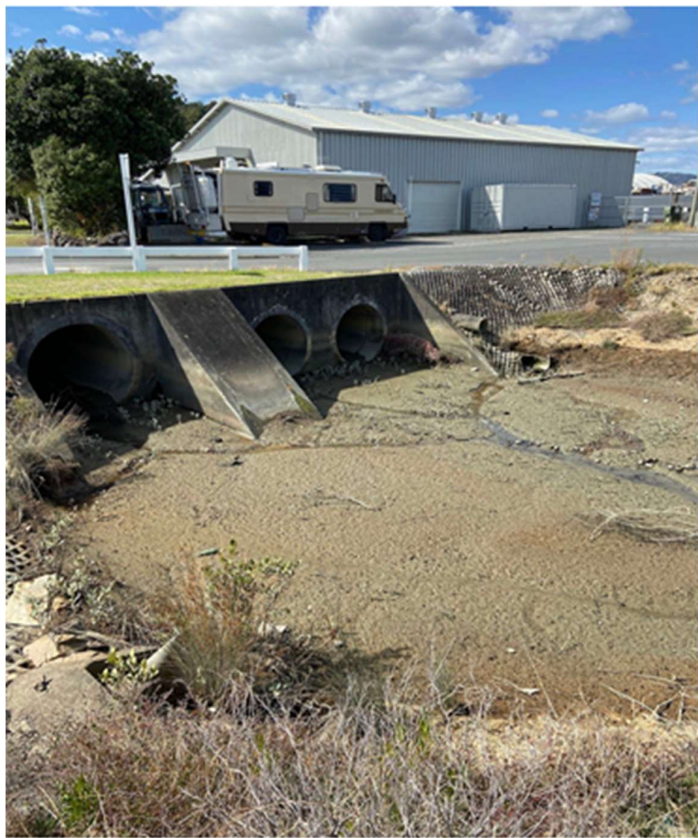
<p>Channel remains clear with recent flows removing the silt layer on the RHS</p>

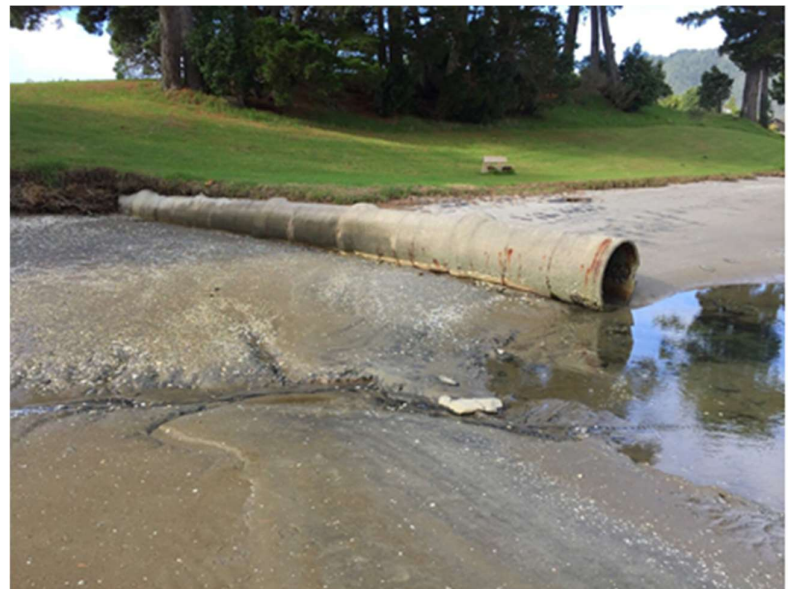
- Site 6, Whangarahi Stream, Wharf Road, Coromandel: minor scouring under the outlet noted after heavy rainfall event during June inspection [Note: the outfall discharges approximately 1 metre above the riverbed so some scouring is always present].

Ref 06	February 2020, Coromandel outfall to Whangarahi Stream	June 2020 Coromandel outfall to Whangarahi Stream
	<p>Silt layer has developed with absence of strong stream flows. Recent work in the CBD has replaced a portion of the upstream SW reticulation improving system performance.</p>  	<p>Site after a heavy rainfall event identifies minor scour under outlet Site conditions remain similar.</p>

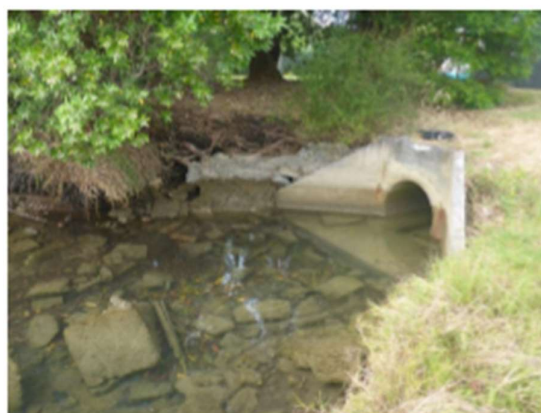
Photo 7. Site 7: Marquet Place, Tairua Harbour.

Observations at this site were similar to the 2014 survey.

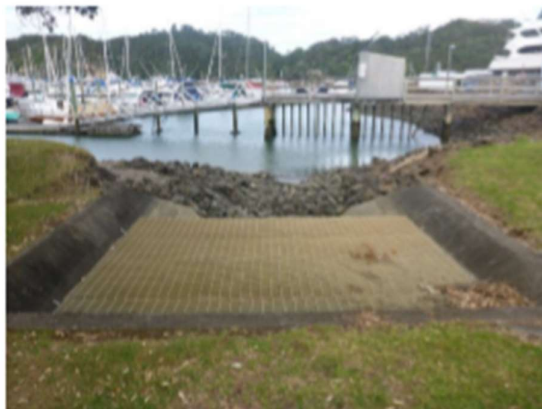
Photo 8. Site 8: Marina hardstand, Whitianga.

- Site 8, Marina Hardstand, Whitianga: fewer fauna species noted compared to 2014 survey.
- Site 9, Moewai Road North, Whitianga: water level in the drain was exceptionally low and there were slightly fewer invertebrate groups found compared with 2014. Site had changed dramatically since 2014 survey with vegetation overhanging stream channel having been removed.
