Draft Whangamata Catchment Management Plan

21 November 2006

Document #: 1194680

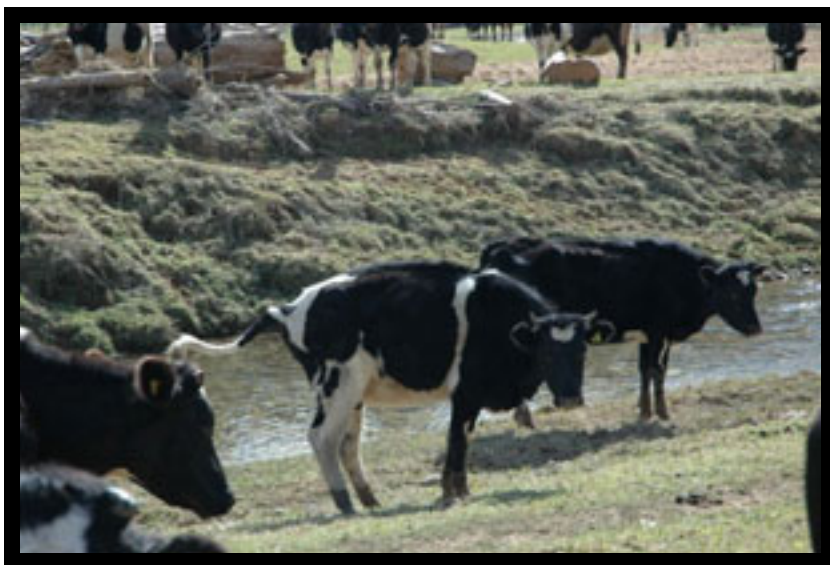
Approximately 70 per cent of the main Wentworth channel is fenced to stock class standard and prevents stock from accessing the stream bed. Of the seven tributaries in this catchment area only the Wairoa Stream has any significant riparian protection (90 per cent fenced, good riparian (stream bank or river bank) cover 90 per cent).

Figure 4. Cattle next to the Wentworth River

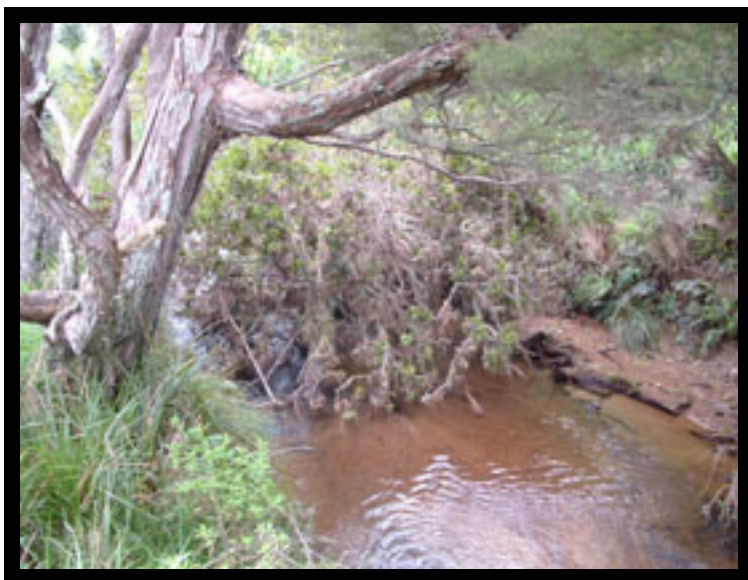
- Large possum numbers in the upper catchment degrading the forest.
- Pampas growth on stream margins (less than 10 per cent).
- Lack of riparian vegetation (present, but needs in-fill planting).
- Isolated blockages within the stream need to be removed.
- Silting up of the stream reducing channel capacity and increasing water temperature.
- Flooding between the causeway and the golf course (refer below for summary of assessment).
- Hetherington Road causeway causing a dam effect at the mouth of the river
- Increased sedimentation of the estuary.
- Unauthorised stopbank and infilling next to the upstream side of the bridge.

Figure 5. Blockage in Wentworth River channel

- Rock work or willow layering on badly eroding corners.
- Stream bank fencing.
- Clearance of pampas (spray or mechanical removal) to reduce seed source and spread.
- Willow and/or poplar pole planting in highly eroding areas.
- Planting of native riparian species.
- Removal of mangrove seedlings on an annual or as needed basis.
- Initiation of channel surveys with consequent adaptive management practices.

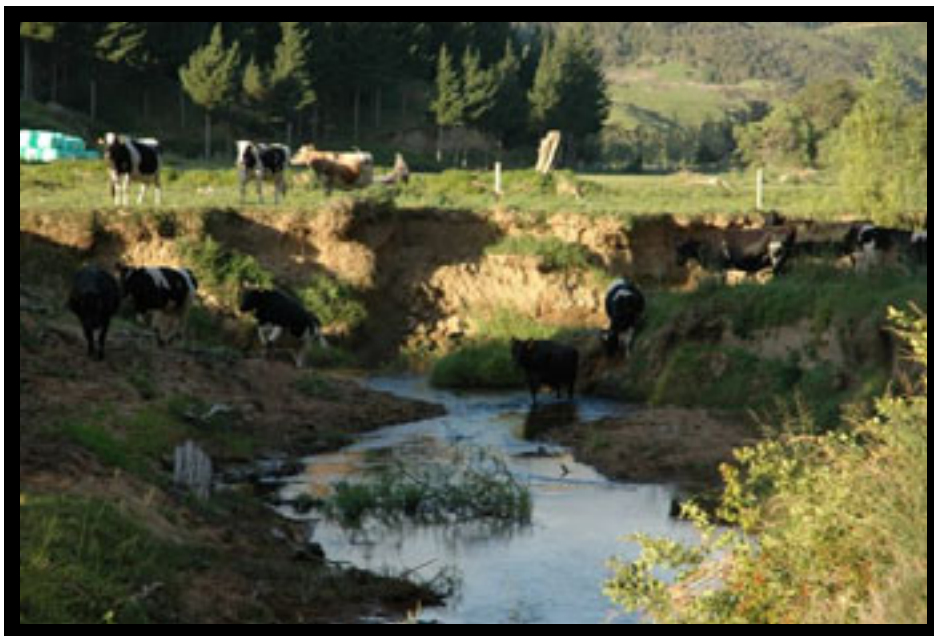
This section is the most degraded in the catchment area and probably the greatest contributor of sediment within the Whangamata catchment.

Figure 6. Slumping of the riverbank and stock access

- Possible digger work to carry out minor repairs and to remove some in stream vegetation.
- Upgrade fencing to cattle class standard.
- Undertake plant pest control (pampas and wattle).
- Undertake possum and goat control in the upper catchment.

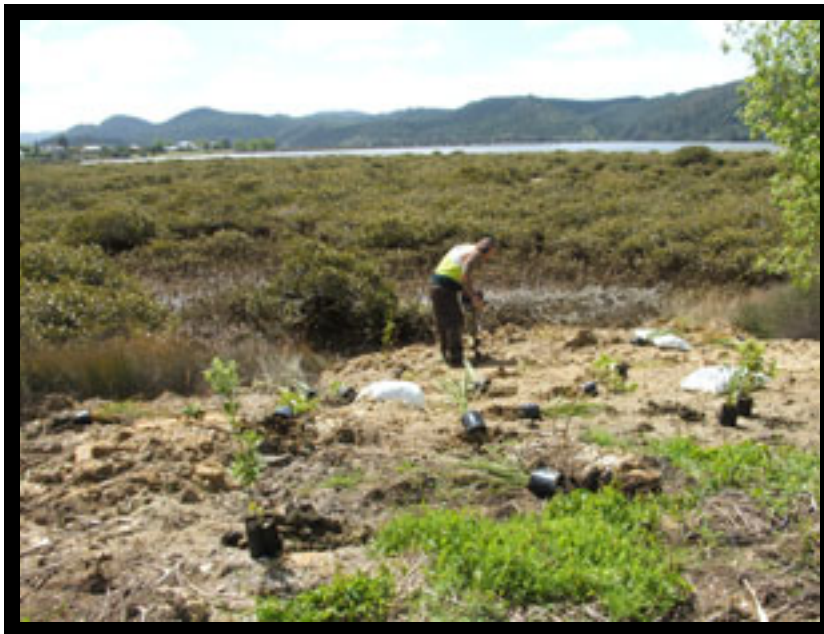
Figure 7. Planting on coastal margin of Te Weiti Stream

- Regular maintenance of the stream channel through the mangroves into the harbour.
- Upgrade the stream fence and plant with appropriate natives.
- Maintain existing silt traps.
- Investigate potential in this area to carry out coastal wetland enhancement for biodiversity purposes.

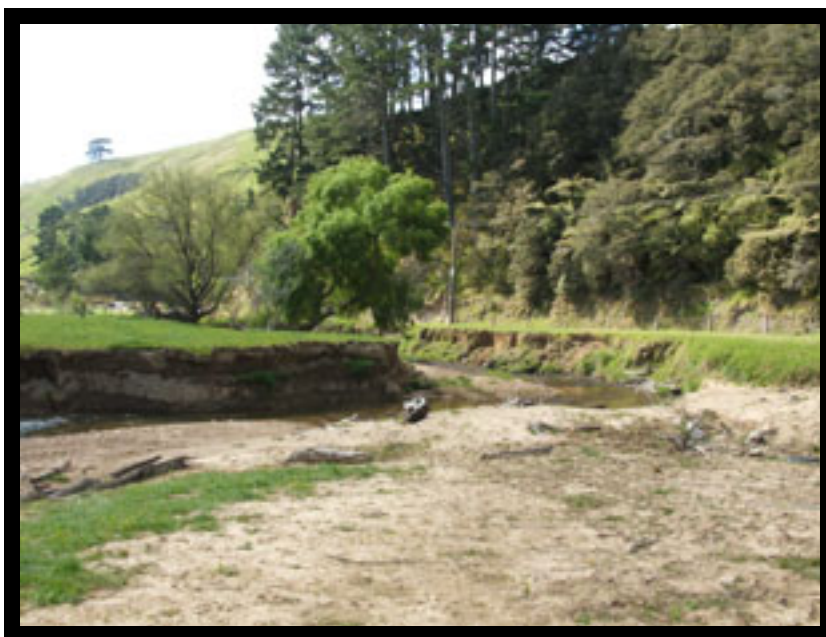
Figure 9. Stream bank erosion in the Wentworth River
