# **ANNUAL REPORT**

**Comprehensive Stormwater Discharge Consents  
2018 - 2020**

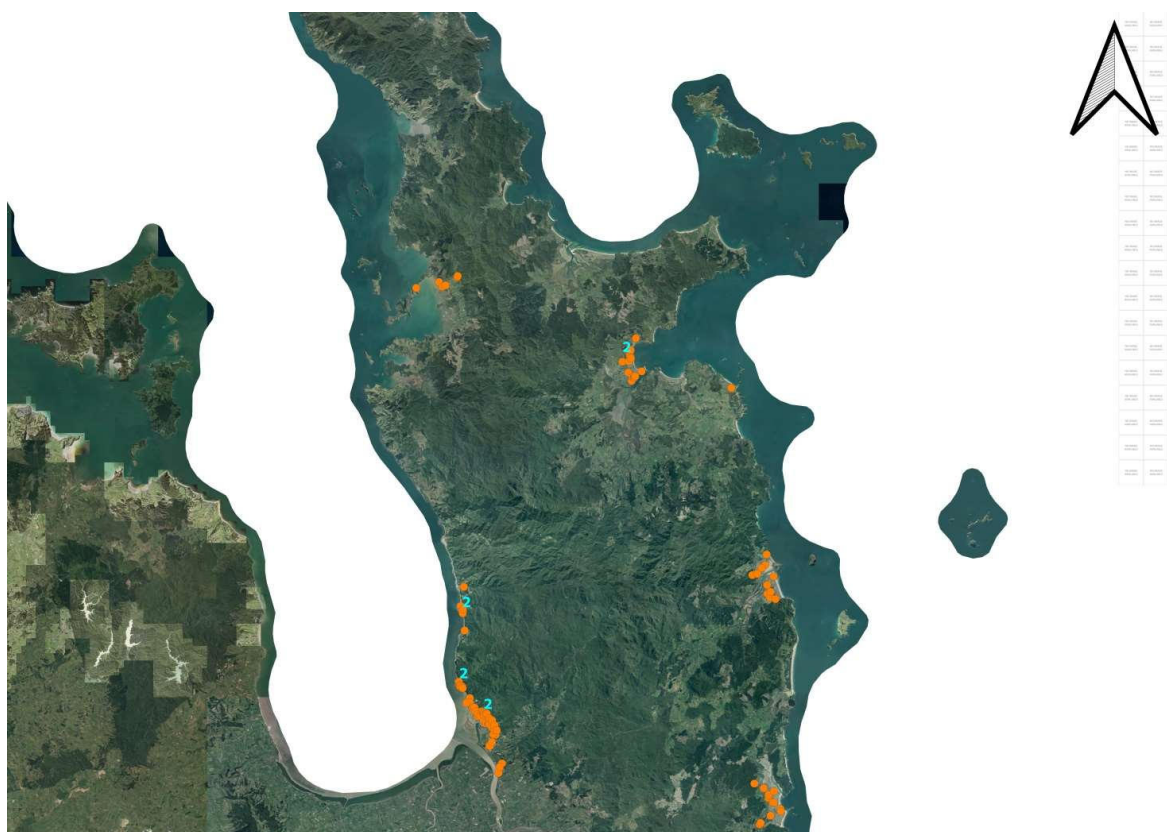
The location of all requests is shown in the map below.

The largest number of requests for service District Wide was received in July 2018 which coincided with a major storm event in the area.

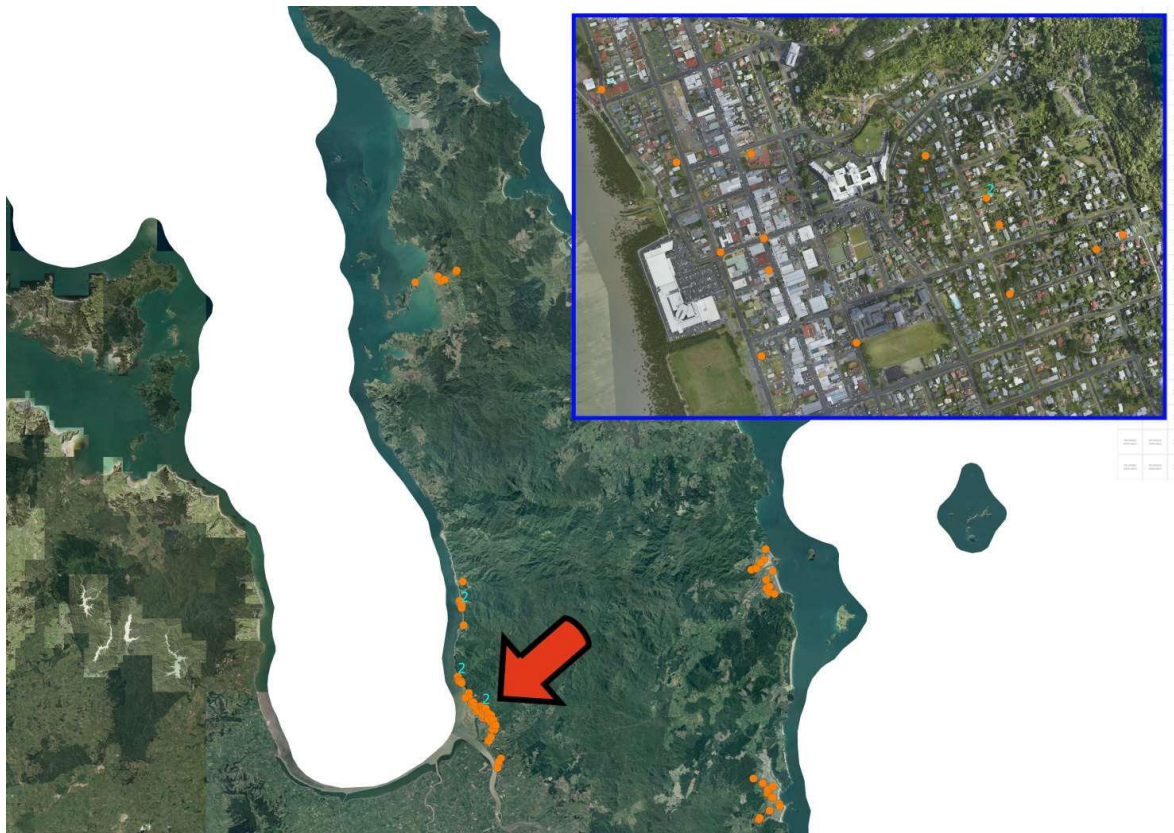
**Thames Central**

The two requests at the same address (414B Sandes Street) both relate to the ratepayer requesting a stormwater pipe to be installed alongside his property. This has been added to the Capital Projects list for consideration and budget.

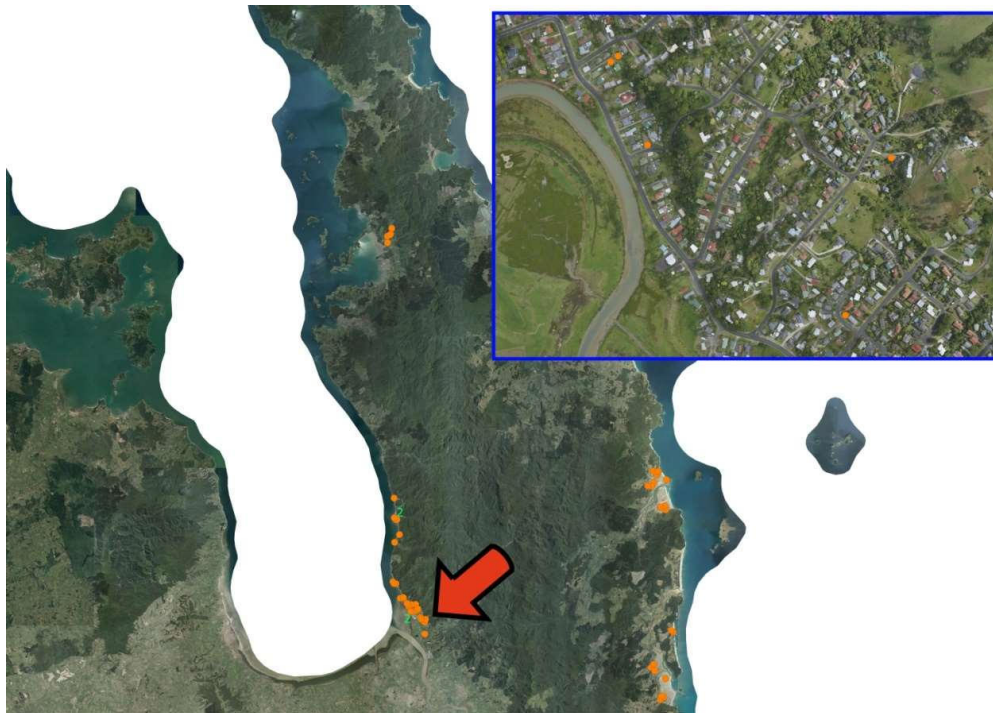
### **Thames South**

There were two requests in Parawai Road during this period, as indicated at the top of the inset map; however they are related to different assets. The first was a request for a stormwater pipe to be cleared in July 2019 (Asset 450,166) and the second was a request for a stormwater wing wall inlet (Asset 553,953) to be cleared following a storm event in June 2020. Both assets are on private property.

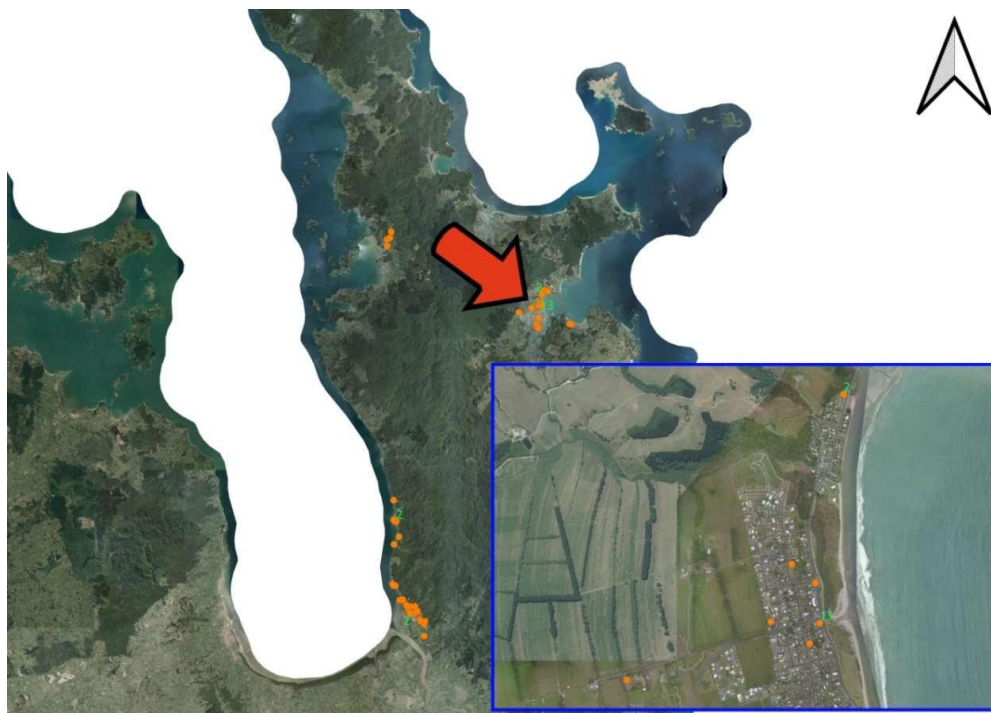
### Buffalo Beach Foreshore

The map below shows the spread of requests in the catchment area that the bulk of requests were received. With the exception of the requests to clear the mouth of the Taputapuatea Stream, the map identifies that the requests are spread throughout each catchment and do not demonstrate any particular area of concern.

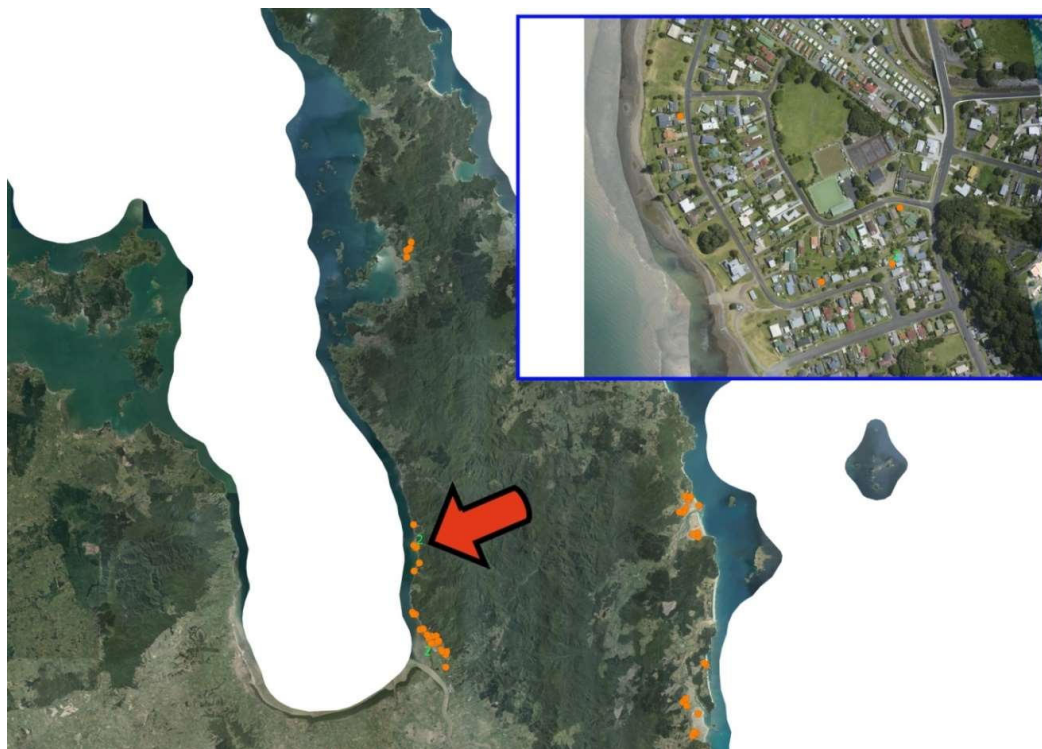
## Te Puru

The map below includes an inset that shows the spread of requests for service in the Te Puru, the catchment area that the bulk of requests were received.

There were two requests for one address in Tatahi Street, Te Puru for the same stormwater open drain (Asset ID 450433). The first was requesting the drain be in August 2019 and the second to request the drain be sprayed in March 2020.

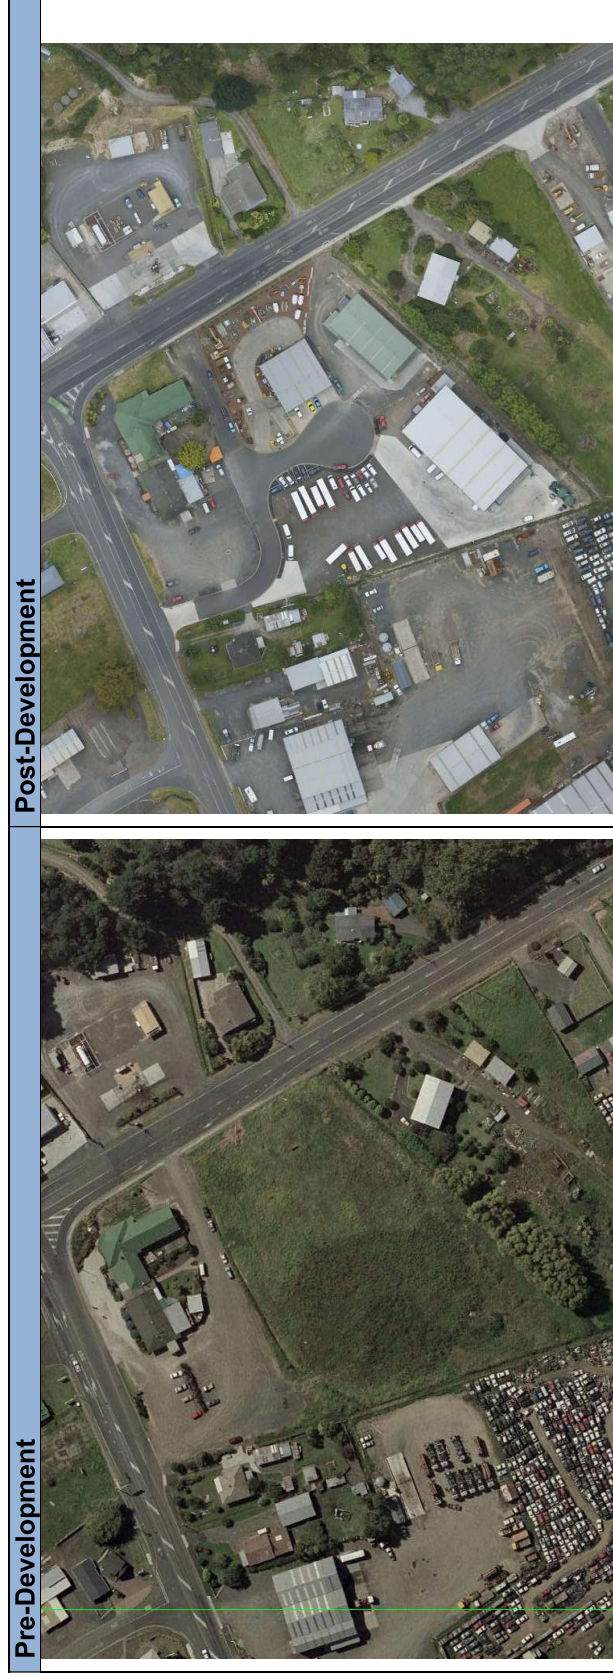
**1 Kopu Road, Kopu (2011-2012)**

Address	Year	Gross Area (ha)	No. of Lots	Average lot Size (ha)	Pre-Development				Post-Development				Flow Increase (m <sup>3</sup> /s)
					Q=CIA/360 (m <sup>3</sup> /s)	C (coefficient)	I (mm/hr)	A (ha)	Q=CIA/360 (m <sup>3</sup> /s)	C (coefficient)	I (mm/hr)	A (ha)	
1 Kopu Road, Kopu	2011-2012	1.66	5	0.33	0.21	0.51	87.6	1.66	0.29	0.72	87.6	1.66	0.08

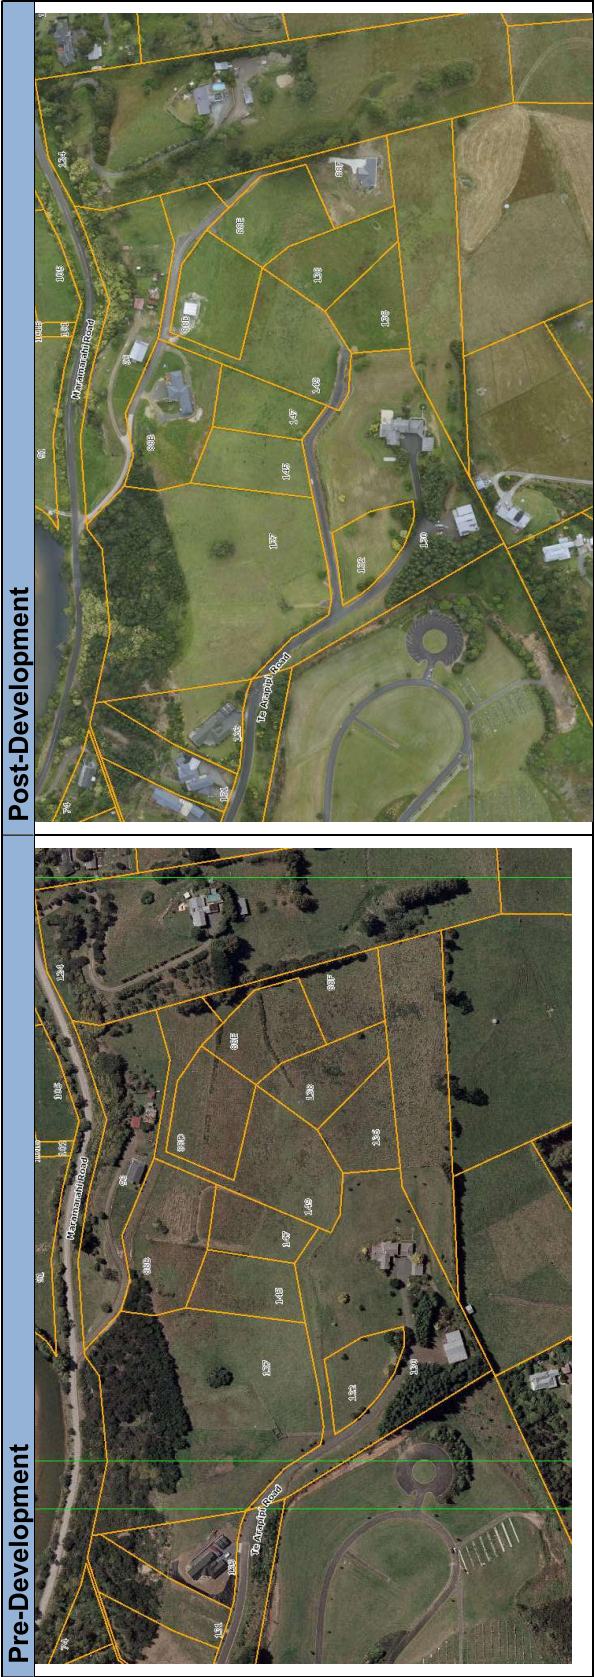
130 and 134 Te Arapipi Road, Thames (2014-2015)

Address	Year	Gross Area (ha)	No. of Lots	Average lot Size (ha)	Pre-Development			Post-Development			Flow Increase (m3/s)	
					Q=Q/A/360 (m3/s)	C (coefficient)	I (mm/hr)	A (ha)	Q=Q/A/360 (m3/s)	C (coefficient)	I (mm/hr)	A (ha)
130 & 134 Te Arapipi Road, Thames	2014-2015	6.05	5	1.21	0.52	0.52	0.35	87.6	6.05	0.80	0.54	87.6
												6.05
												0.28

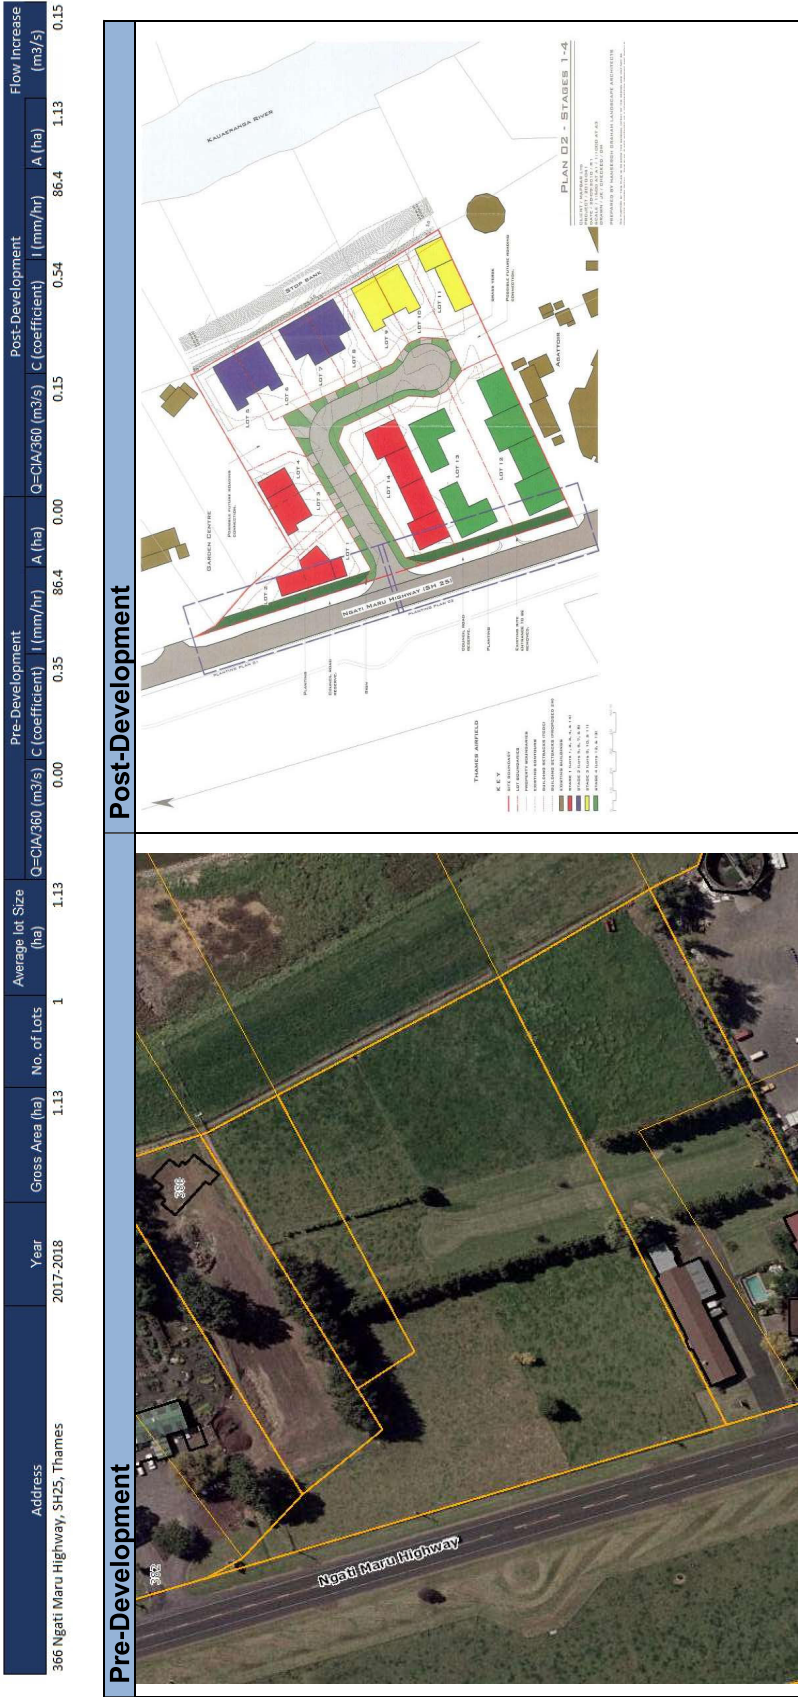
366 Ngati Maru Highway, SH25, Thames (2017-2018)

This subdivision is a light industrial development on the outskirts of Thames.

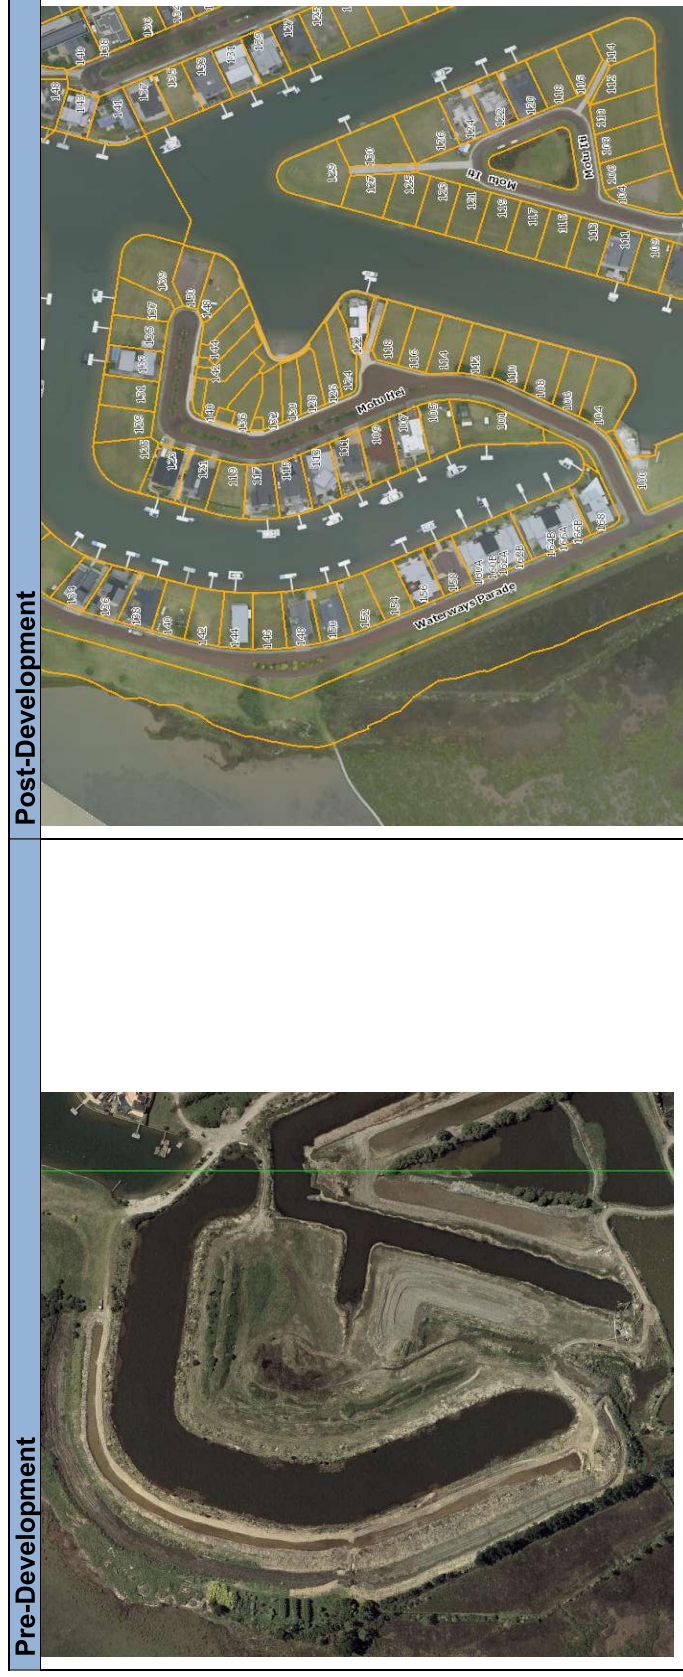
Motu Hei, Pauanui (2015-2016)

Address	Year	Gross Area (ha)	No. of lots	Average lot Size (ha)	Pre-Development			Post-Development			Flow Increase (m <sup>3</sup> /s)
					Q=CIA/360 (m <sup>3</sup> /s)	C (coefficient)	I (mm/hr)	Q=CIA/360 (m <sup>3</sup> /s)	C (coefficient)	I (mm/hr)	
Motu Hei, Pauanui	2015-2016	0.75	12	0.06	0.07	0.35	97.2	0.75	0.11	0.54	0.75
											0.04

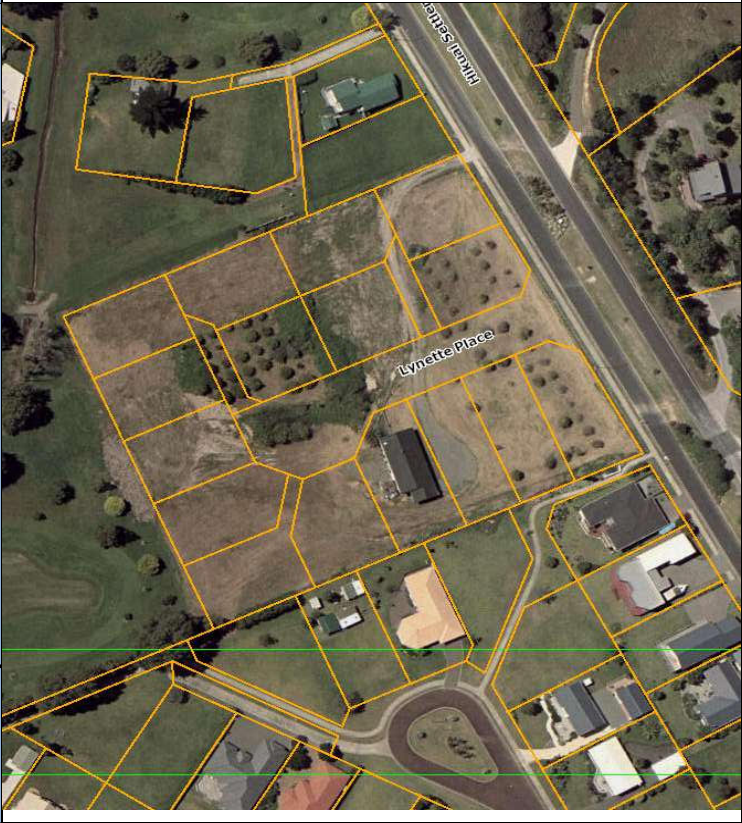
Address	Year	Gross Area (ha)	No. of Lots	Average lot Size (ha)	Pre-Development			Post-Development			Flow Increase (m3/s)	
					Q=CIA/360 (m3/s)	C (coefficient)	I (mm/hr)	A (ha)	Q=CIA/360 (m3/s)	C (coefficient)	I (mm/hr)	A (ha)
1201 Hikua Settlement Road, Pauanui	2017-2018	1.22	16	0.08	0.12	0.35	98.4	1.22	0.18	0.54	98.4	1.22
												0.06

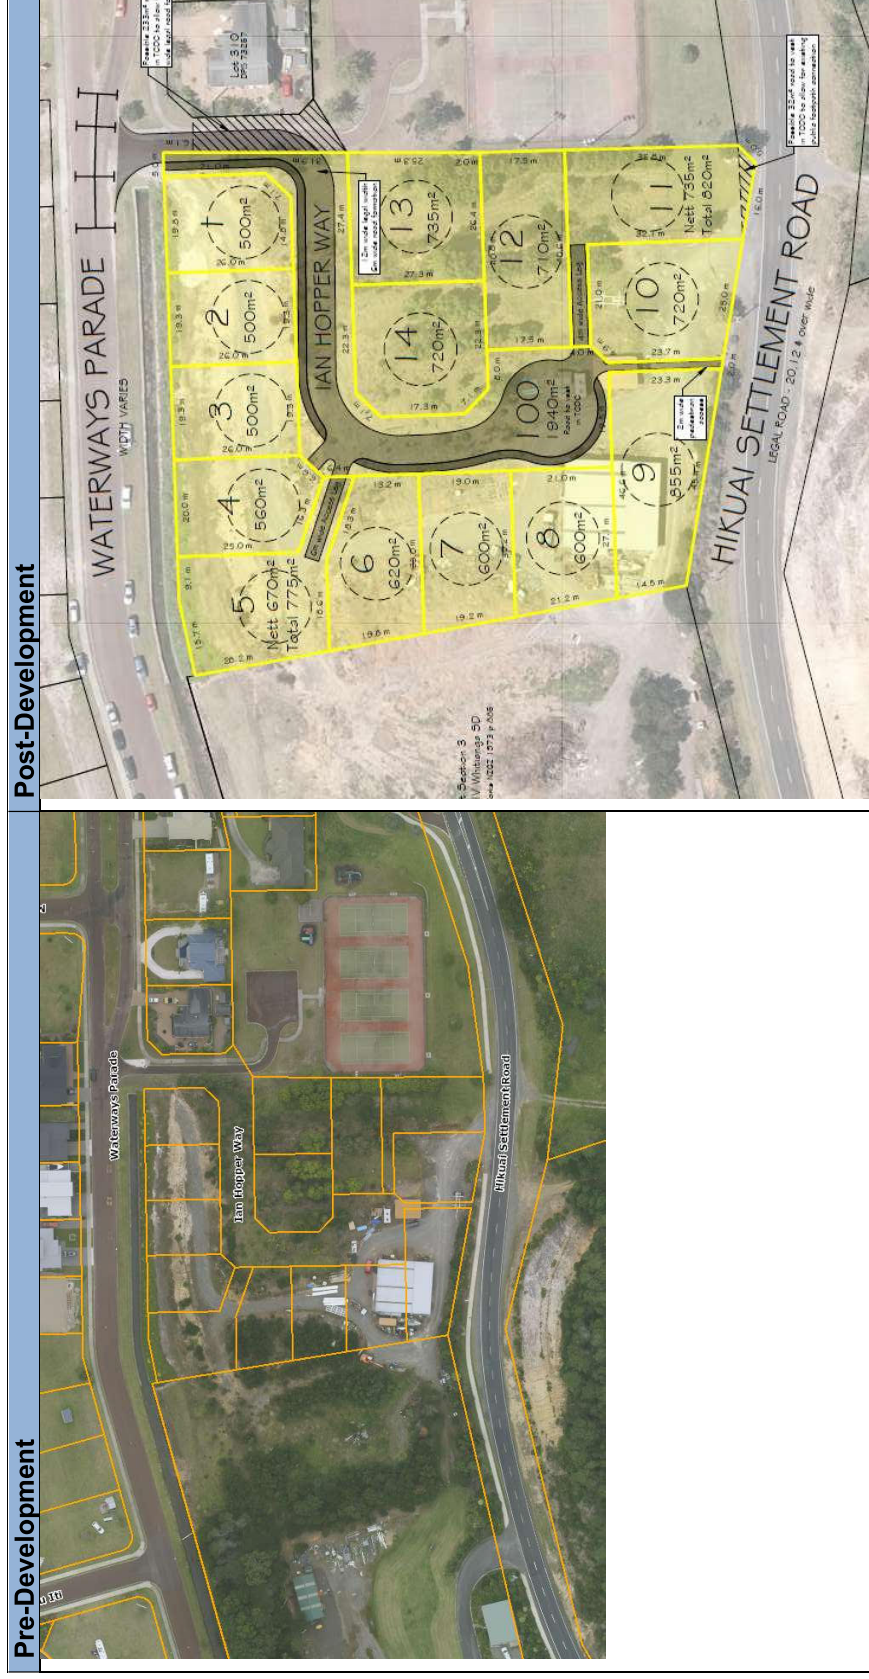
## Pauanui Waterways – The Terraces (2019-2020)

Address	Year	Gross Area (ha)	No. of Lots	Average lot Size		Pre-Development			Post-Development			Flow Increase (m <sup>3</sup> /s)		
				(ha)	(ha)	Q=CIA/360 (m <sup>3</sup> /s)	C (coefficient)	I (mm/hr)	A (ha)	Q=CIA/360 (m <sup>3</sup> /s)	C (coefficient)		I (mm/hr)	A (ha)
Pauanui Waterways - The Terraces	2019-2020	1.14	14	0.08	0.11	0.11	0.35	97.8	1.14	0.17	0.54	97.8	1.14	0.06

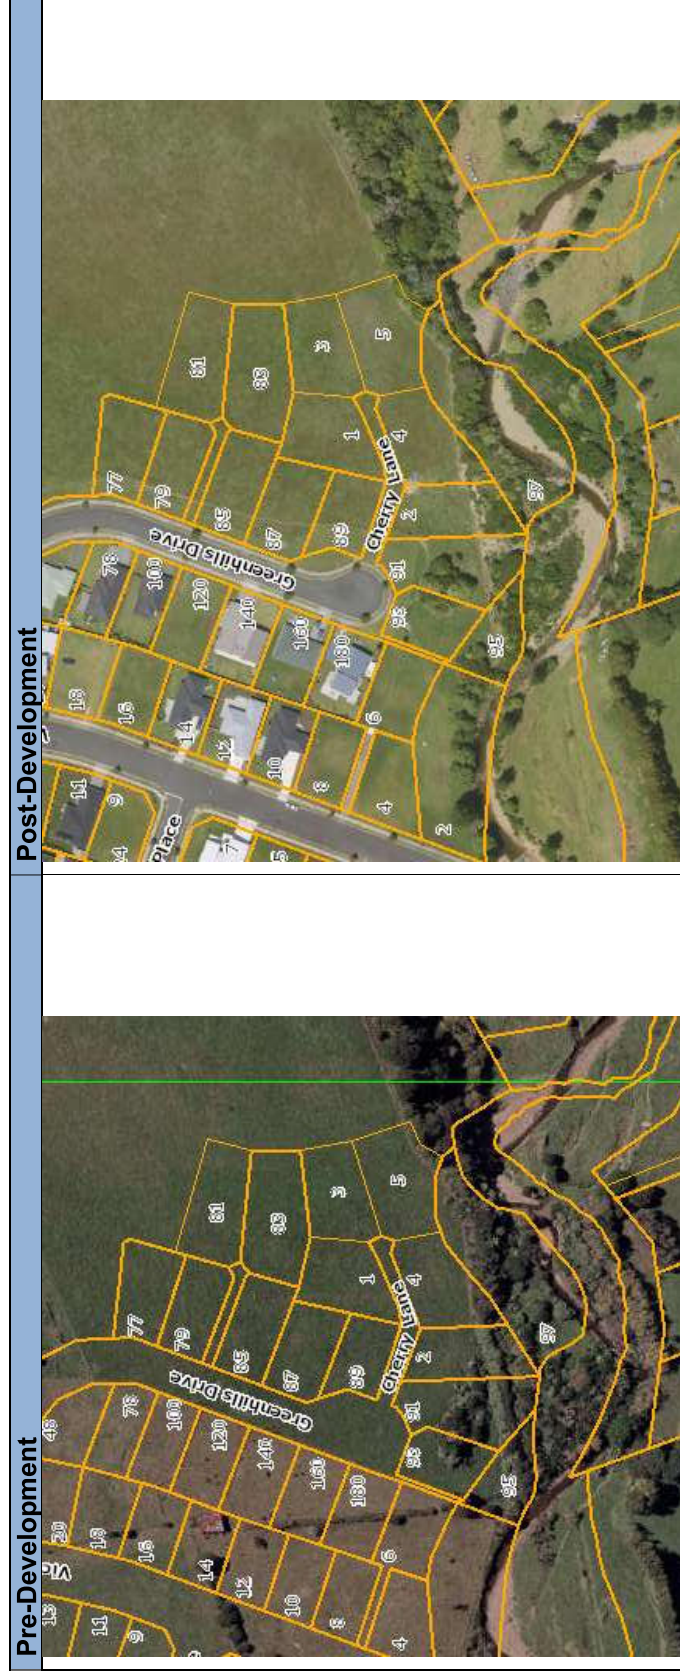
**1 Albert Street, Coromandel (2016-2017)**

Address	Year	Gross Area (ha)	No. of Lots	Average lot Size (ha)	Pre-Development				Post-Development				Flow Increase (m <sup>3</sup> /s)
	2016-2017				Q=Q/A/360 (m <sup>3</sup> /s)	C (coefficient)	I (mm/hr)	A (ha)	Q=Q/A/360 (m <sup>3</sup> /s)	C (coefficient)	I (mm/hr)	A (ha)	
1 Albert Street, Coromandel		1.30	14	0.09	0.09	0.12	0.35	96	1.30	0.19	0.54	96	0.07

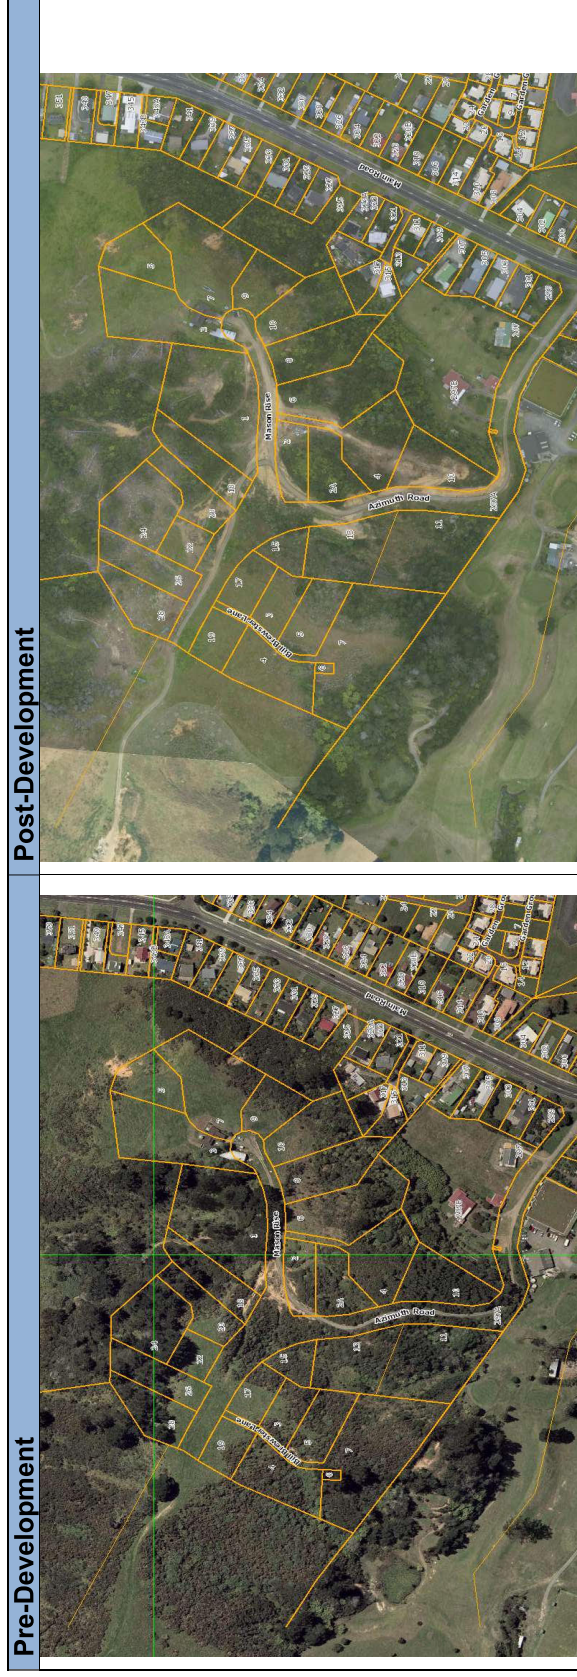
Azimuth Estates, 297C Main Road, SH25, Tairua (2016-2017)

Address	Year	Average lot Size (ha)	Gross Area (ha)	No. of Lots	Pre-Development				Post-Development				Flow Increase (m <sup>3</sup> /s)
	2016-2017				Q=CIA/360 (m <sup>3</sup> /s)	C (coefficient)	I (mm/hr)	A (ha)	Q=CIA/360 (m <sup>3</sup> /s)	C (coefficient)	I (mm/hr)	A (ha)	
297C Main Road, SH25 Tairua		0.36	10.02	28	0.94	0.35	96.60	10.02	1.46	0.54	96.60	10.02	0.52

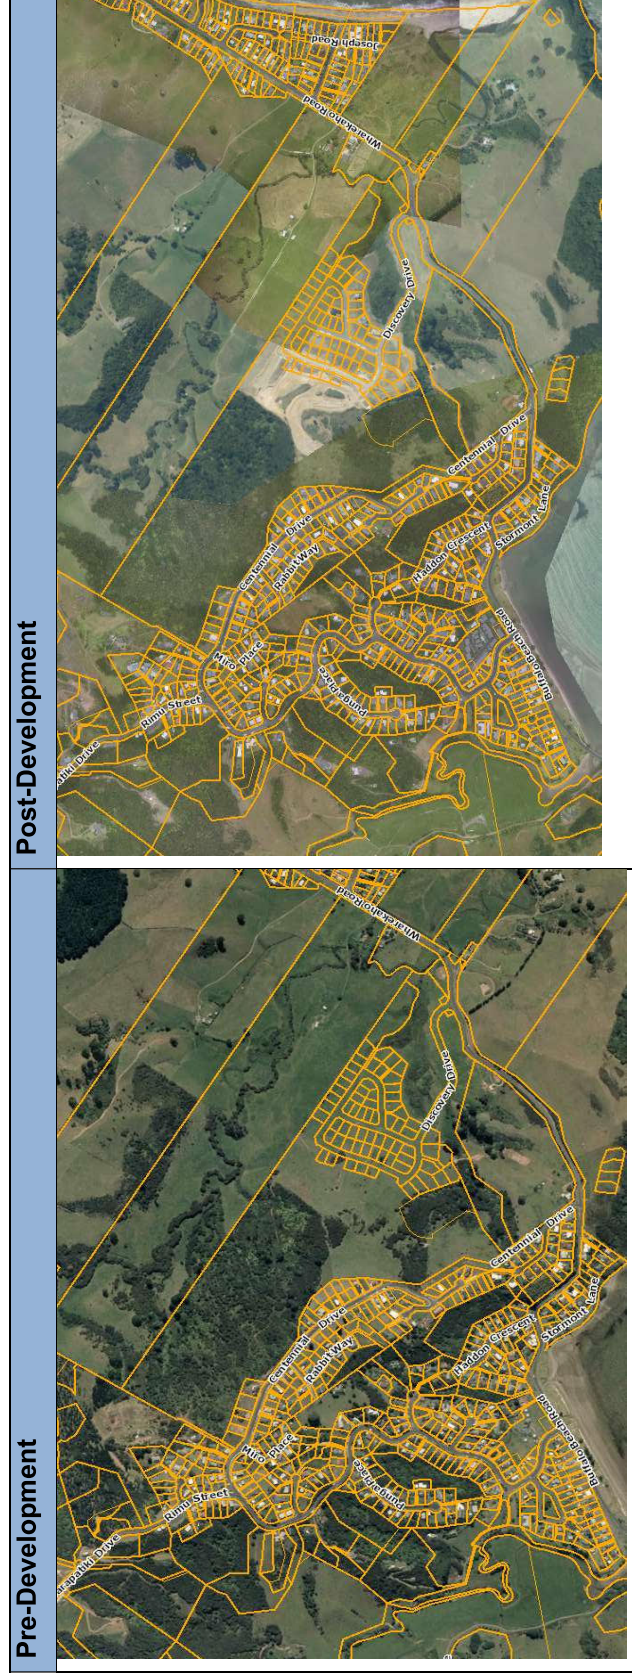
15 Wharekaho Road, Wharekaho (2014-2015)

Address	Year	Gross Area (ha)	No. of Lots	Average lot Size (ha)		Pre-Development				Post-Development				Flow Increase (m³/s)
				Q=CA/360 (m³/s)	C (coefficient)	I (mm/hr)	A (ha)	Q=CA/360 (m³/s)	C (coefficient)	I (mm/hr)	A (ha)			
15 Wharekaho Road, Wharekaho	2014-2015	46.78	111	0.42	4.37	0.35	96	46.78	6.77	0.54	96	46.78	2.40

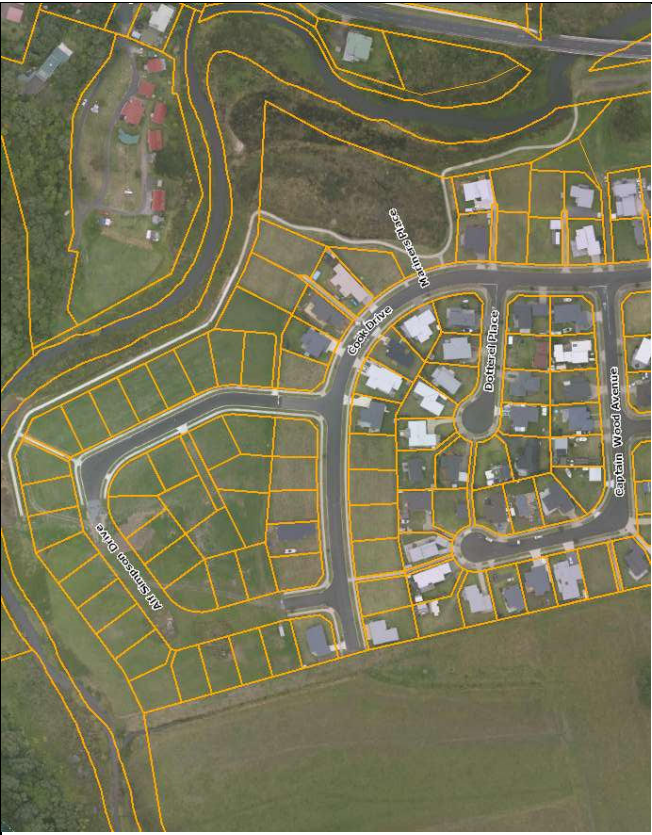
Pacific Estates, Cook Drive, Whitianga (2014-2015)

Address	Year	Gross Area (ha)	No. of Lots	Average lot Size (ha)	Pre-Development			Post-Development			Flow Increase	
					Q=CA <sub>A</sub> 360 (m3/s)	C (coefficient)	I (mm/hr)	Q=CA <sub>A</sub> 360 (m3/s)	C (coefficient)	I (mm/hr)	A (ha)	Flow Increase (m3/s)
Pacific Estates, Cook Drive, Whitianga	2014-2015	6.49	63	0.10	0.60	0.35	95.4	6.49	0.93	0.54	95.4	6.49
<div> <div>Pre-Development</div>   </div> <div> <div>Post-Development</div>

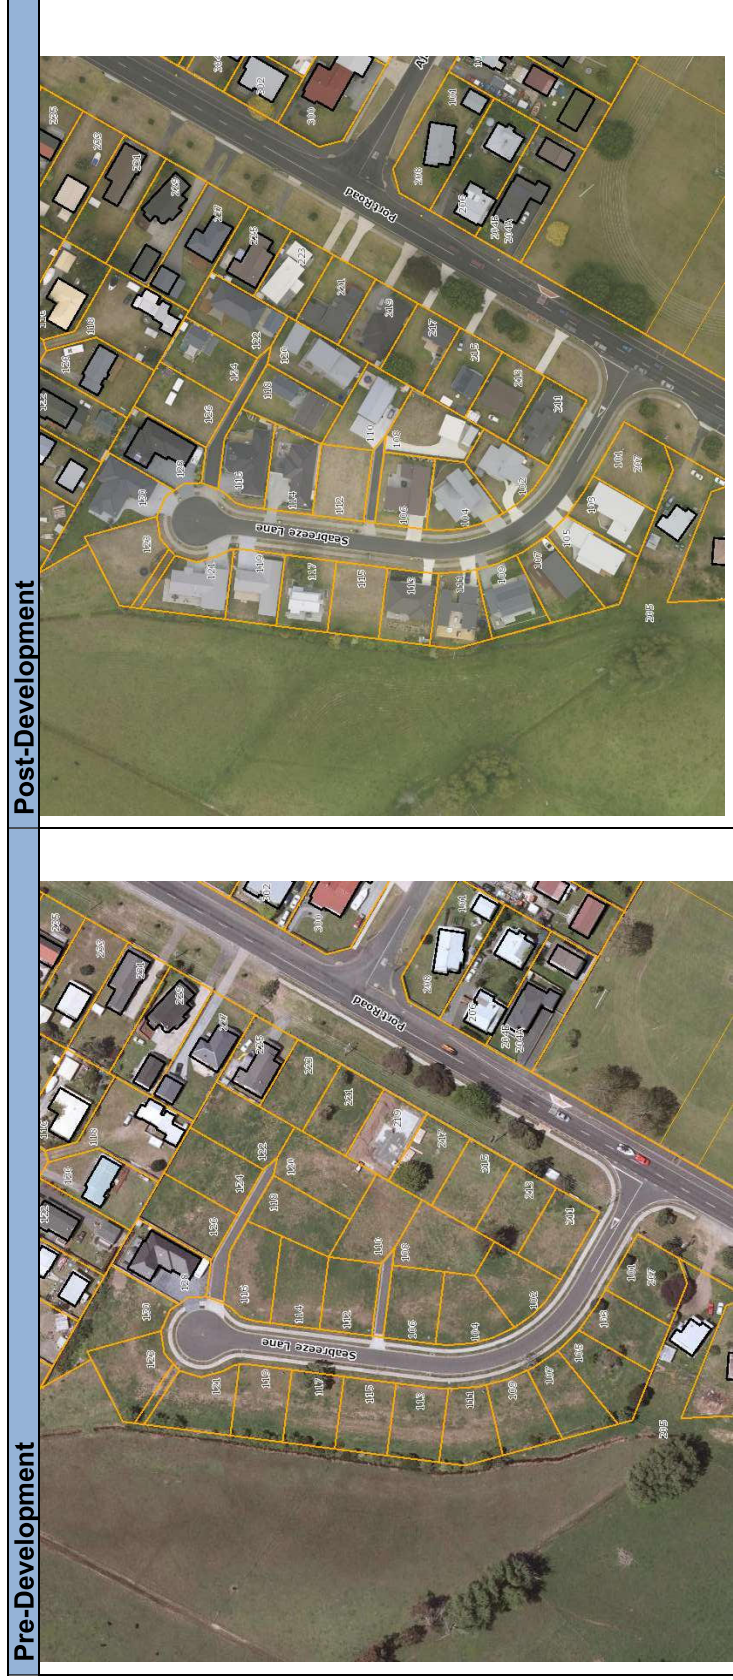
207 Port Road, Whangamata (2011-2012)

Address	Year	Gross Area (ha)	No. of Lots	Average lot Size (ha)	Pre-Development			Post-Development			Flow Increase (m <sup>3</sup> /s)
207 Port Road, Whangamata	2011-2012	2.04	38	0.05	Q=Q/A/360 (m <sup>3</sup> /s)	C (coefficient)	I (mm/hr)	Q=Q/A/360 (m <sup>3</sup> /s)	C (coefficient)	I (mm/hr)	A (ha)
					0.19		0.35	96.6	0.30	0.54	96.6
								2.04			2.04
											0.11

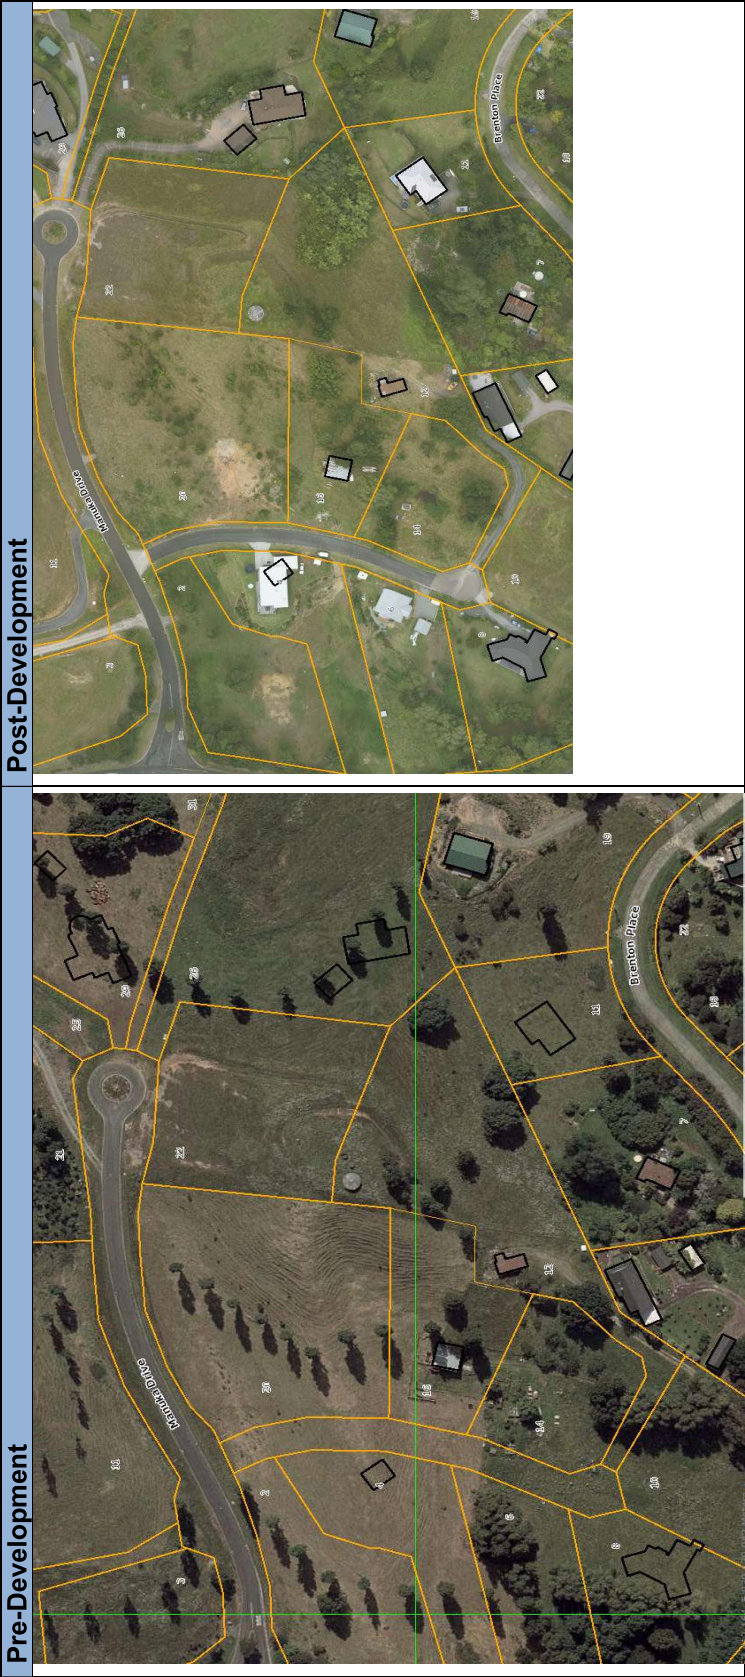
Address	Year	Gross Area (ha)	No. of Lots	Average Lot Size (ha)	Pre-Development			Post-Development			Flow Increase (m³/s)	
					Q=Q/A/360 (m³/s)	C (coefficient)	I (mm/hr)	A (ha)	Q=Q/A/360 (m³/s)	C (coefficient)		I (mm/hr)
12 Manuka Drive, Whangamata	2015-2016	1.79	4	0.45	0.17	0.35	97.2	1.79	0.22	0.46	1.79	0.05

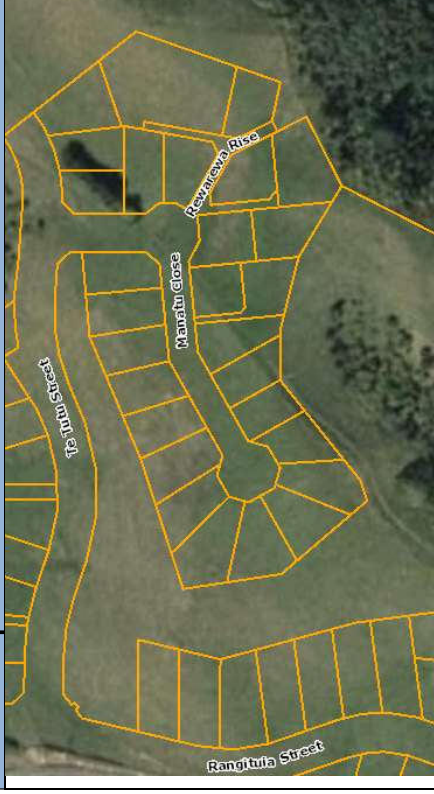
**Pre-Development**

Address	Year	Gross Area (ha)	No. of Lots	Average lot Size (ha)	Pre-Development				Post-Development				Flow Increase (m <sup>3</sup> /s)	
					Q=CA/360 (m <sup>3</sup> /s)	C (coefficient)	I (mm/hr)	A (ha)	Q=CA/360 (m <sup>3</sup> /s)	C (coefficient)	I (mm/hr)	A (ha)		
2752 SH25, Whangamata	2016-2017		32	0.10	0.10	0.31	0.35	97.2	3.27	0.48	0.54	97.2	3.27	0.17

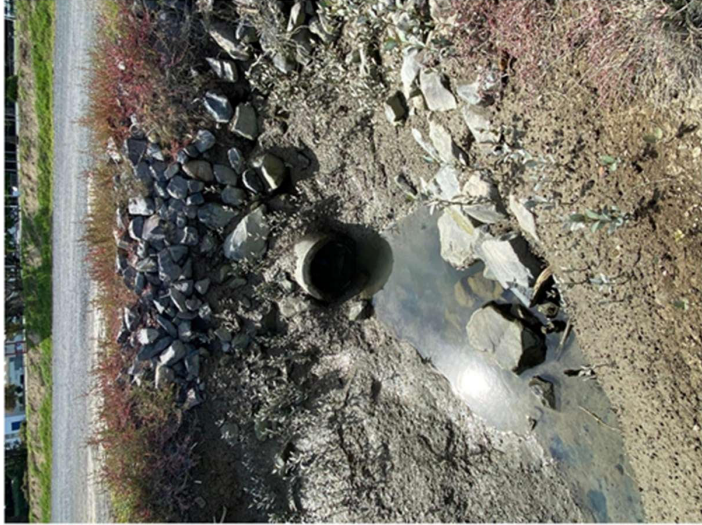
Ref 01	February 2020, Shortland Wharf, Thames	June 2020 Shortland Wharf, Thames
	<p>SW outlet has been redeveloped in 2018 and the outlet channel broadened and cleared of mangroves</p>

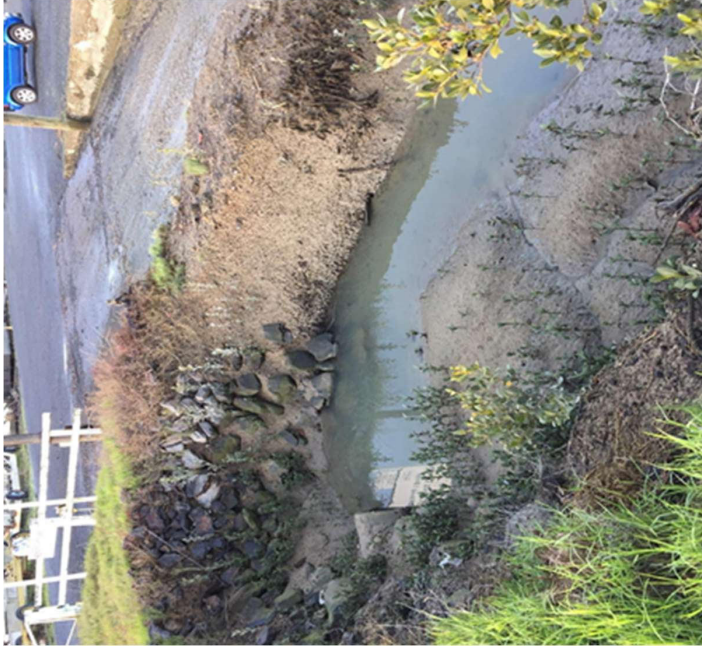
<p>Channel remains well defined and clear of vegetation although silt build up is evident</p>

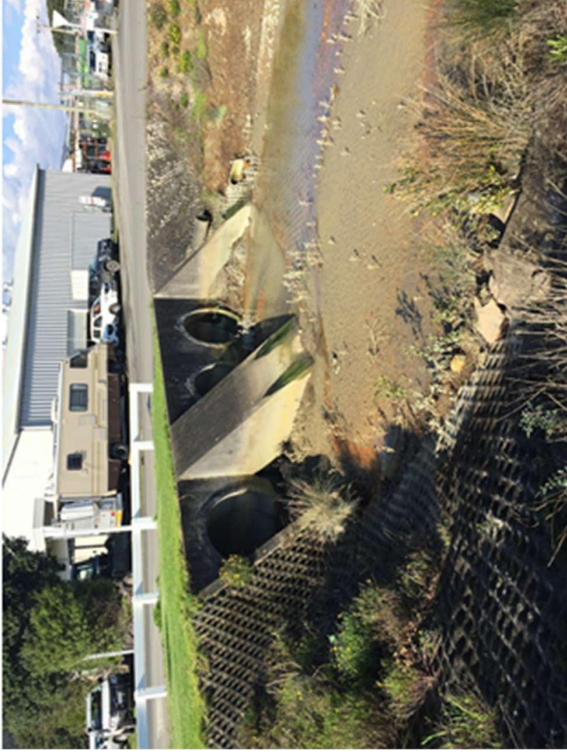
<p>Channel remains clear with recent flows removing the silt layer on the RHS</p>

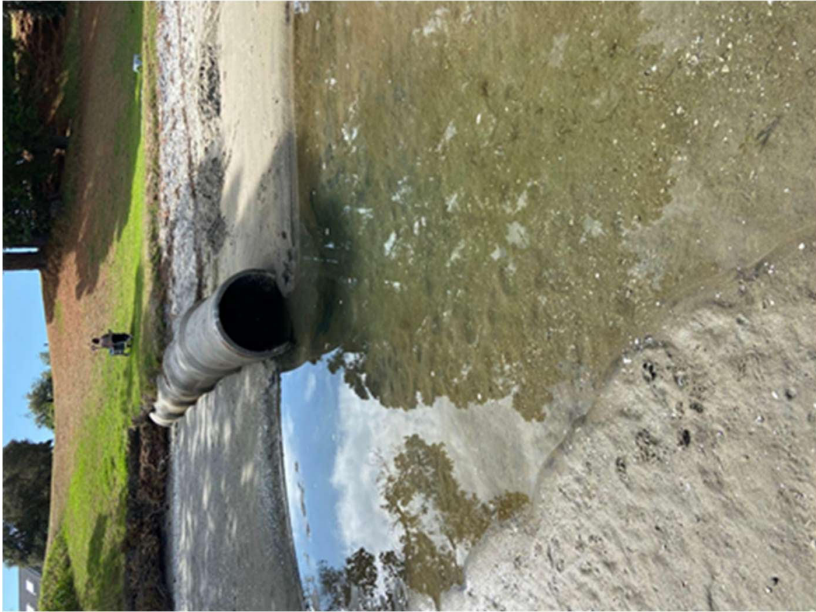
Sites are in an improved condition to those recorded in previous reports. Conspicuous changes are evident for the outlets in Thames at Shortland wharf and Sealey Street. The monitored site at Shepard Avenue in Pauanui is manifesting erosion of the embankment on the eastern side of the outlet structure.

Ref 05	February 2020, Shepard Avenue, Pauanui	June 2020, Shepard Avenue, Pauanui
	<p data-bbox="339 1055 403 1877">Downstream of outlet is stable Embankment to LHS is eroding 4 pipe lengths visible</p>

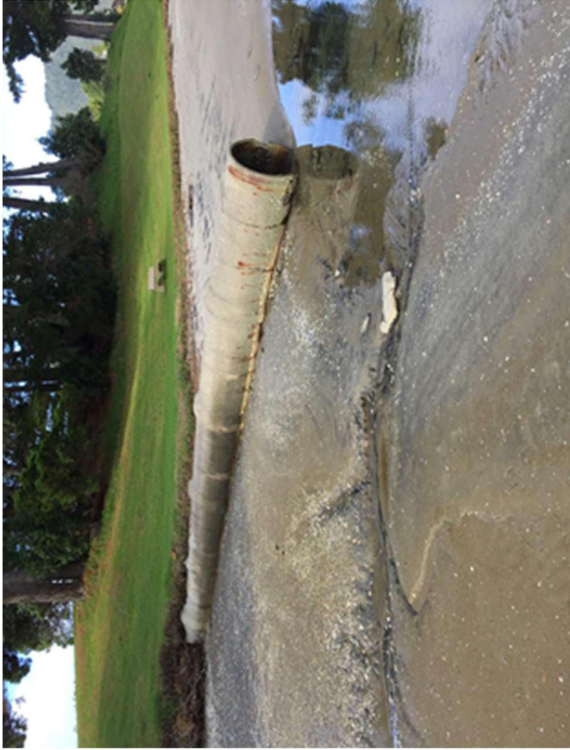
<p data-bbox="339 280 403 1055">Continued loss of embankment to the LHS of the outlet. 6 pipe lengths now visible</p>

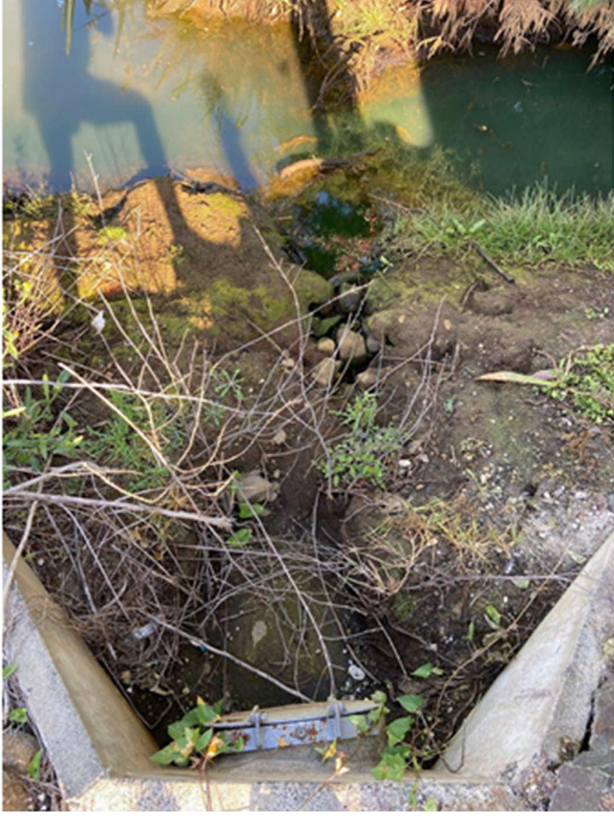
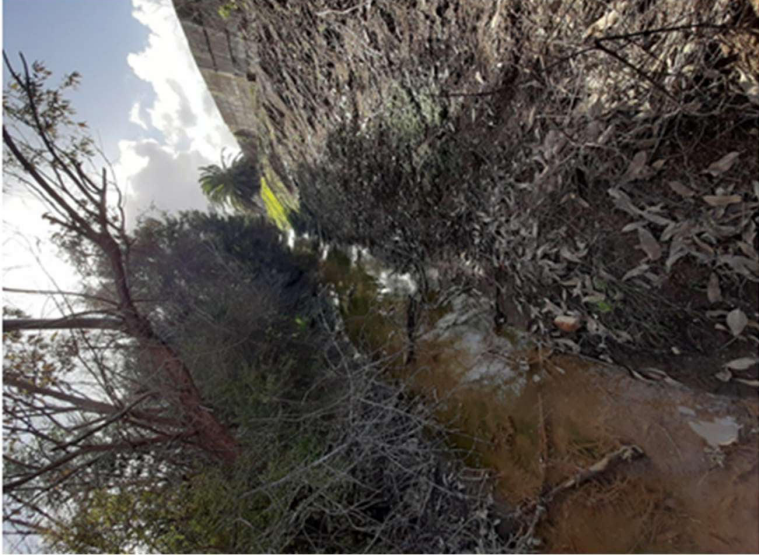
Ref 09	<p>February 2020, Moewai road Whitianga</p> <p>Downstream drain remains tidal.</p>	<p>June 2020, Moewai road drain</p> <p>Drain has received maintenance work.</p>

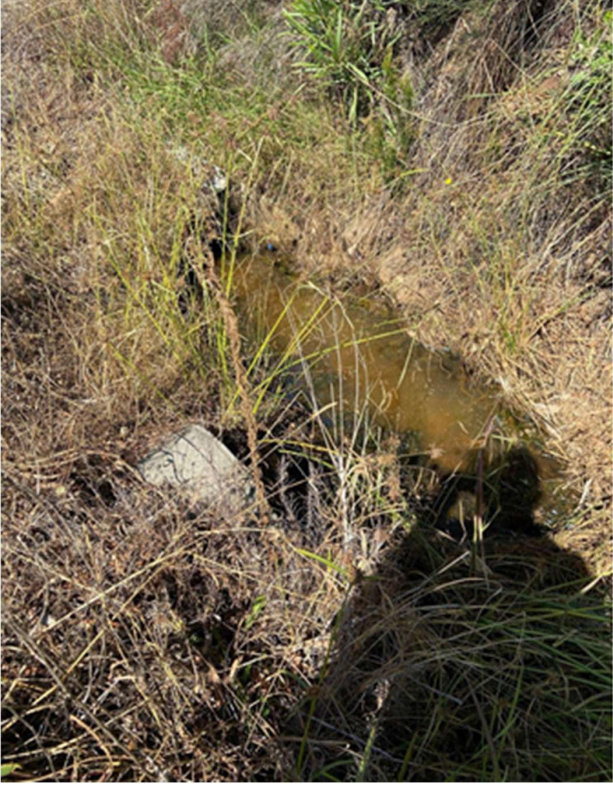
Ref 12	February 2020, Aicken Road Whangamata	June 2020, Aicken Road Whangamata
	<p data-bbox="341 1294 368 1870">Outlet to drain. Drain requires vegetation control</p>

<p data-bbox="341 719 368 1064">Vegetation control completed</p>
