# **ANNUAL REPORT**

**Comprehensive Stormwater Discharge Consents  
2018 - 2020**

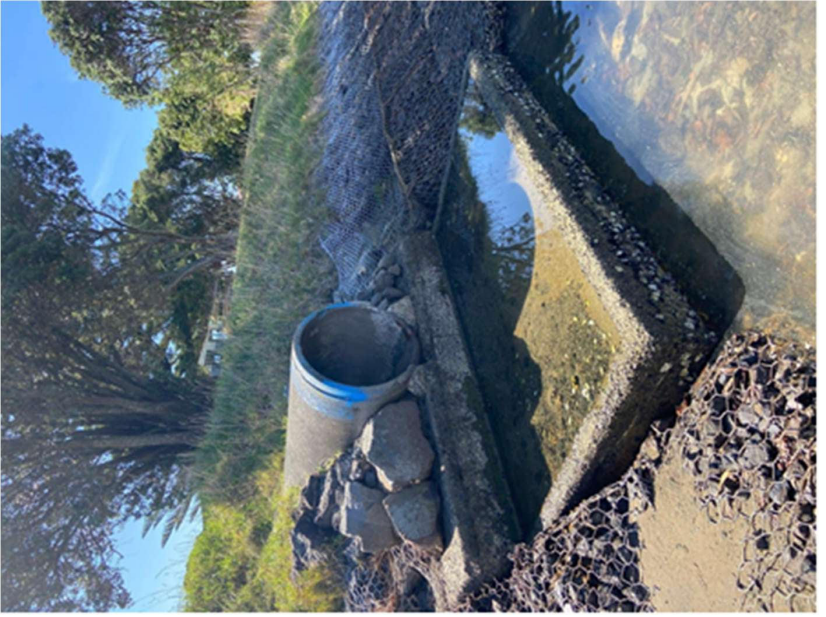
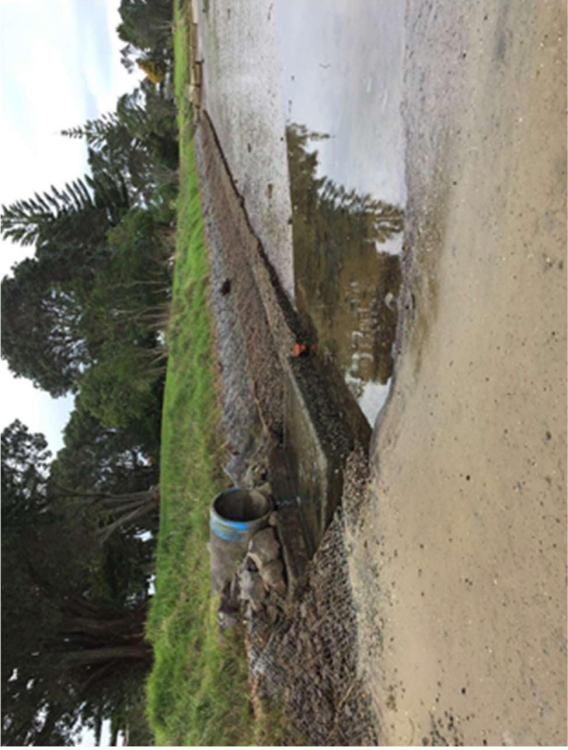
Ref 14	February 2020, Kotuku street Whangamata	June 2020, Kotuku street Whangamata
	Site remains unchanged from the previous inspection. Small ponding area in front of splash area	Site is unchanged. Area to the RHS middle of image is the reference site for sediment and ecological studies

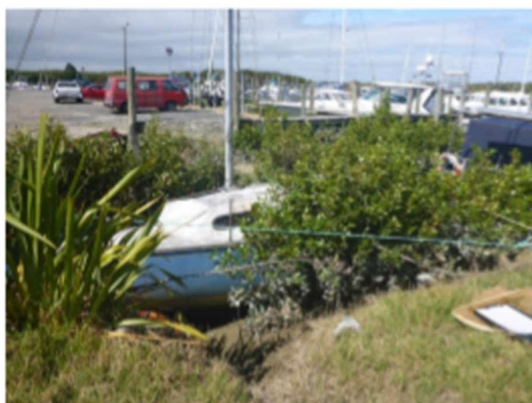
Photo 1. Site 1: Thames Marina.

The outlet flows into a short channel then into the estuary. The channel banks are moderately steep with a narrowly incised channel. The marine mud substrate was deep, with some gravel in the base and no woody debris. Flow through the culvert was very low at the time of sampling.

Mangrove seedlings present at the 2014 survey have established and were 0.5-1 m tall. Tunnelling mud crab (*Austrohelice crassa*) burrows were abundant over all surfaces of the channel. Rock oysters (*Saccostrea glomerata*), mud snail (*Potamopyrgus* sp.) and whelks (*Cominella*) were abundant. One mudflat snail (*Amphibola crenata*) was also found. Fish access into the culvert was not impeded, but is tide dependent. Oligochaete worms and Tanypod fly larvae were present in the 2014 survey, but were not observed in 2018.

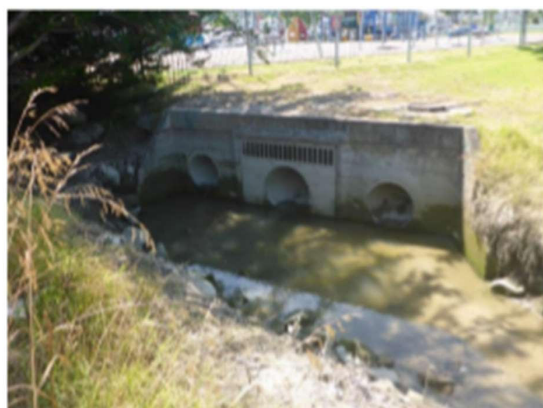
Photo 2. Site 2: Sealey St, Thames.

The tunnelling mud crab burrows and mud snails were abundant, other fauna include estuarine mudflat snail, oligochaetes, chironomid non-biting midge larvae, and the pest fish *Gambusia affinis*. Fish access into the culvert was blocked due to the metal cones fixed into the culvert openings.

This site was physically very different to 2014. Built-up mud and debris present on the culvert apron at the previous survey have been removed or washed out, and metal cones had been fitted to the culvert openings.

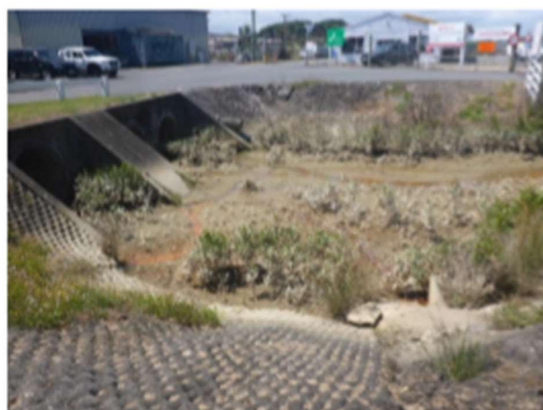
Photo 3. Site 3: Burke St outlet, Thames.

Tunnelling mud crab burrows and mud snail and tubificid oligochaete worms were abundant; and chironomid non-biting midge larvae were also present. Fish access was unimpeded.

Observations at this site were similar to the 2014 survey.

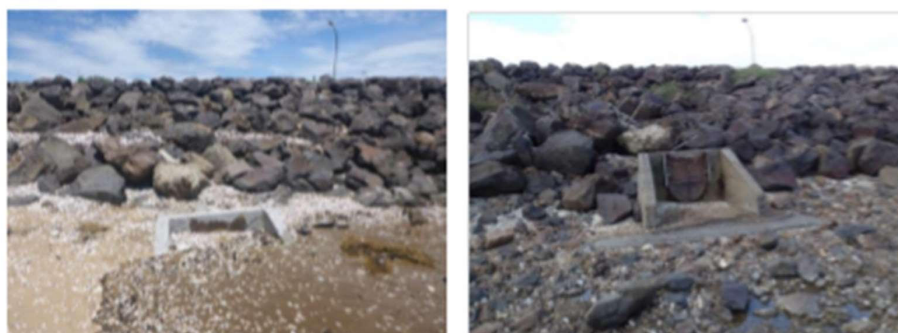
Photo 4. Site 4: Fergusson Dr, Thames in 2018 (left) and 2014 (right).

This stormwater outlet is controlled by a tide gate which opens directly onto the beach. At the time of survey, the concrete structure was buried in sand, almost to the top of the structure, possibly by the recent storm event, and could not be surveyed.

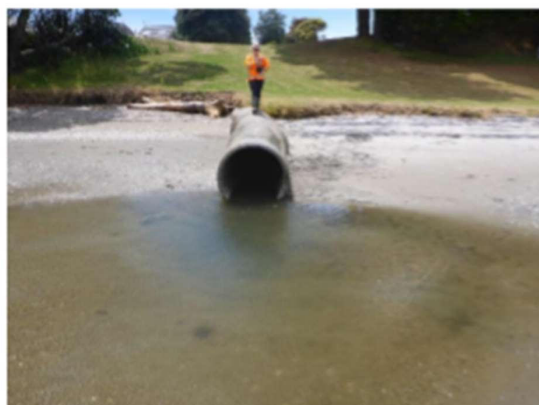
Photo 5. Site 5: Sheppard Ave, Pāuanui.

No aquatic plants were present, and the inside of the pipe was lined with rock oysters (*Saccostrea glomerata*). Other fauna species present included; shrimp which were abundant as well as mudflat snail and spire shells (*Zeacumantus* sp.). Fish access was unimpeded.

Compared with the 2014 survey, observations at this site were very similar, excepting that bivalve shellfish (i.e. cockle (*Austrovenus stutchburyi*) and pipi (*Paphies australis*) were not detected.

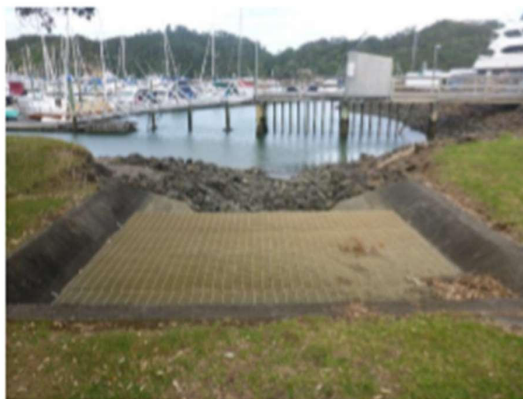
Photo 8. Site 8: Marina hardstand, Whitianga.

- Site 8, Marina Hardstand, Whitianga: fewer fauna species noted compared to 2014 survey.
- Site 9, Moewai Road North, Whitianga: water level in the drain was exceptionally low and there were slightly fewer invertebrate groups found compared with 2014. Site had changed dramatically since 2014 survey with vegetation overhanging stream channel having been removed.

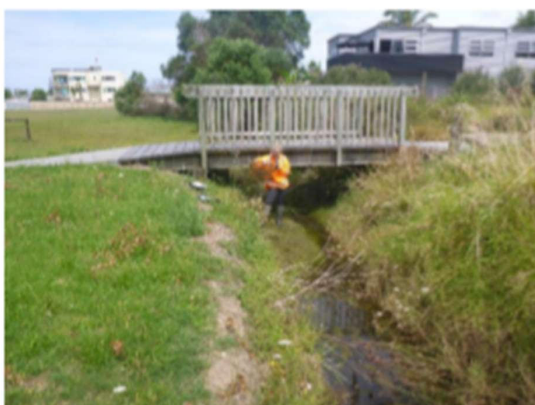
Photo 10. Site 10: Casement Rd, Whangamatā.

- Site 10, Casement Road drain, Whangamata: similar to 2014 survey except fewer invertebrate species observed.
- Site 13, Lindsey Road, Whangamata: noted banks are eroding but unclear if due to active erosion or high rainfall event.

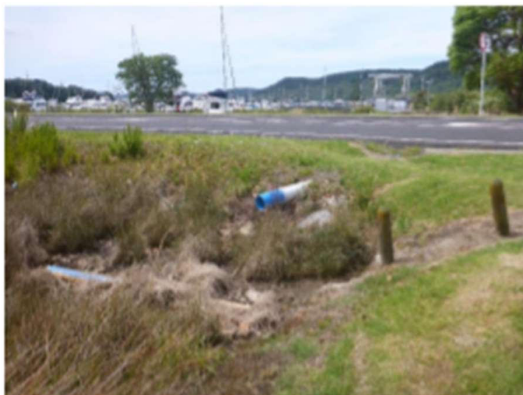
Photo 11. Site 11: Hetherington Rd, Whangamatā.

This outlet flows into a small saltmarsh on the edge of the harbour, although there was no flow at the time of the survey. The sediment around the outlet was dry, soft sand and soil, densely vegetated with *Juncus* sp., and glasswort (*Salicornia quinqueflora*), oioi (*Apodasmia similis*), and the creeper (*Samolus* sp.). No aquatic plants were present at the site. Tunnelling mud crab burrows were present but no other fauna were observed and there was no fish access to the culvert pipe.

Observations at this site were similar to the 2014 survey.

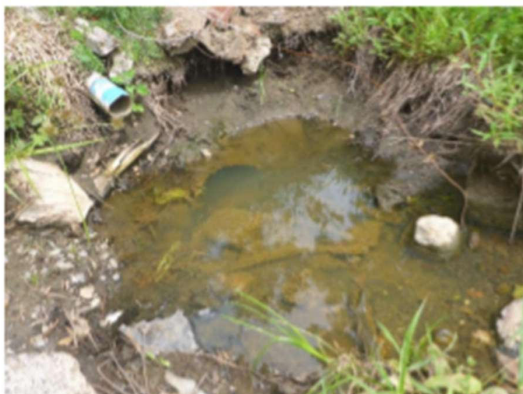
Photo 12. Site 12: Aicken Rd, Whangamatā.

There were a few mud snails, chironomid non-biting midge larvae and oligochaete worms present and fish access was unimpeded.

Observations at this site were similar to the 2014 survey.

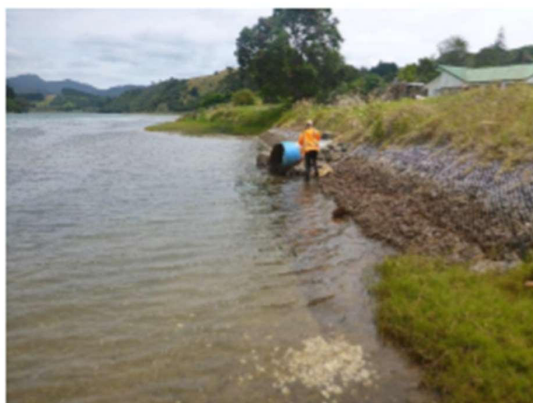
Photo 14. Site 14: Kotuku St, Whangamatā.

Cat's eye snails (*Lunella smaragda*) were abundant. Other species included shrimp, rock oyster (*Saccostrea glomerata*), limpet (Lottidae), oligochaete worms, amphipods, estuarine mud snail and whelk. No aquatic plants were present and fish access was not impeded.

Observations at this site were similar to the 2014 survey.

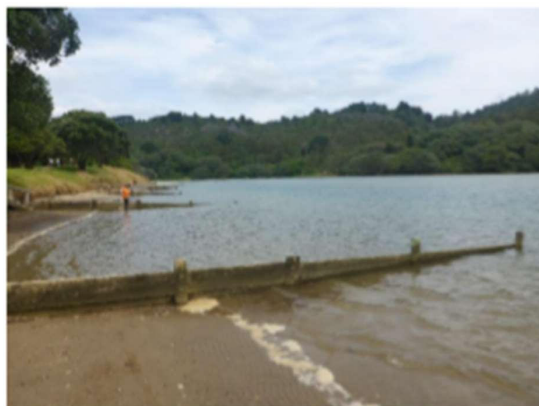
Photo 15. Site 15: Otahu Estuary, Whangamatā.

Site 15 is the estuary control site, with no stormwater outlet present. The substrate at this site was sandy. Fauna present included tunnelling mud crab, little black mussel (*Xenostrobus neozelanicus*), whelk, amphipods, isopods, mudflat topshell (*Diloma* sp.), cat's eye snail and shrimp. The estuarine triplefin fish (*Forsterygion nigrifenne*) was common. No aquatic plants were present.
