# Intertidal habitat mapping for ecosystem goods and services: Waikato estuaries

Prepared by:  
Hazel Needham, Michael Townsend, Judi Hewitt, Sarah Hailes  
National Institute of Water & Atmospheric Research Ltd

For:  
Waikato Regional Council  
Private Bag 3038  
Waikato Mail Centre  
HAMILTON 3240

September 2013

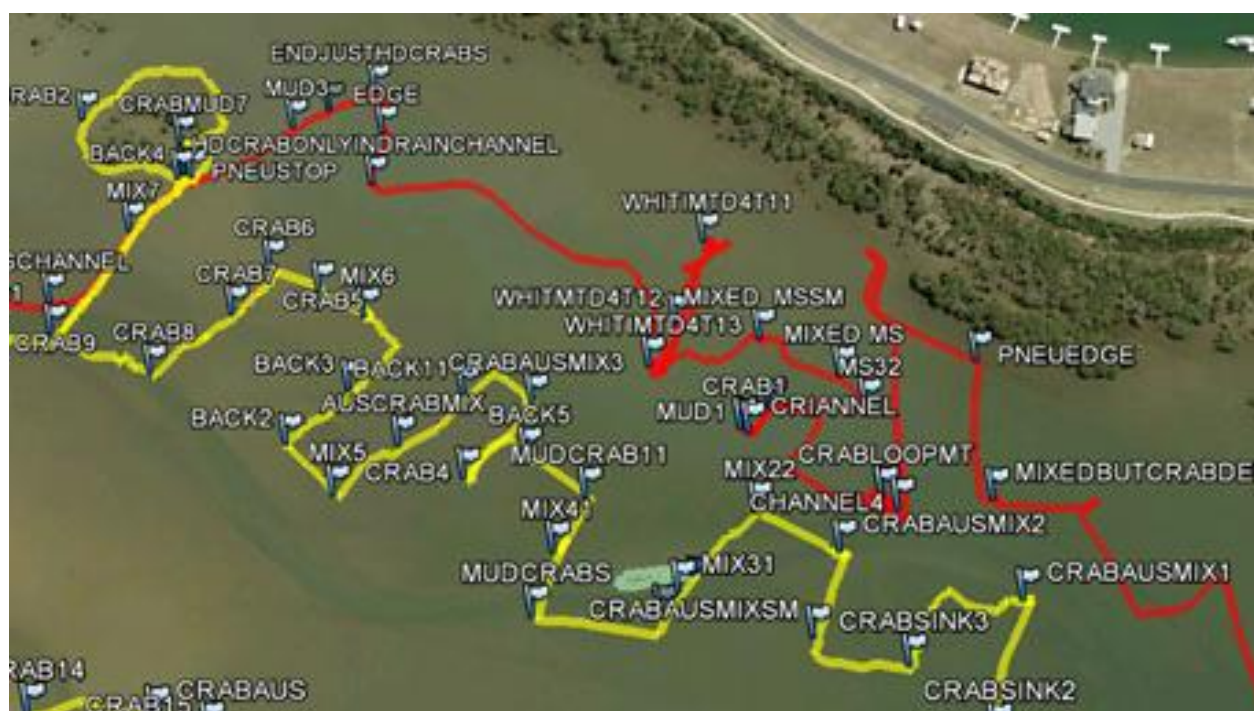
**Figure 2-1: Transects walked by two personnel in Whitianga displaying zig-zag technique for maximising the area covered.**

Field techniques followed those of Needham *et al.* (2013). To cover expansive intertidal flats quickly and effectively, transects were walked in a zig-zag formation to maximise the areas covered (Figure 2-1). Changes (or similarities) in habitat type were confirmed by multiple personnel and noted using waypoints. Similarly, a fan formation, whereby each individual would walk from a central point, was used to maximise coverage in long but narrow bays (Figure 2-2). Obvious boundaries between habitats were apparent for a number of the defined habitat types (for example, raised banks of shell rich sediments or mangrove patches). Where practicable, patch boundaries were walked in their entirety. Where extensive habitat regions existed (e.g., mangroves, seagrass) a section of the perimeter was walked (noted by GPS waypoints) so that this could be referenced to both the WRAPS 2012 aerial photos and existing GIS vegetation layers (both supplied by WRC). In areas where wide, expansive patches existed, two individuals walked the perimeter in opposite directions until they came together. Patches <10 m in their longest dimension were not noted on their own, due to the accuracy of the GPS units, but were amalgamated into the description of the surrounding area, or in the case of obvious vegetation, were drawn from WRAPS photos. Photographs were taken to collate information on different habitat characteristics and to cross reference each habitat type to ensure repeatability for these and future surveys.

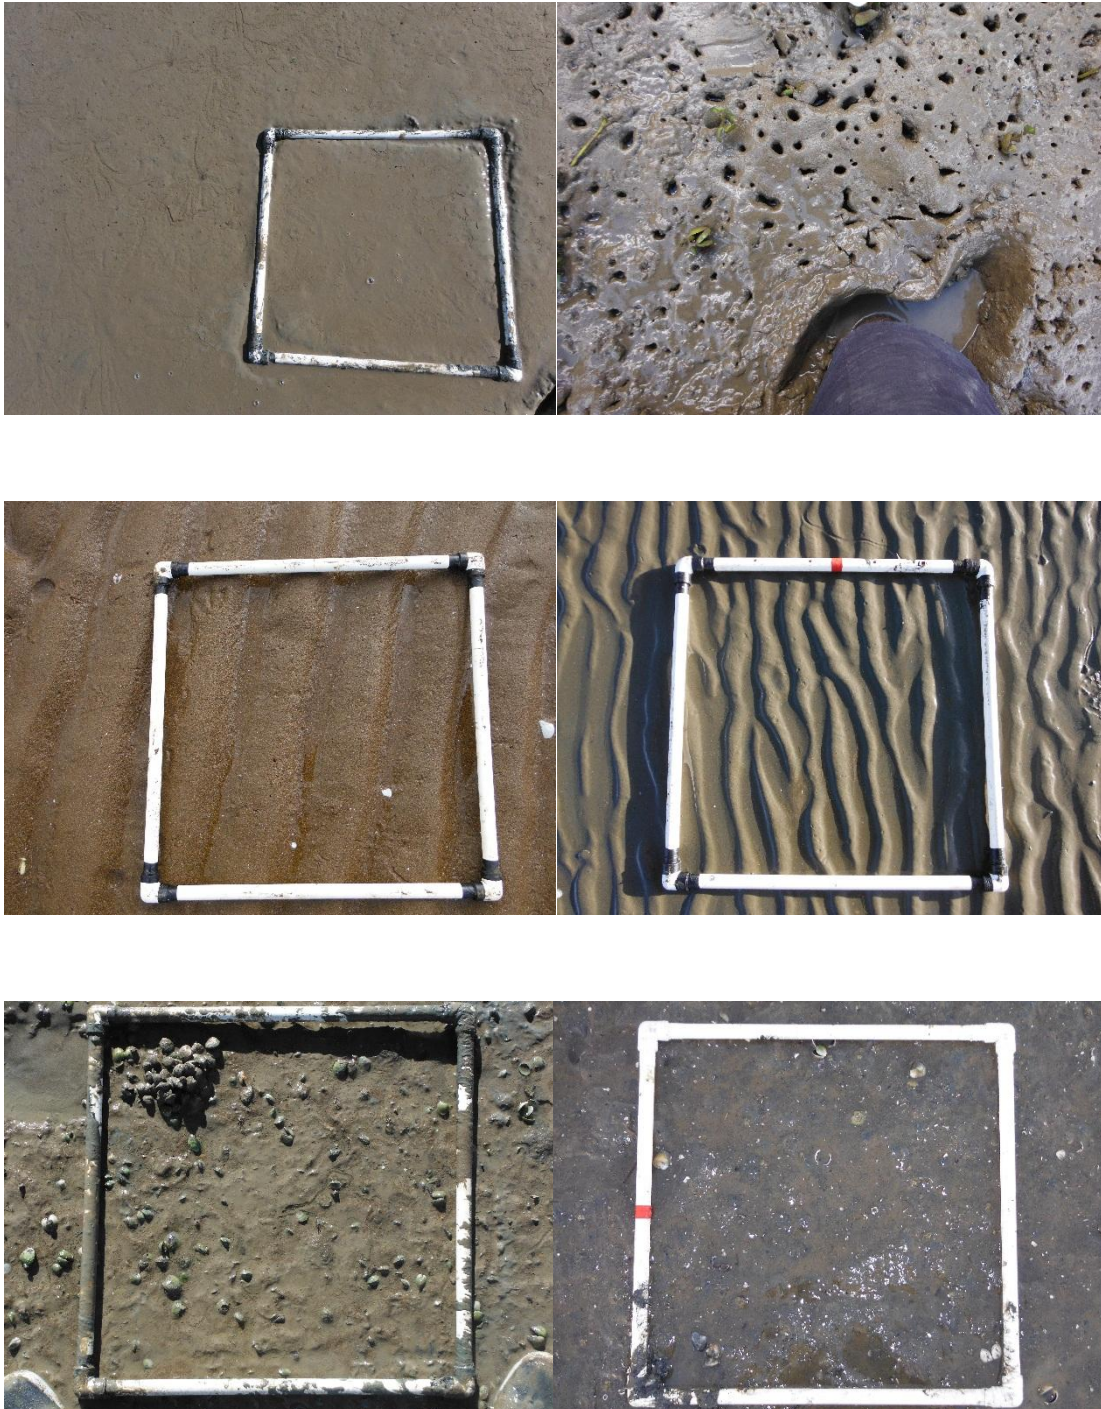
**Figure 2-3: Example of the sediment types: mud (top), sand (middle) and sandy mud/muddy sand (bottom).**

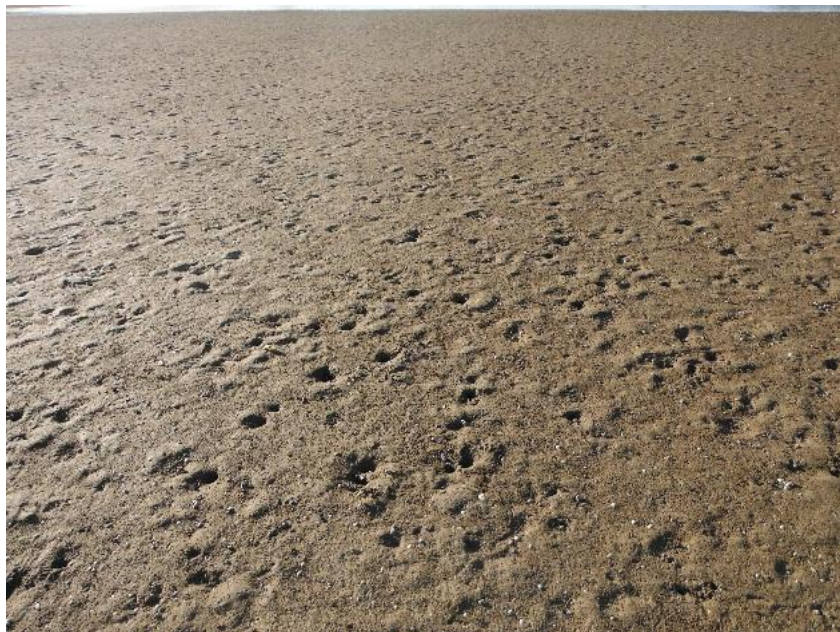
**Figure 5-2: High frequencies of small ray pits in the western bays of Whangamata could be mistaken for burrows.**

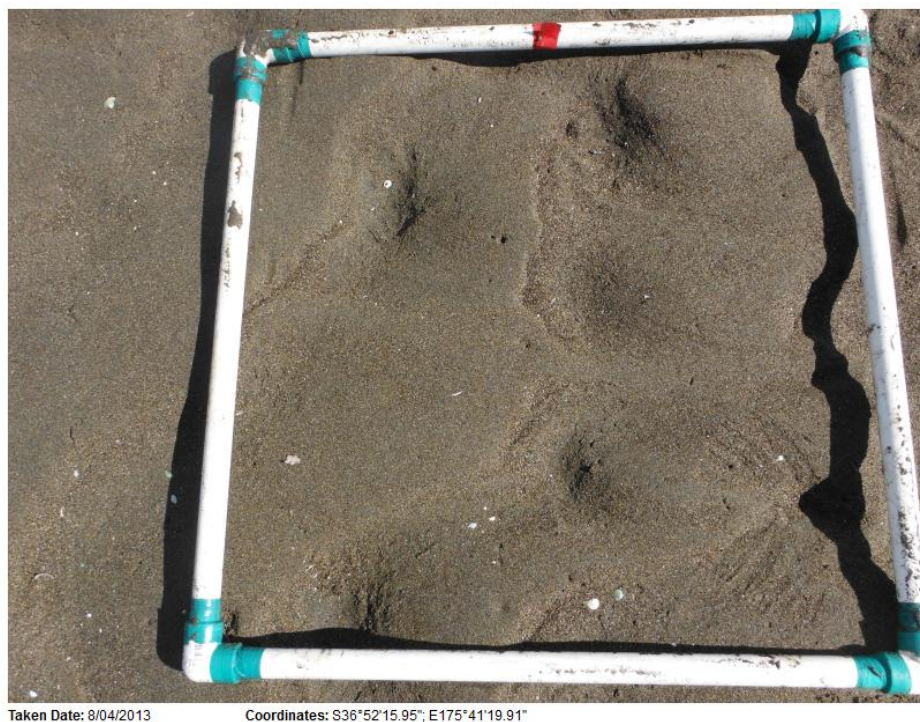
**Figure 5-6: Sandy sediment in the upper reaches of Whitianga Harbour.**

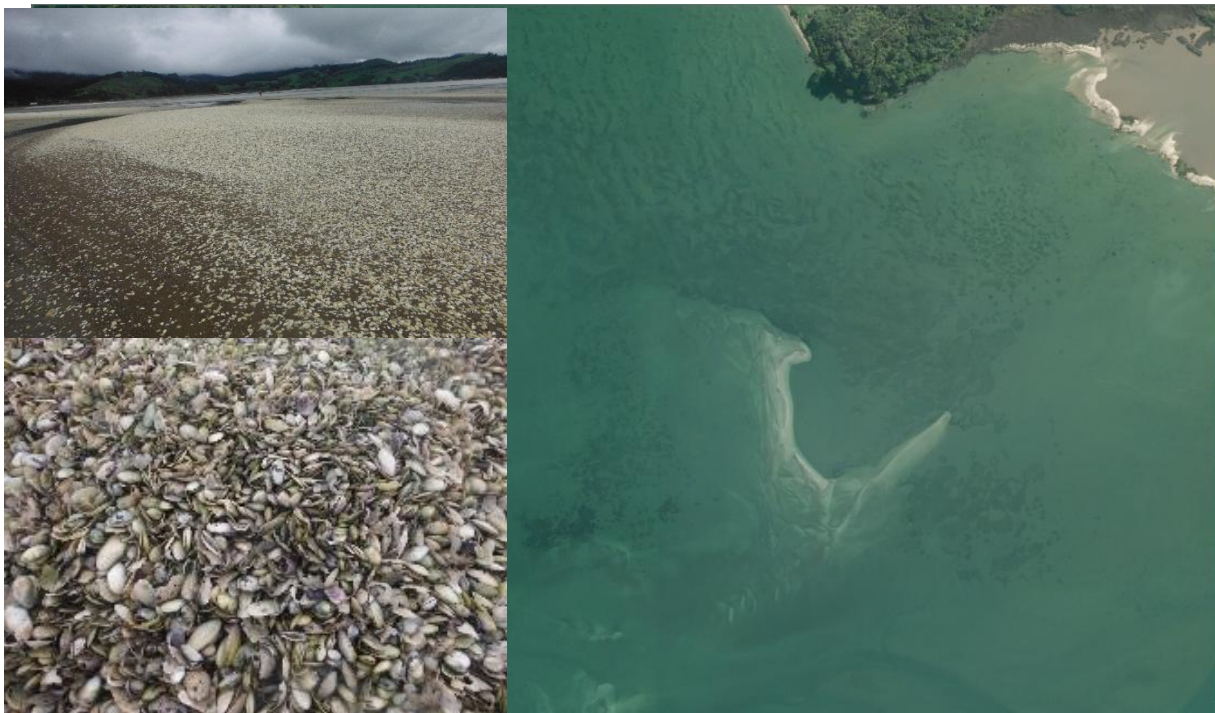
**Figure 5-13: The shell bank found in Brickfield Bay.** Seen as the white outline in the centre of the picture (right). The bank is comprised of pipi and some cockle shells (left).

- Coromandel Harbour has extensive intertidal flats and is host to many mussel and oyster farms.
- The large shell bank in Brickfield Bay is migrating shoreward (Figure 5-13). *Google Earth* images show that it has moved approximately 60 m since 2001; equating to a rate of  $\sim 5 \text{ m y}^{-1}$ .
- Intertidal oyster farms have altered flow dynamics and facilitated silt and mud accrual in the surrounding areas (Figure 5-14).
- More litter present than any of the other estuary.
