THAMES COROMANDEL DISTRICT COUNCIL

ANNUAL REPORT

Comprehensive Stormwater Discharge Consents 2018 - 2020

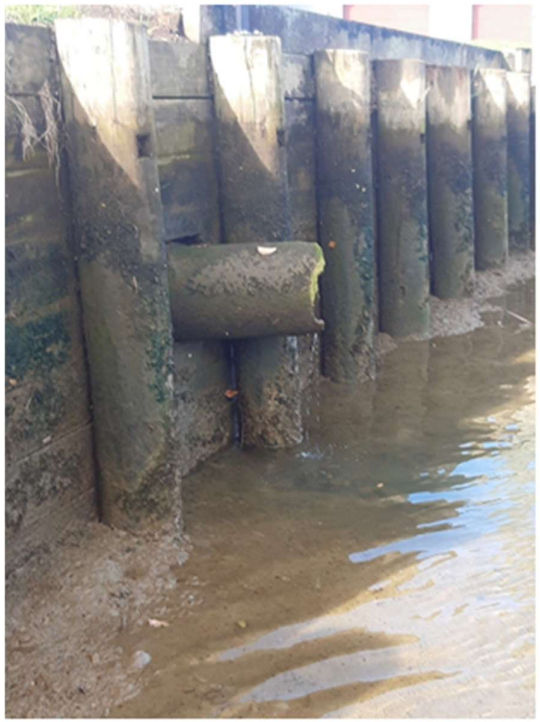
Ref 06	February 2020, Coromandel outfall to Whangarahi Stream	June 2020 Coromandel outfall to Whangarahi Stream
	Silt layer has developed with absence of strong stream flows. Recent work in the CBD has replaced a portion of the upstream SW reticulation improving system performance. 	Site after a heavy rainfall event identifies minor scour under outlet Site conditions remain similar.
