# **Whangamata Stormwater Catchment Management Study Catchment Management Study**

**Updated** Issues and Options Report

Draft **Version 2**

*Thames-Coromandel District Council*

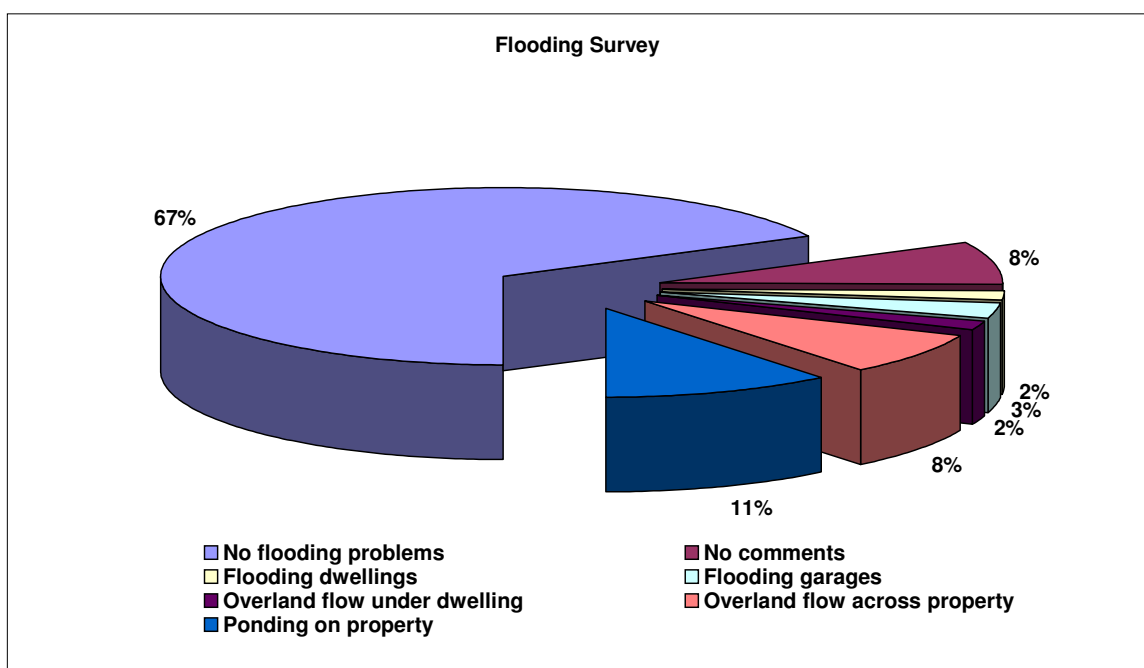
The questionnaire responses indicate that 67% of residents have no flooding problems and the remaining 33% do experience flooding problems to some degree. A total of 2% have had their dwellings flooded, 3% garages flooded, 11% ponding on property, 2% overland flow under dwellings, and 8% overland flow across property. A graphical representation of the distribution and the nature of flooding problems is shown below:

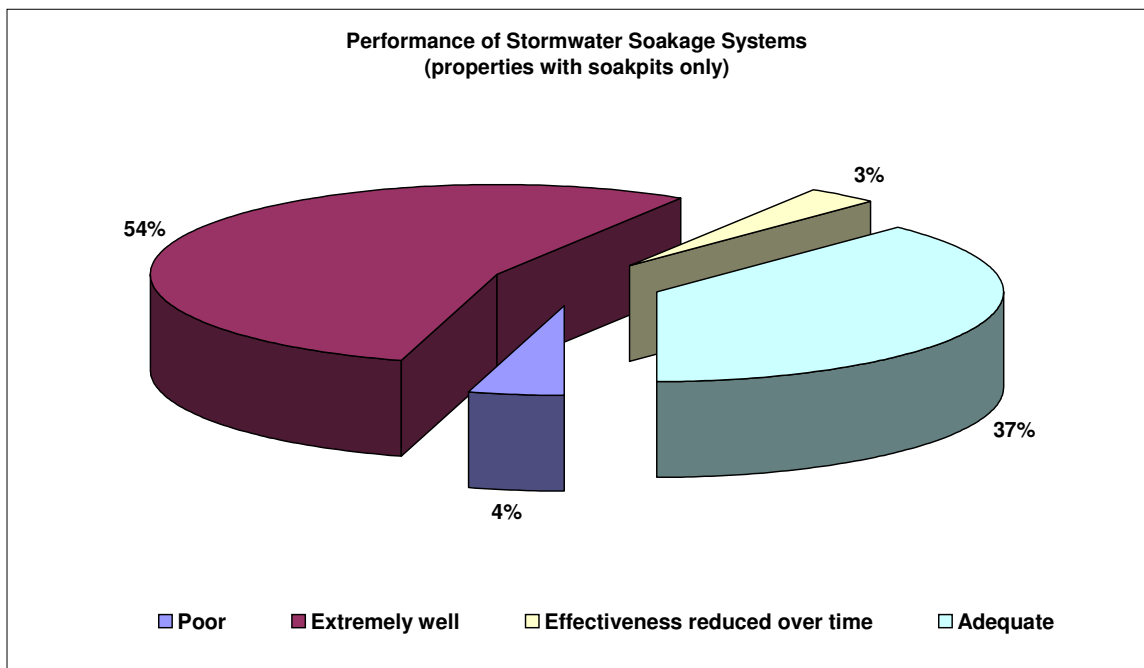
The questionnaire responses indicate that 29% do not have a soakage pit on their property (or presumably are not aware of it) and the rest (71%) have a soakage pit, of which 54% record soakage to be working extremely well. A graphical representation of the soakage performance is shown below:
