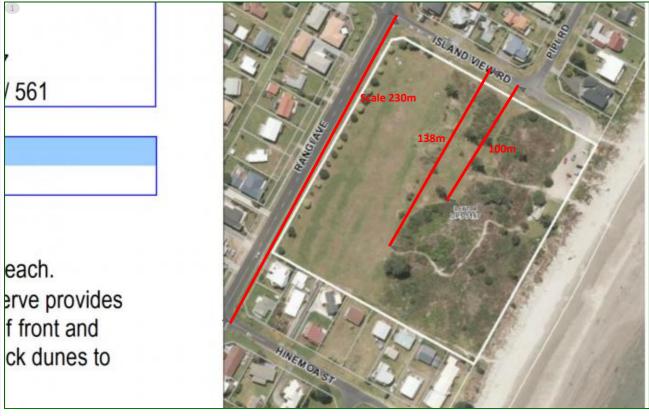
2013 Island View in TCDC Adventure playground submission.jpg

This 2013 satelite image is attached to the consultation document for the adventure playground.

The 100m mark is scaled off the road separation between Island View and Hinemoa at 230m

The 100m mark is the edge of the then detention area.

The 138m plot is the track through the sand dunes that later had a boardwalk built.

It appears the green vegetation is the extent of the detention area.

Note the boardwalk is not yet installed. This construction could well have caused the detention area width to be reduced to save building piles.
