**MEMO****To:** Jonathan Smith**From:** Tim Lockie; Manu Ward**CC:****Subject:** WILLIAMSON ROAD STORMWATER ASSESSMENT**Date:** 9 May 2018**File number:** J000056.01

This memo report outlines the hydraulic relationship between Williamson Golf Course and Williamson Park Pond in Whangamata, based on the 2007 model of the stormwater network.

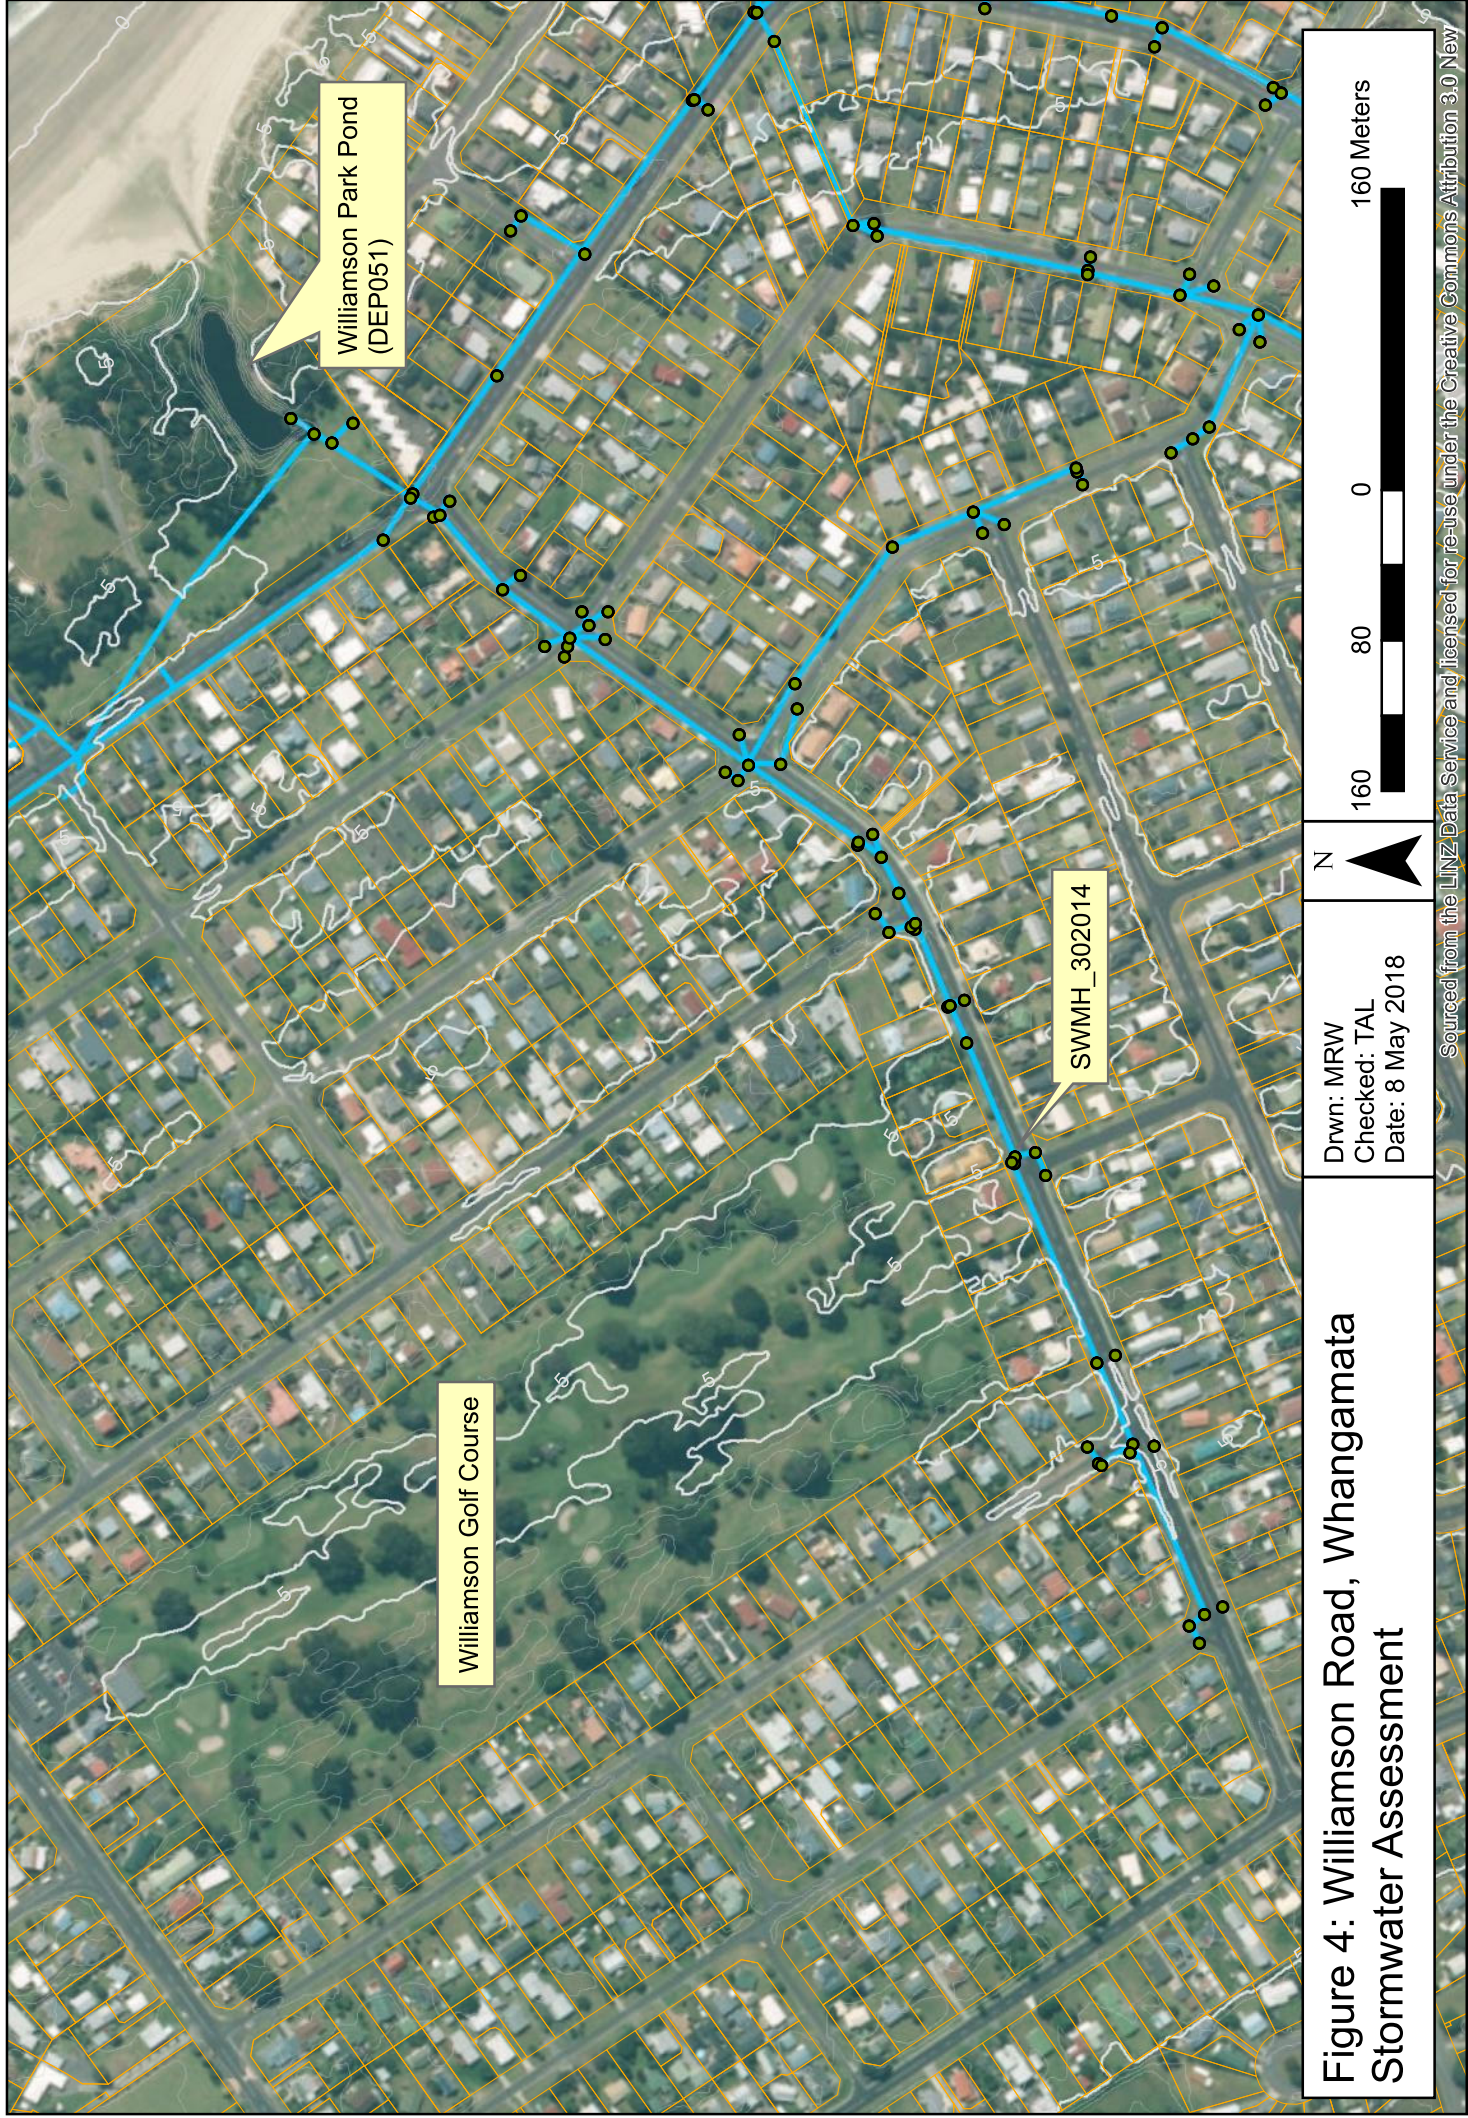
FIGURE 5: SWMM 5YR MODELLED LEVELS

Water levels at these locations are plotted in the attached chart (Figure 5).

The scenarios are differentiated by tone: dark/bold lines indicating “normal” conditions, and light lines indicating “blocked” conditions as described above.

However, spillway blockage and reduced soakage at the pond does appear to affect the length of time that water levels are raised within in the upstream network. At the manhole near Williamson Golf Course, water levels are higher than 4.4 m RL for 17.1 hours under “normal” conditions, but 45.8 hours under “blocked” conditions (compare the dark and light green lines in Figure 4 attached). According to LiDAR information, low points in the golf course surface are at about 4.4 m RL, so flooding is expected when TWLs are above that level.

The network will perform better if the pond is well maintained, including regular removal of sludge to ensure good infiltration rates, and shaping/levelling the overflow path for extreme events.

- Regular maintenance of the pond is recommended, including removal of sludge and periodically clearing sediment and vegetation from the spillway.
- If Council wish to carry out options analysis for additional work to address wider flood issues in the Williamson Road area, it is recommended that the 1D model is updated to a coupled 1D/2D model. Better efficiencies and economies of scale can be achieved if this is carried out for the entire Whangamata Catchment as part of a wider strategy to develop a Catchment Management Plan.
