HITEX DIAMOND CAVITY PLASTER CLADDING SYSTEM

Hitex Diamond cavity plaster system (often called by its generic name EIFS) was manufactured between 2003 and 2010 by Hitex Building Systems Limited in response to the 'leaky building' crisis.

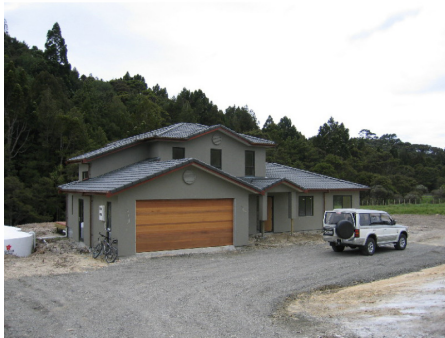
Figure 5 (above) : House at Hxxxx Bxx, Dairy Flat, built in September 2004

Figure 6 (right) : Moisture readings over two year period.

Figure 5 as an example shows a house that has had moisture probes in place since it was built two years ago. The three moisture readings that have been taken over two years are shown in Figure 6. The Risk scores vary from 8 -13 on this building (Table 2) . The references to either NZBC Clause E2 or to the Hitex web site for the SWD's is also included in the table.

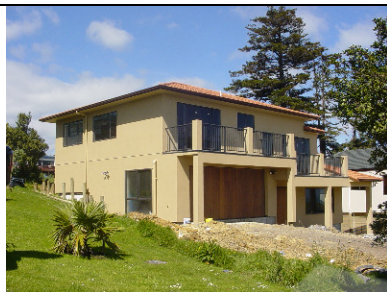
**Figure 7 (above):
Photograph of house at
Cxxxxxxx Place, Maraetai**

**Figure 8 (right): Moisture
readings over two year period**

This has been demonstrated with Mdu's in walls clad with the Hitex Diamond cladding with Risk scores in the 14 -17 range. The use of Mdu's has provided an opportunity for the ongoing monitoring of buildings, e.g. house at Cxxxxxxx Place, Maraetai (Figure 7) where the initial moisture content in some of the timber was high at construction then was shown to reduce over time to well below 18% moisture content (Figure 8) . More recent moisture content readings in 2006 (Table 3) have picked up an increase at some probe positions and this is now being investigated. The rise in moisture content is presently under investigation. There are 8 possible leak sources to look at (Figure 9).
